IMPROVING THE RESILIENCE OF EXISTING HOUSING TO SEVERE WIND EVENTS

MANY OF US LIVE IN HOMES WITH VULNERABILITIES THAT CONTRIBUTE TO COMMUNITY WIND RISK. THIS PROJECT AIMS TO INVESTIGATE WINDSTORM RISK MITIGATION BY: (A) DEVELOPING VULNERABILITY MODELS FOR STRUCTURAL STRENGTH OF HOUSING FROM FIELD AND LABORATORY OBSERVATIONS, AND (B) EVALUATING POTENTIAL UPGRADING AND RETROFITTING SOLUTIONS FOR RESIDENTIAL STRUCTURES.

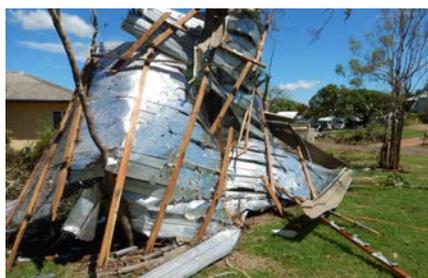
Wind-induced failure of a metal cladding roof at the batten to rafter connection during Cyclone Marcia (2015) in Yeppoon, Australia - there appeared to be no retrofitting of the weaker connections.
