INVESTIGATION OF DAMAGE: BRISBANE 27 NOVEMBER 2014 SEVERE STORM EVENT

Research proceedings from the Bushfire and Natural Hazards CRC
& AFAC conference
Adelaide, 1-3 September 2015

K. I. Parackal^{1,3}, M. S. Mason^{2,3}, D. J. Henderson^{1,3}, D. J. Smith^{1,3} and J. D. Ginger^{1,3}

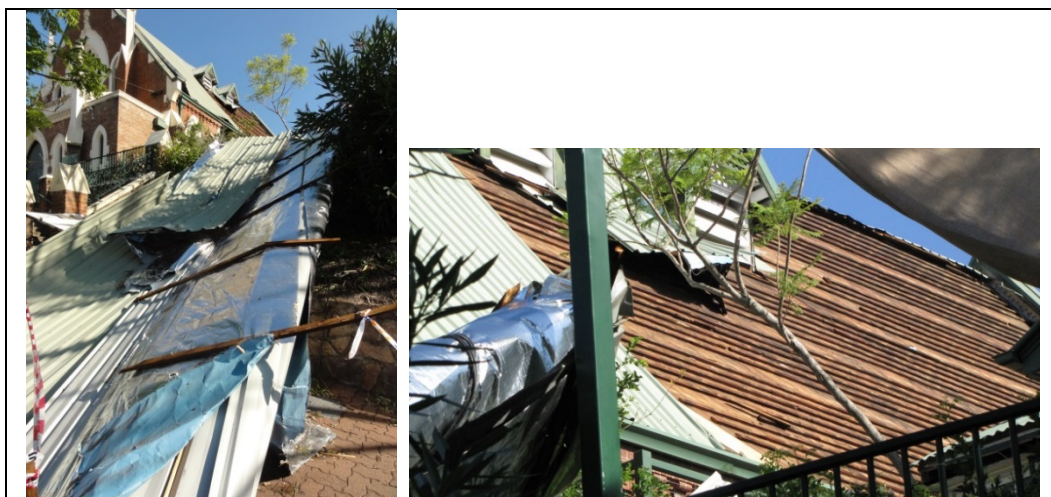
Several failures of new roofs installed on old structures were observed. This was often the case for tile roof buildings that were replaced with newer metal cladding (Figure 3) Generally original battens were retained but the new cladding only fastened to a few battens. In one case this was to every 3rd batten and in another every 6th batten. This resulted in the overloading of batten to truss connections or cladding fasteners during the storm, causing the failure of large sections of the roof. In some cases, when metal clad roofs were replaced with new cladding, the older battens were not checked for rot or degradation. In one case this resulted in the loss cladding of the entire roof (Figure 4)

Figure 3: Loss of metal cladding and battens of a church. Originally a tile roof, the new metal roof was only secured to every 6th timber batten.

Damage from this event highlights the importance of reconstruction and repairs being carried out in accordance with relevant Standards and the regular inspection of structural elements within the roof space, to look for signs of deterioration such as corrosion and rot. For the rebuilding or upgrading of older housing, the complete load path from roofing to foundations must be considered, this is especially relevant when changing from a tile roof to metal roof cladding. Reference should be made to documents for the upgrading of older housing such as HB132.1 or AS1684 User guide no 3 (FWPRDC, 2002, Standards Australia, 1999).

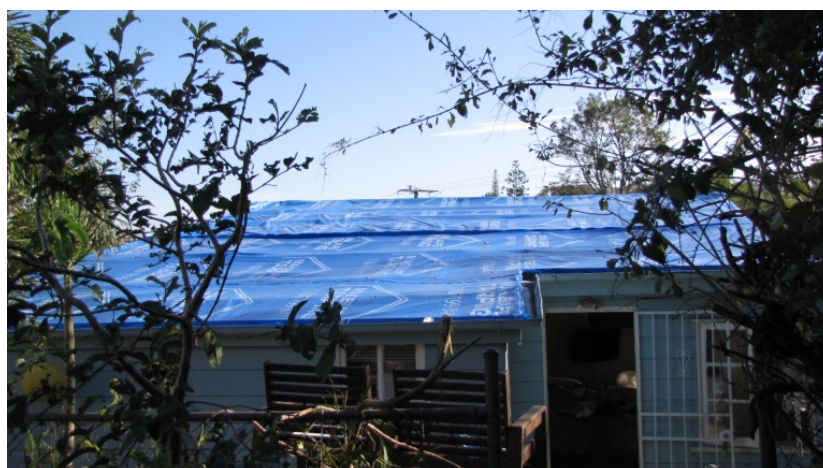
Figure 4: Loss of cladding and battens of an older home. New cladding had been installed onto the original battens.

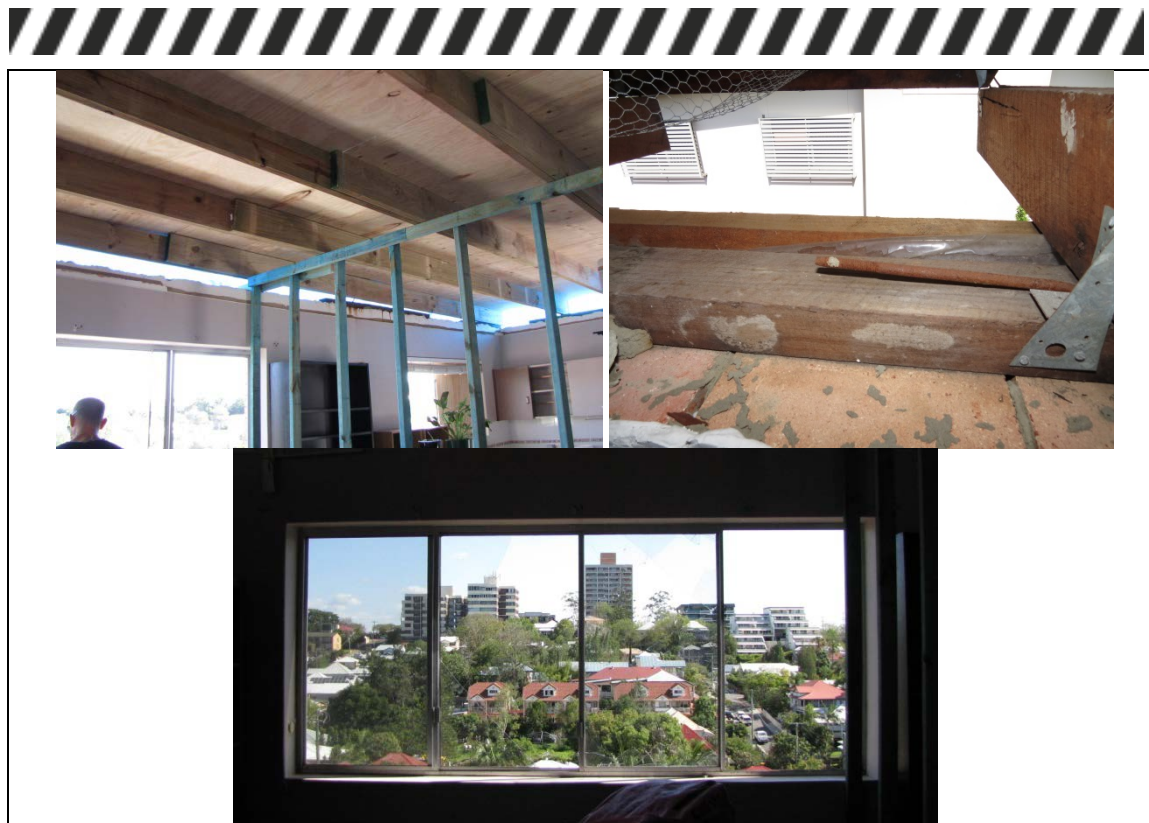
There were cases of complete roof loss of top floor units of some double brick apartments with timber roofs. For one site that was surveyed this had occurred due to window damage by hail, and a subsequent dramatic increase in internal pressure. The timber rafters of this apartment was observed to have insufficient tie down and resulted in the loss of the entire roof structure (Figure 5). Most cases were roof failures occurred resulted in debris damage to neighbouring properties otherwise undamaged by wind loading.

Figure 5: An example of complete roof loss of the top storey unit of a 3-storey apartment building (new roofing currently being installed). Original timber rafters had inadequate tie down to withstand internal pressure due to the breakage of a large southern facing window. The unit was also located on top of an escarpment (outlook shown in the lower photograph) and may have experienced slightly higher wind speeds.

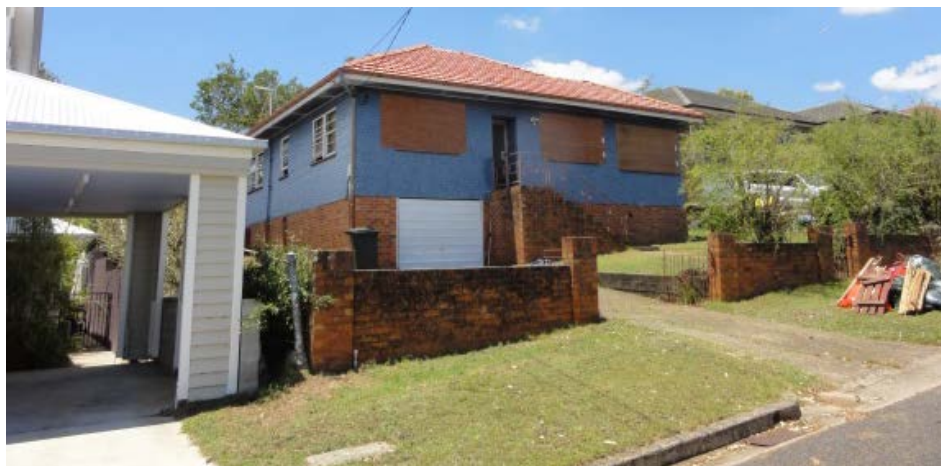
The level of damage to houses was especially high due to window breakage from hail and subsequent water ingress. The latter could be observed by damaged furniture and goods that were placed outside of homes for collection (Figure 6). Apart from the widespread damage to cars from hail, it is likely that water ingress would be a large contributor to insurance claims from this event.

Figure 6: Broken windows on the southern facing wall as well as water damaged goods placed at the front for collection was commonly observed.

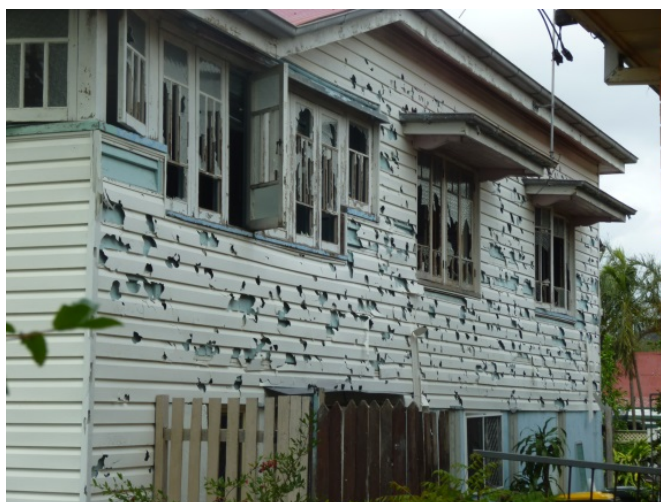
The strong winds created a significant horizontal component in the trajectory of the hail. Many streets were surveyed that had the majority of windows on the southern side broken, even those that were protected by awnings, while windows on other sides were undamaged (Figure 7).

Figure 7: Hail damage to windows and vinyl cladding of an older house. The proximity of the neighbouring house on the right and the size of the window shades suggest hail being driven at a sharp angle by the wind.

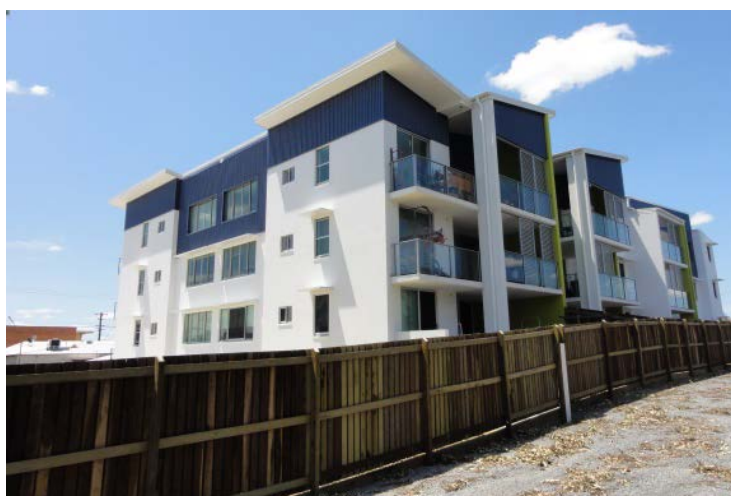
It was observed that newer windows showed a better resistance than older thinner window glass. There were several examples of new homes or recently renovated homes with new windows experiencing little to no hail damage compared to older houses nearby (Figure 8). Thus, anecdotally, the installation of the new windows can reduce the vulnerability to water ingress and potential structural damage from internal pressures.

Figure 8: A new apartment building in a storm-affected neighbourhood. All windows on the exposed southern side were undamaged, indicating the improved performance of new window glass.
