Influence of Road Characteristics on Flood Rescues in Australia

Andrew Gissing^{1,2,3}, Simon Opper¹, Jonathan van Leeuwen¹

¹ Risk Frontiers, ² Macquarie University, ³ Bushfire & Natural Hazards CRC

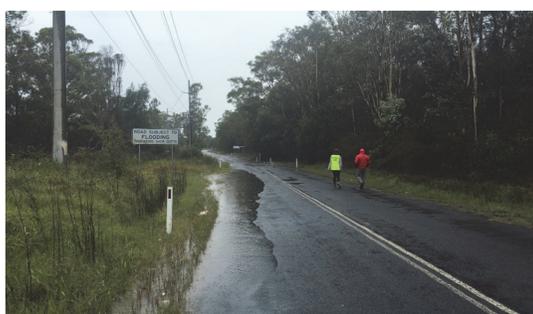
Site of flood fatality at Leppington, 2016

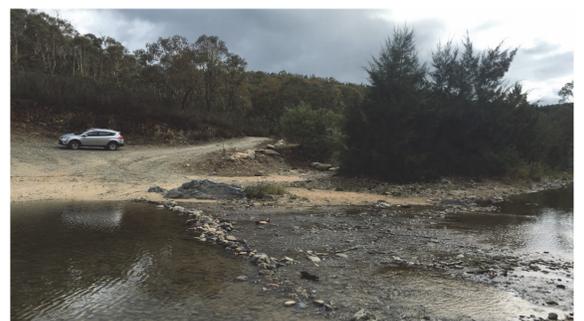
Site of flood fatality outside of Canberra, 2016

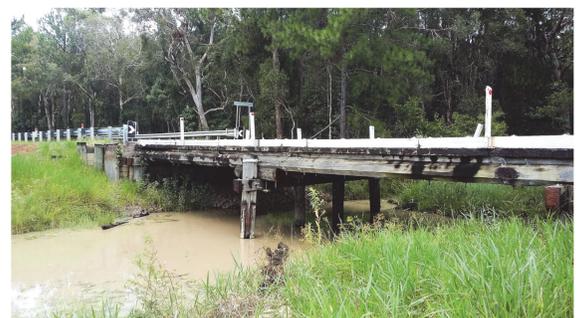
Site of flood fatality Caboolture, QLD, 2015
