Improving the Resilience of Existing Housing to Severe Wind Events

John Ginger, Korah Parackal, David Henderson - Cyclone Testing Station - James Cook University, Townsville

Martin Wehner, Ryu Hyeuk, Mark Edwards – GeoScience Australia, Canberra

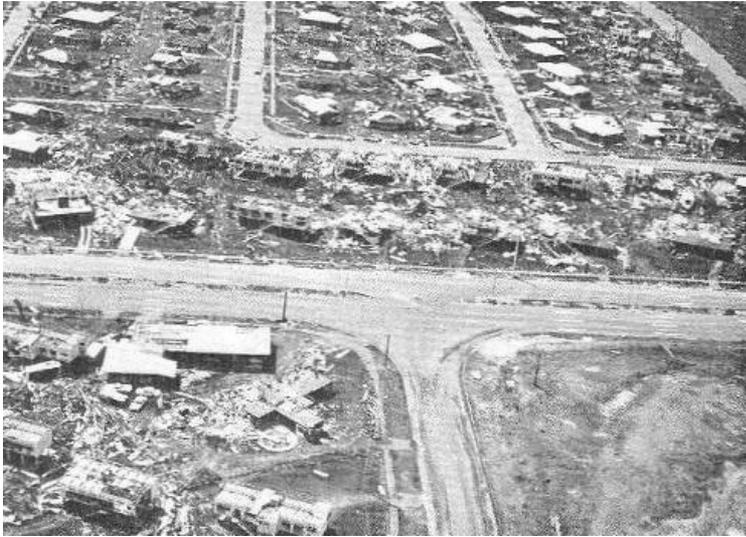
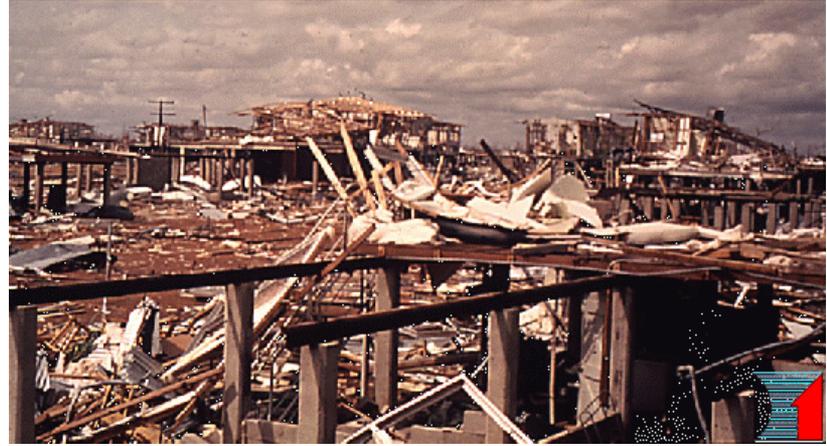
Cyclone Tracy - 1974

- Post windstorm Damage investigations following have shown that Australian houses built prior to the mid 1980s do not offer the same level of performance as houses constructed to contemporary building standards.
- The primary objective of this project is to develop cost-effective strategies for mitigating damage to housing from severe windstorms across Australia. These strategies will be
 - a) tailored to aid policy formulation and decision making in government and industry and
 - b) provide guidelines detailing various options and benefits to homeowners and the building community for retrofitting typical at-risk houses in Australian communities.

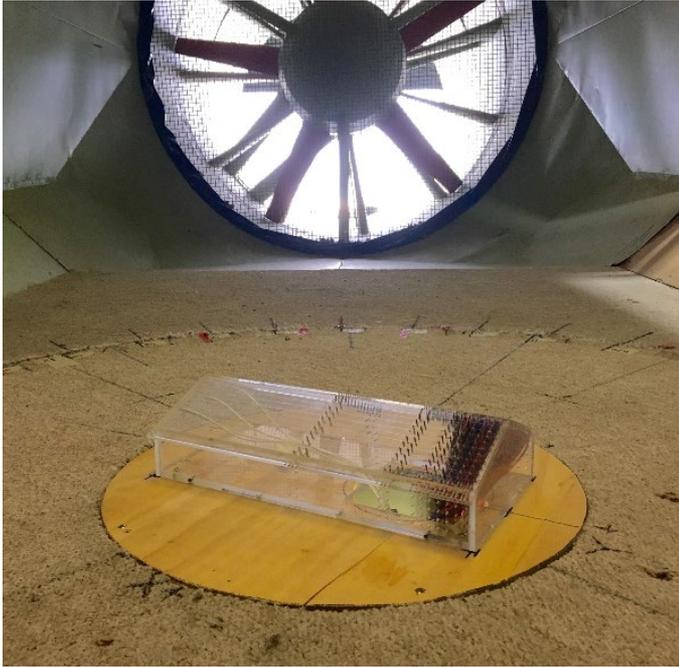
External Pressures on a Roof

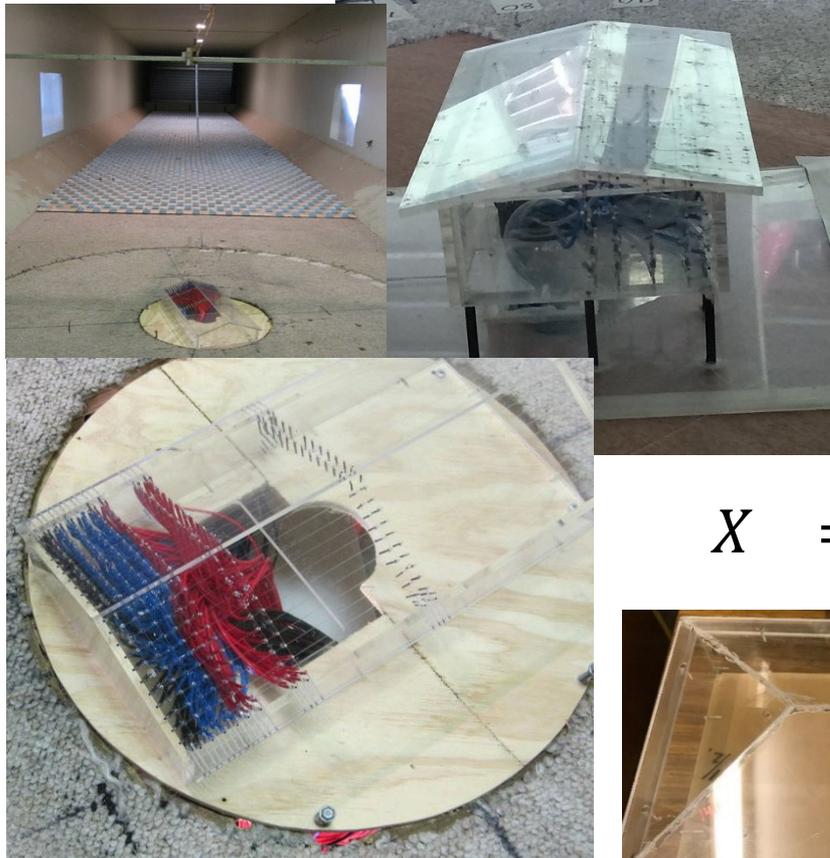
Wind Tunnel Model Tests

Tests in Wind Tunnel at the Cyclone Testing Station, James Cook University. On representative houses at a length scale (L_r) of 1/50
