Cyclone Testing Station Preliminary Damage Report

Tropical Cyclone Olwyn, WA, Australia

March 11-14th, 2015

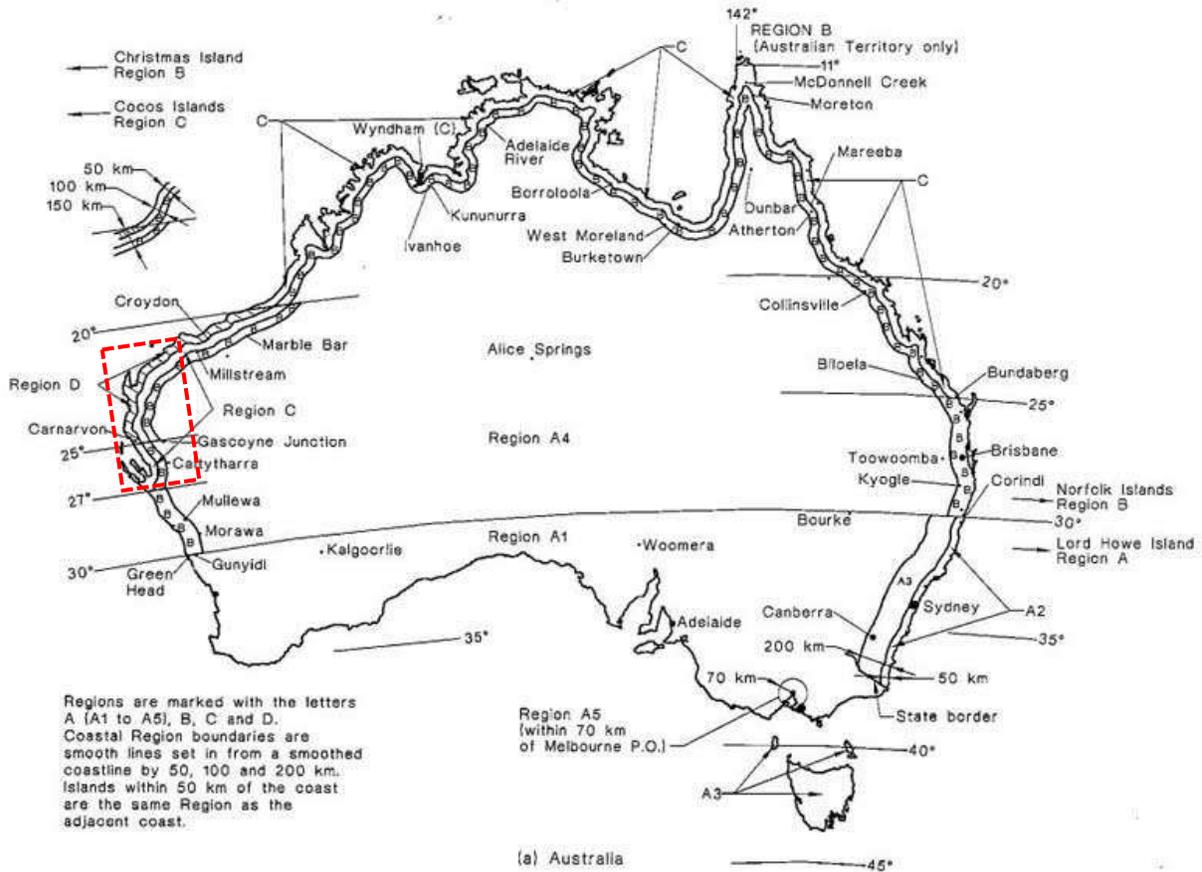
Figure 3. Design wind speeds for Australia based upon AS 1170.2 (2002). The region impacted by Tropical Cyclone Olwyn (highlighted by the rectangle) has a design wind speed varying from 88 m/s (316 km/h, 197 mph, $V_{0.2}$) for Exmouth to Carnarvon in Region D, to 57 m/s (205 km/h, 128 mph, $V_{0.2}$) at Geraldton in Region B.

Exmouth is in wind Region D as defined in AS 1170.2 as shown in Figure 3 with regional design gust wind speed in standard conditions for Importance Level 2 buildings of 316 km/h (88 m/s, 196 mph). Residential structures designed in WA since the mid-1980s should meet a design wind speed defined in different ways in the varying standards but with an ultimate wind speed equivalent always near 310 km/h (86 m/s, 193 mph). Hence the recorded peak gust in the cyclone near landfall was ~64% of the design ultimate wind speed for residential buildings in that location (allowing for the conversion of 3 second gusts to design wind speeds).

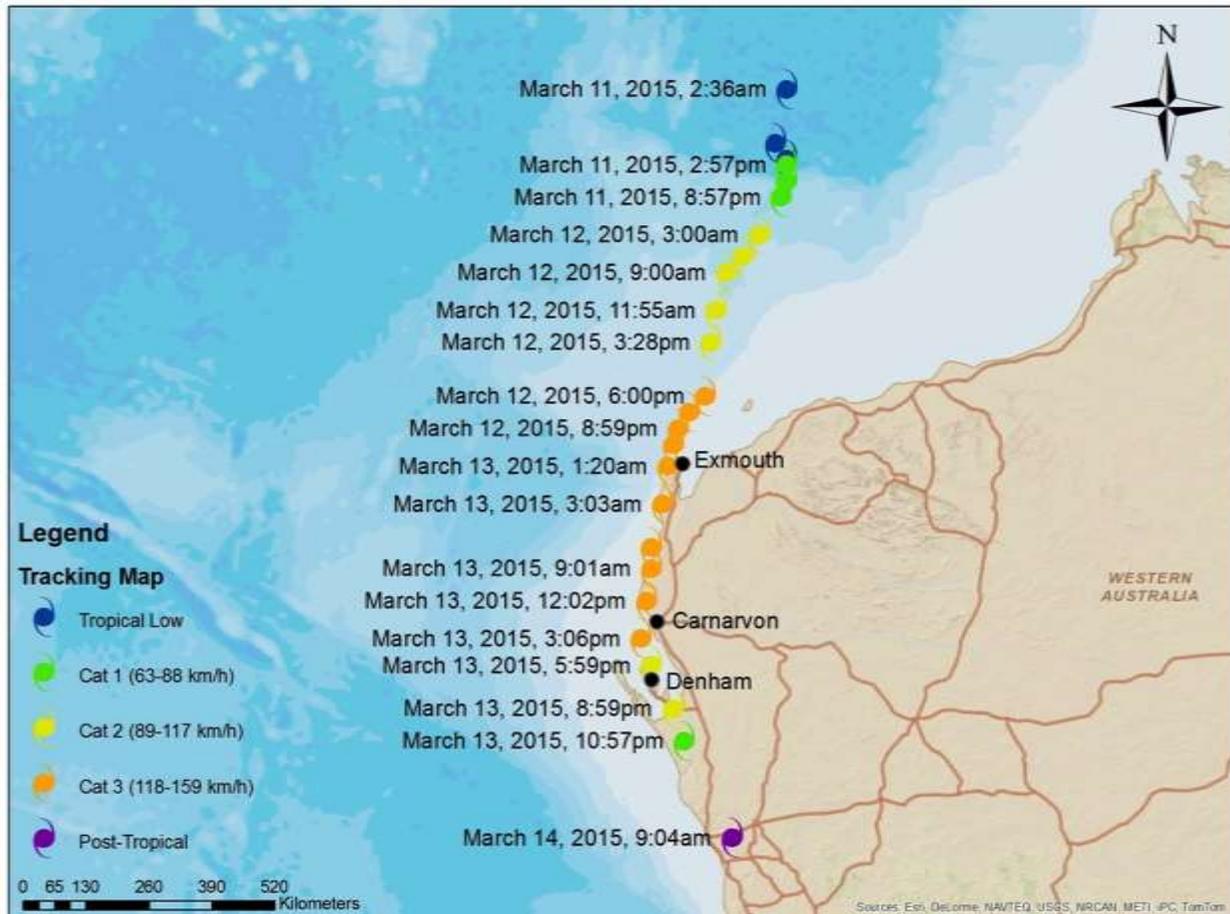
Figure 4. Tracking map for Tropical Cyclone Olwyn based upon bulletins from the Australian Bureau of Meteorology. Times are in Australian Western Standard Time (+8 UTC). The legend shows cyclone categories with 10-minute sustained wind speeds (See Table 1 for 3 second gust speeds).

Figure 4 shows the track of TC Olwyn based upon bulletins from the Australian Bureau of Meteorology (BoM). Times are given in Australian Western Standard Time (AWST), which is 8 hours ahead of UTC. It should be noted that the Category designations are from the BoM. The scales are summarized in Table 2. Note that the Australian classification uses 10-minute sustained (mean) as opposed to the 1-minute sustained (mean) used by the Saffir-Simpson Scale in the U.S.. Therefore, the 3-second peak gust speeds (used by both scales) should be used for comparison purposes.

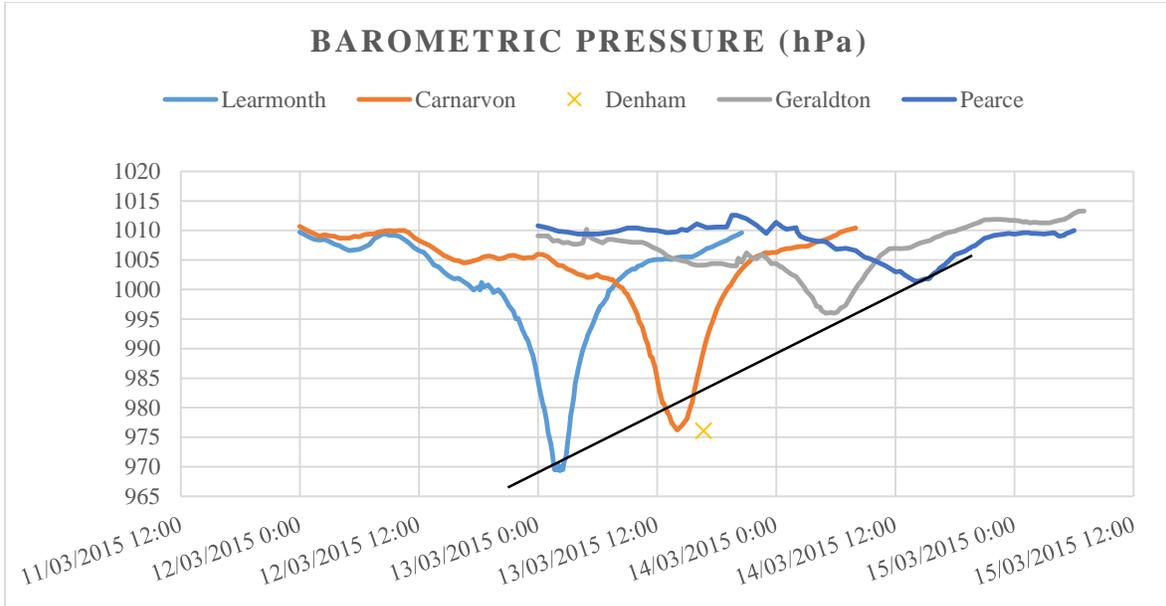
Figure 5. Barometric pressure (hPa) time-histories for BoM automatic weather stations during Tropical Cyclone Olwyn.

In each of Figures 5-7, the data from the four AWS have been summarized to show the reduction in intensity of the system with time over land. This is raw data and has yet to be confirmed by the Bureau of Meteorology. Their more detailed analysis of the AWS data may involve correction for calibration factors of each instrument and establishing whether the reported data may have been truncated or corrupted for any reason. However, for a preliminary assessment, the data shows that measured wind speeds correlate well with measured pressures and show a consistent reduction with time over land.

The change in wind speed and central pressure has been highlighted in Figures 5 and 6 by trend lines. In Figure 7 the change in direction with the passage of the eye has been highlighted using ellipses for Learmonth, Carnarvon, Geraldton and Pearce from left to right on the plot. For both Exmouth and Carnarvon, the wind shifted from SE to N via E with the peak wind coming from NE. For both Geraldton and Pearce, the wind shifted from SE to NW via W with the peak wind coming from SE.

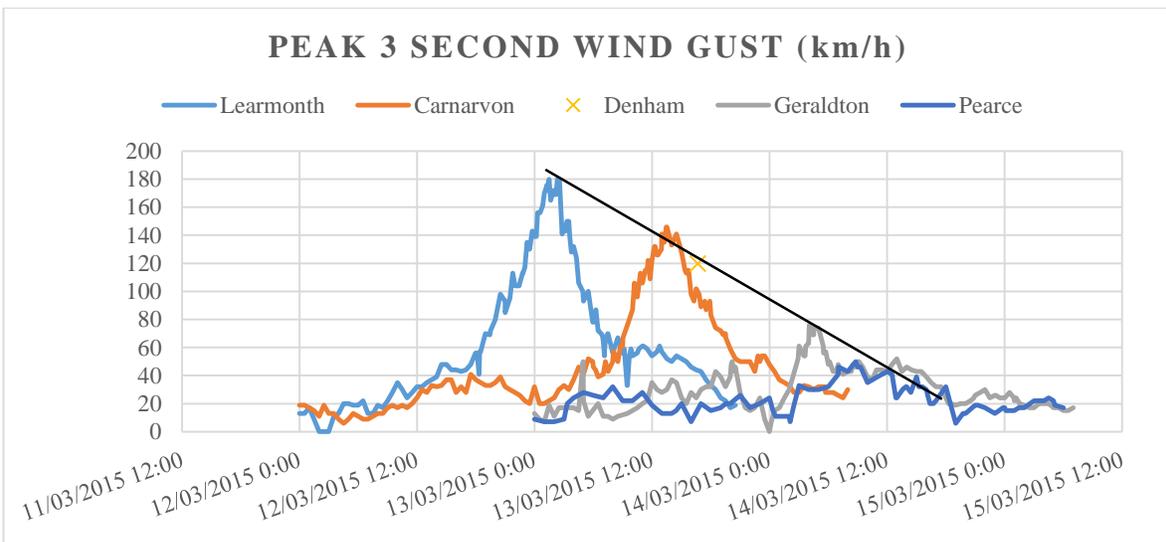
Figure 6. Peak 3 second wind gust (km/h) time-histories for BoM automatic weather stations during Tropical Cyclone Olwyn.

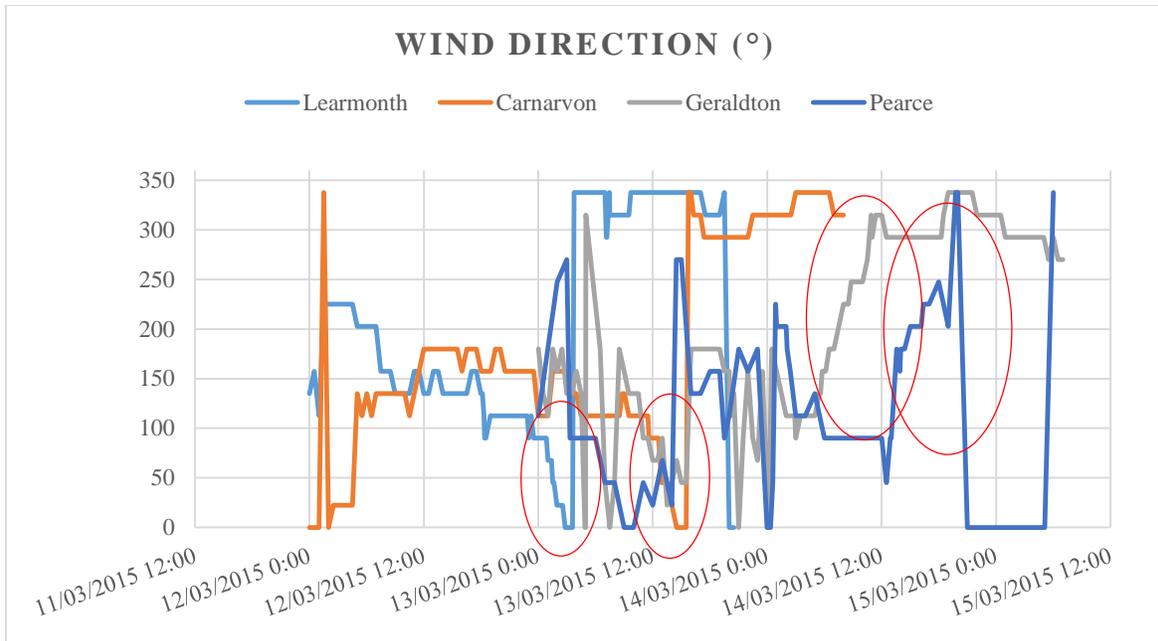
Figure 7. Wind direction (°) time-histories for BoM automatic weather stations during Tropical Cyclone Olwyn.

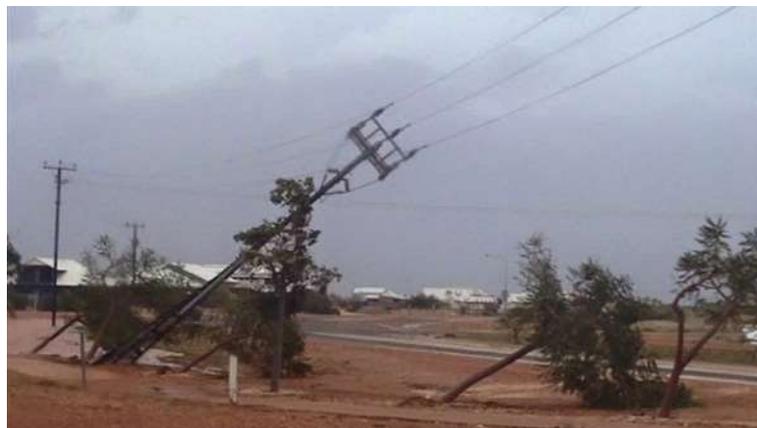
The population of Exmouth is approximately 2200 as of the 2011 census. Media reports from Exmouth indicated that 20 buildings needed SES attention. Indications are that roof damage was relatively minor. Damage to a power poles and older light industrial building shown in Figures 8 and 9 respectively is reminiscent of that seen after TC Vance in 1999, but this type of damage was more widespread in TC Vance.

Figure 8. Damage to power poles in Exmouth (Courtesy: ABC news).

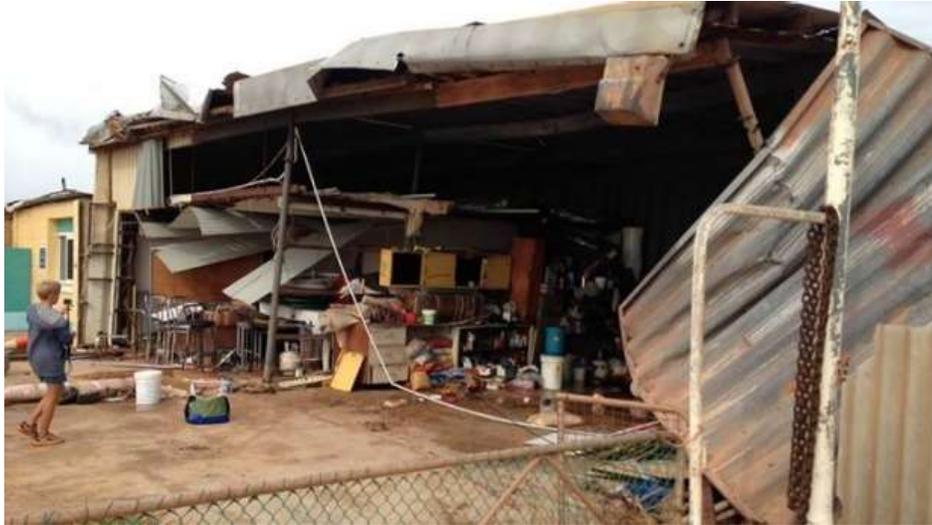
Figure 9. Damage to shed in Exmouth (Courtesy: Daniel Mumby)

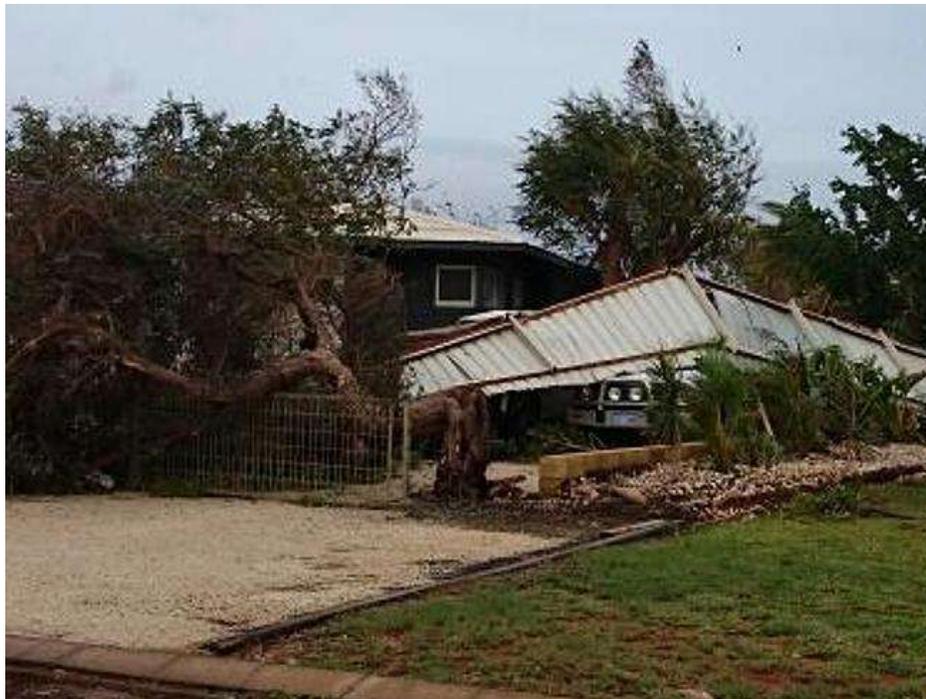
Figure 10 shows fence and tree damage in Exmouth. As the media chose to show this type of damage, it is likely that there is little structural damage to report.

Figure 10. Fence damage in Exmouth (Courtesy: Perth Now).

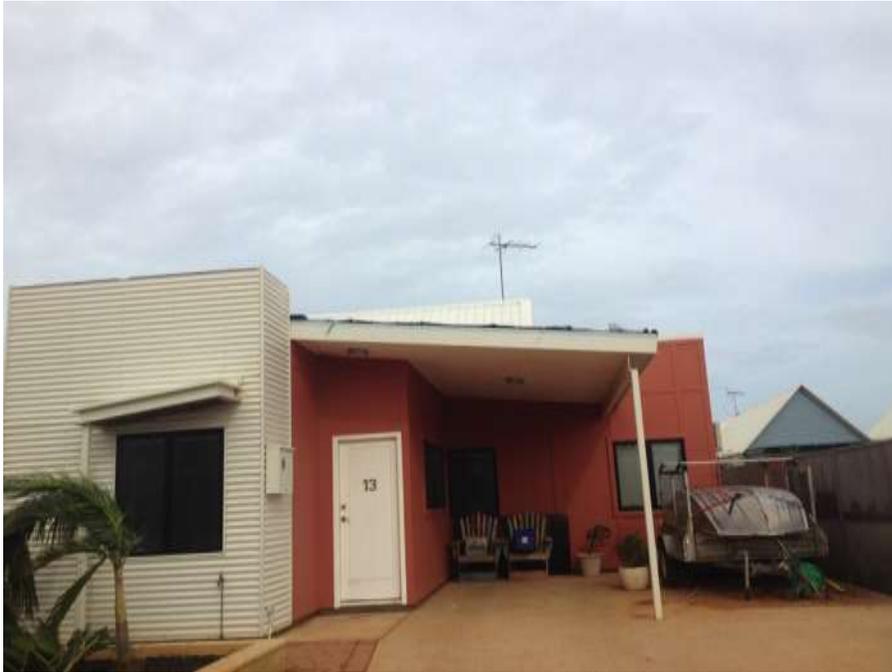
Water penetration into buildings appears to have caused some non-structural damage with anecdotal reports of ceiling loss and significant water ingress in a number of newer houses. Figure 11 shows one that has lost flashing. Water was reported to have gained entry to the ceiling space through flashings, and to the floors via window weep-holes. In some cases, new houses with no apparent physical damage sustained significant water damage to linings.

Figure 11. Flashing damage to more recent buildings in Exmouth

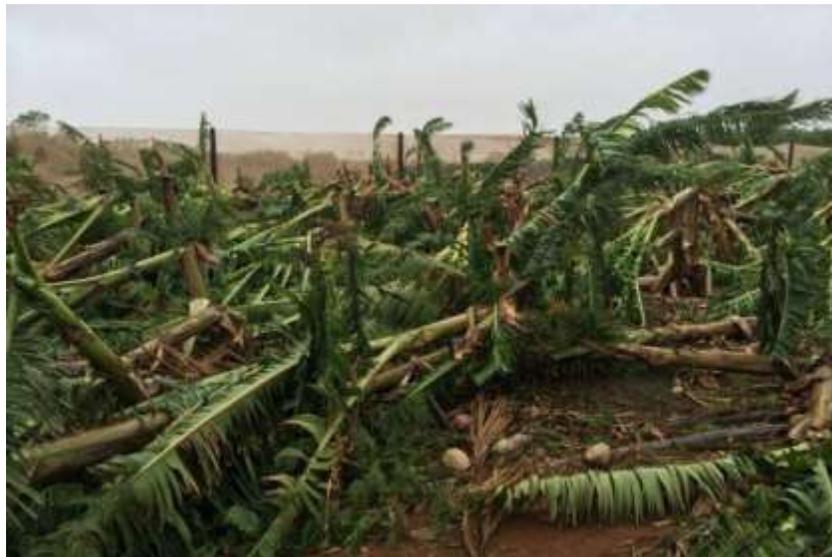
The population of Carnarvon is approximately 4500 per the 2011 census. The majority of buildings in Carnarvon were constructed prior to 2000. Media focus has been on the total loss of the banana plantations and damage to other crops with a few photos showing roof damage to older commercial and residential buildings.

Figure 12. Damage to banana crops at Carnarvon (Courtesy: Katie Pilgram).

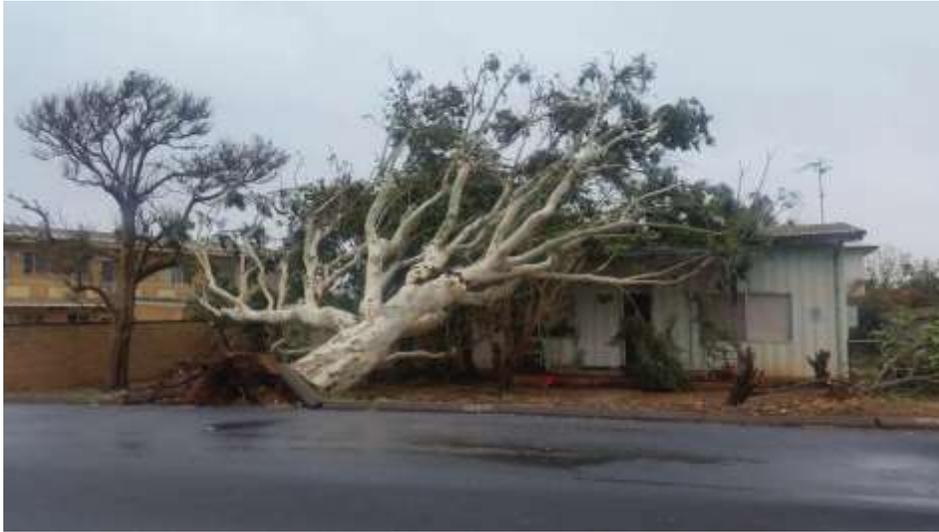
Much of the reported building damage was due to trees as shown in Figure 13 and wind loads on roof sheeting in older buildings as shown in Figure 14.

Figure 13. Fallen tree damage to a building in Carnarvon (Courtesy: Perth Weather Live).

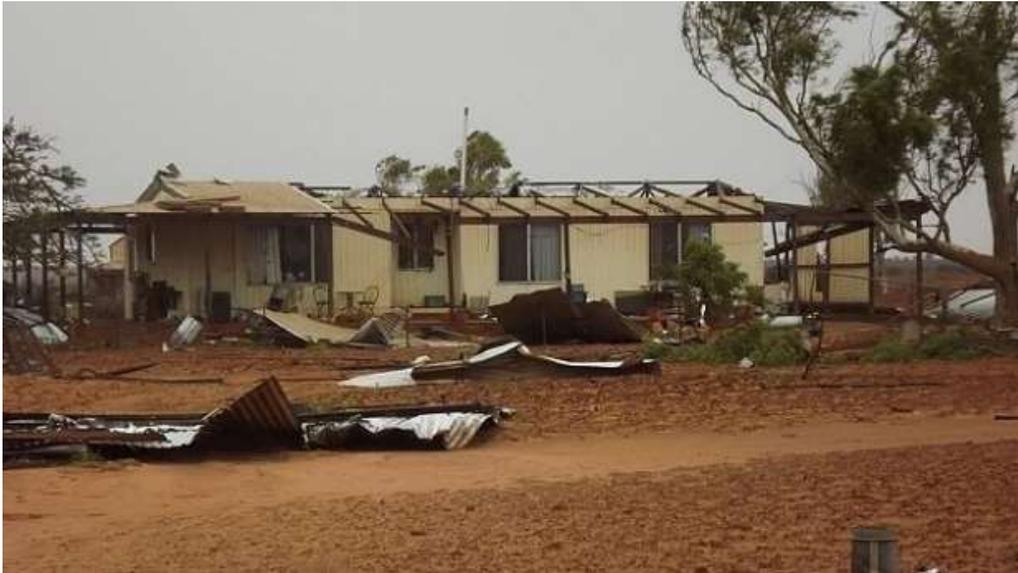
Figure 14. Roof loss at batten-to-truss connection in Carnarvon (Courtesy: Mary Bettini)

News reports indicate that the wind in Carnarvon was the strongest in 50 years, so it is likely that many older houses with nailed batten to truss or rafter connections have never experienced a strong enough wind to test the connections before. Figure 15 shows a similar type of failure to metal clad roofing in agricultural buildings just North of Carnarvon. Reports have also suggested several newer tiled roofs have also sustained damage.

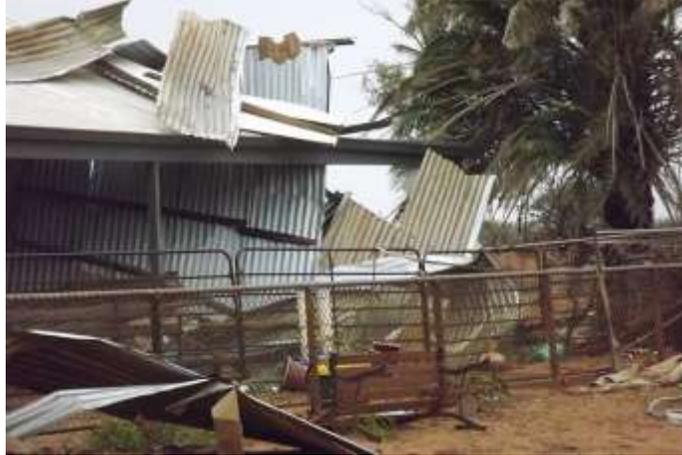
Figure 15. Roof loss at truss/batten connection Boolathana Carnarvon (Courtesy: Mary Bettini)
