# ANALYSIS OF DAMAGE SURVEYS OF HOUSES AND PRELIMINARY INPUT TO VAWS

**David Henderson, Daniel Smith, Korah Parackal, John Ginger**  
James Cook University & Bushfire and Natural Hazards CRC

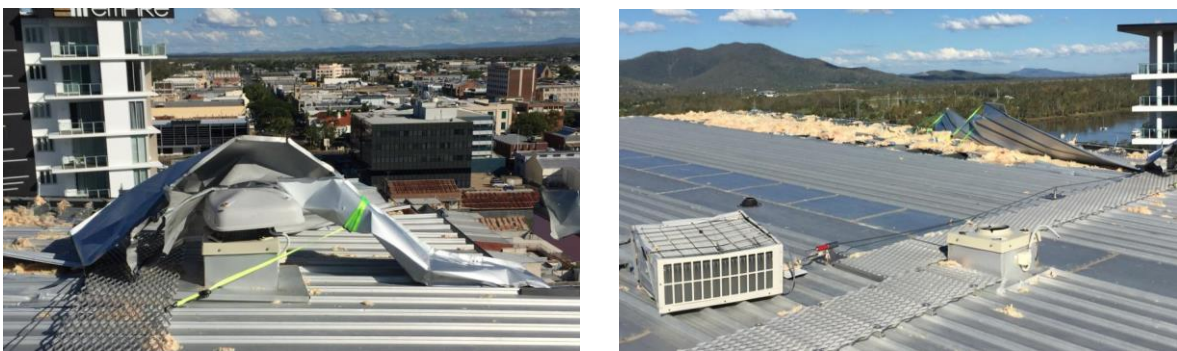
Figure 2. Damage to roof cladding and roof top attachments

There were a number of examples of substantial damage inflicted to new medium rise commercial buildings and industrial sheds, as shown in Figure 2. Examples of observed damage were roller doors, flashings, fascia, the soffits, and failed roof top mechanical plant blown from the buildings. Wind driven rain water ingress damage was greatly exacerbated by the damage to these buildings' envelopes. From the observed damage, all exposed elements such as fascia, flashings, ceilings, vents, etc. and their fixings to the structure should be engineered to withstand design forces to prevent these premature failures and progressive damage from breaches in the building's envelope.

The engineering profession is in a position to manage these risks by ensuring the engineering design of these “secondary” elements does not slip through the gaps between the responsibilities of multi-disciplinary design teams. For example, air-conditioning plant needs to be appropriately fixed, and substantial flashings require wind engineering design if they are to fulfil their waterproofing tasks in edge zones where the wind pressures are highest. Vent covers need to

have demonstrated compliance for wind loads. Likewise, fascia and soffits are part of the envelope of the building and once compromised lead to changes in internal pressure in the building with potentially damaging consequences to ceilings, walls and roofs.

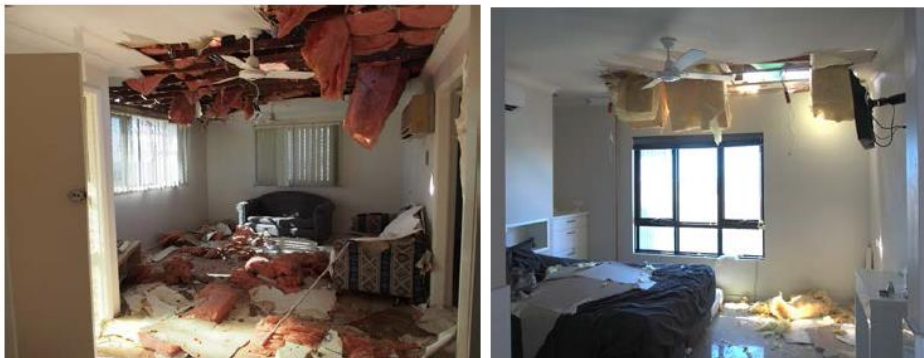
Figure 3. Ceiling damage from water ingress

Although the wind speeds were around the level at which buildings should remain serviceable, there was significant damage to houses and buildings from wind-driven rain entering through flashings, windows and doors. Water damaged plasterboard ceiling and wall linings, carpets, and timber floors, as shown in Figure 3. Many people reported they had tried to deal with the volumes of water entering their house during the cyclone and had put themselves at risk of serious injury while working in front of windward windows or doors.

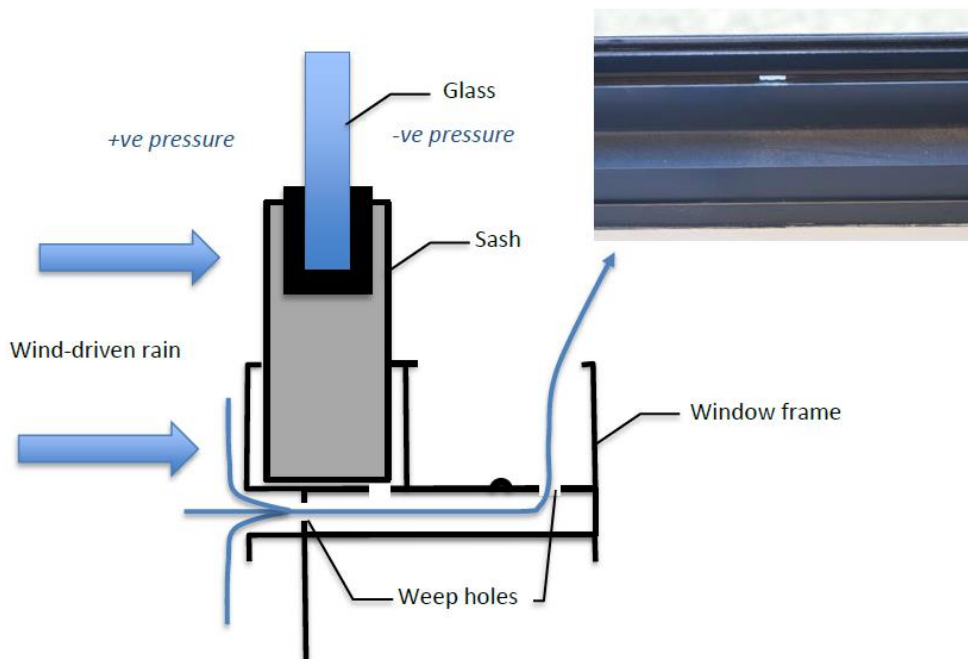
Figure 4. Cross section of window frame showing water ingress mechanism [2]

Analysis of insurance claims data has shown that water ingress is a major contributor to losses in residential construction in recent events [8]. Approximately 80% of claims analyzed from TC Yasi mentioned water ingress with approximately 70% of those claims having no breach of the building envelope. That is, the wind driven rain was entering via “undamaged” windows, doors, flashings, etc. This is not surprising given that the test pressure for the Australian water resistance test requirements for windows and doors is roughly a tenth of the wind load strength design pressure, thereby making it less than the wind load serviceability pressure. A cross section of a typical window frame is shown in Figure 4. The pressure difference from exterior windward wall to interior (i.e. positive pressure to negative pressure) results in a mechanism for water being drawn into house. The pressure difference quickly exceeds the static pressure capacity (head) of the window sill.

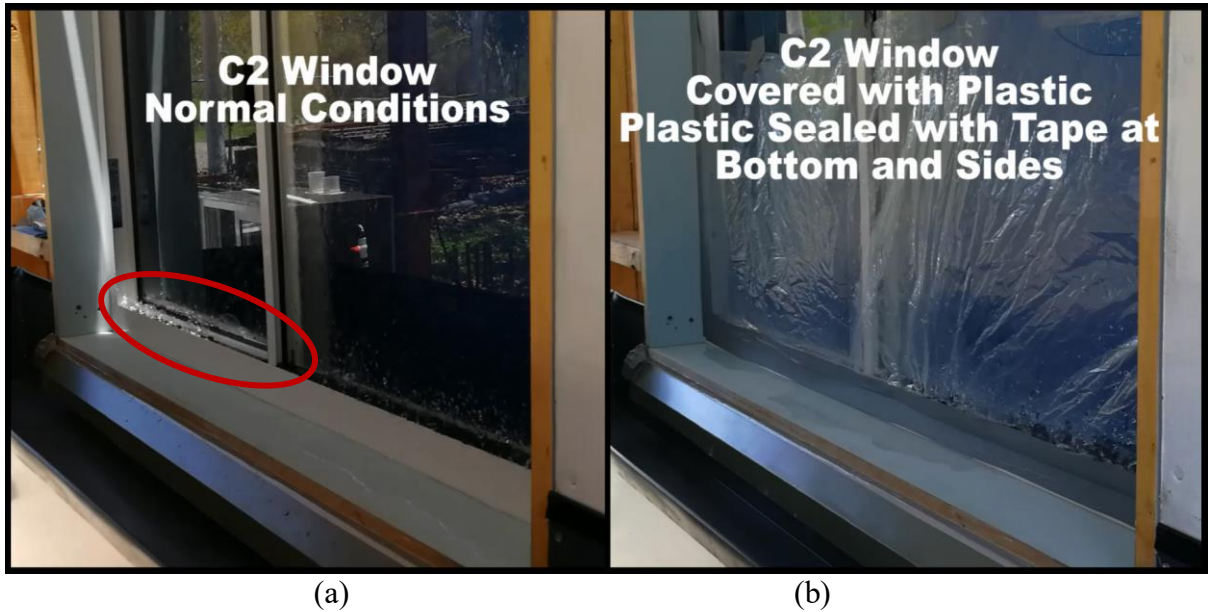
Figure 5. Wind driven rain test chamber at CTS; (a) water bubbling over sills during dynamic pressure trace; (b) simple retrofit retaining water from entering house.

Mitigation of losses can occur through employing a combination of (a) reducing water ingress by complying with a higher serviceability test pressure, (b) using water resistant internal linings and (c) occupant education that wind driven rain will enter the residence. However the cost of products designed to more stringent test pressures may be prohibitive. The CTS is trialing several retrofit methods for reducing wind driven rain entry through typical windows and doors (Figure 5).
