The Structural Response and Progressive Failure of Batten to Rafter Connections
under Wind Loads

DOCTORAL THESIS

Doctor of Philosophy

(Structural Engineering)

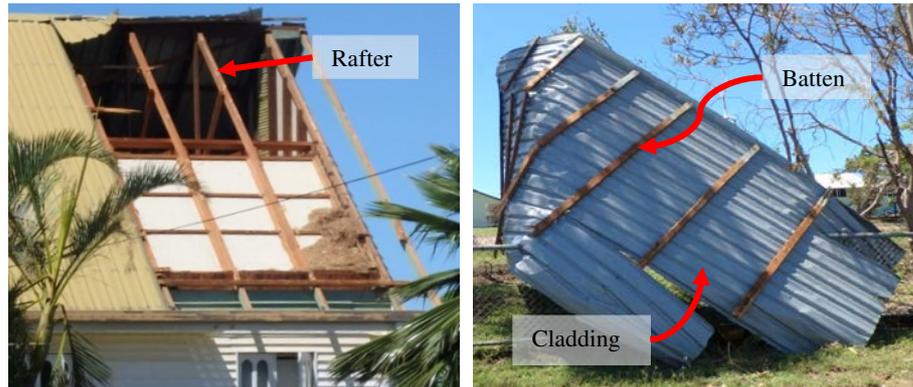
Figure 1.1 Typical batten-rafter connection failure: a large section of the roof envelope removed (right) with cladding still attached to battens and rafters left intact (left). Adapted from Boughton et al. (2017)

Observations from damage surveys have shown that failures of batten to rafter connections often result in the removal of large sections of the roof envelope as shown in Figure 1.1. It is most likely that these failures occur in a progressive or cascading manner as loads are redistributed upon connection failure. These progressive failures are of concern as the failure of a small number, or even a single connection can result in the failure of a disproportionately larger area of the roof structure.

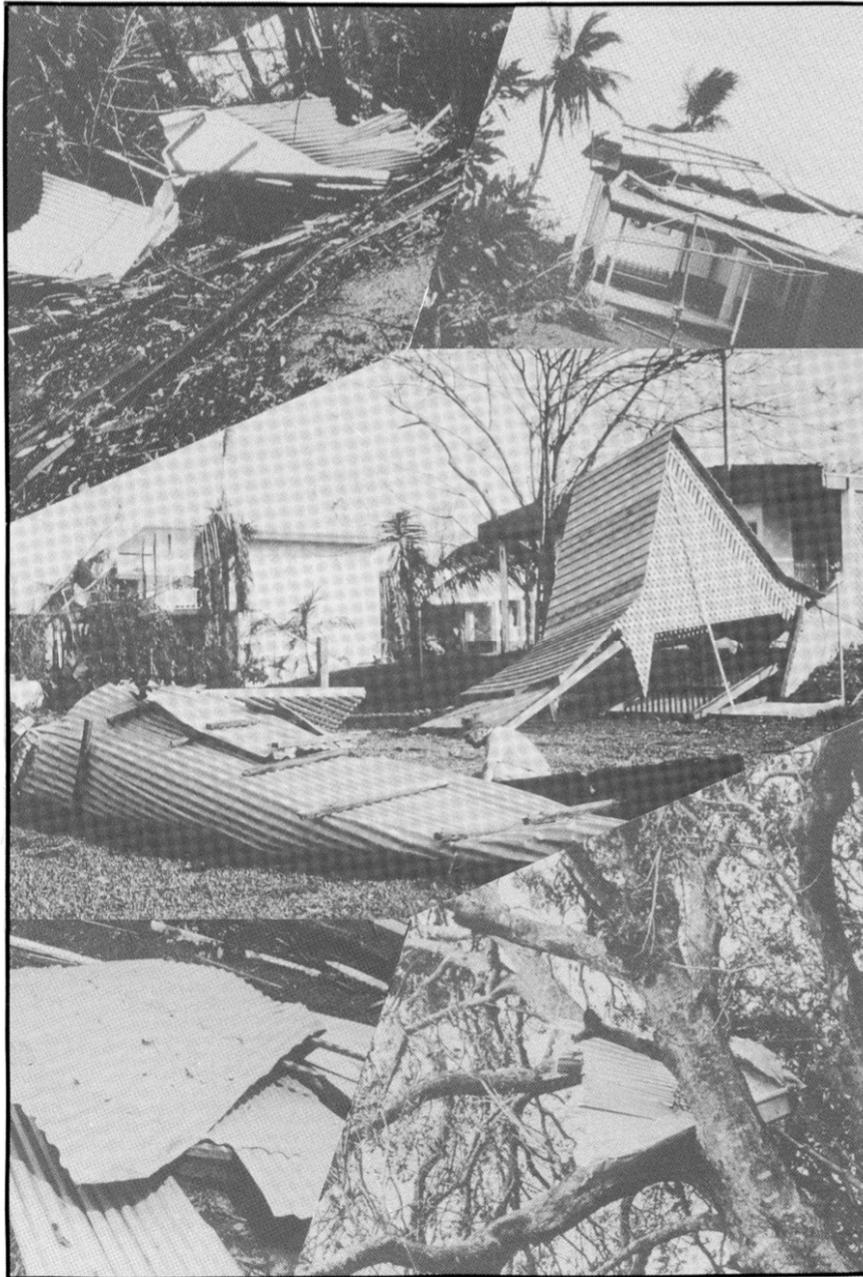
Figure 2.2 Several batten to rafter failures during cyclone Winnifred (Reardon et al. 1986).

This damage survey also noted that batten to rafter connection failures were one of the most common structural failures during the event. This survey noted a shift from failures of cladding fasteners to the failure of batten to rafter connections being more common. This shift was due to the uptake of using power driven screws for cladding fasteners with no change to the nailed batten to rafter connections below. These failures were predominantly for older houses built before 1982 (Reardon et al. 1986).

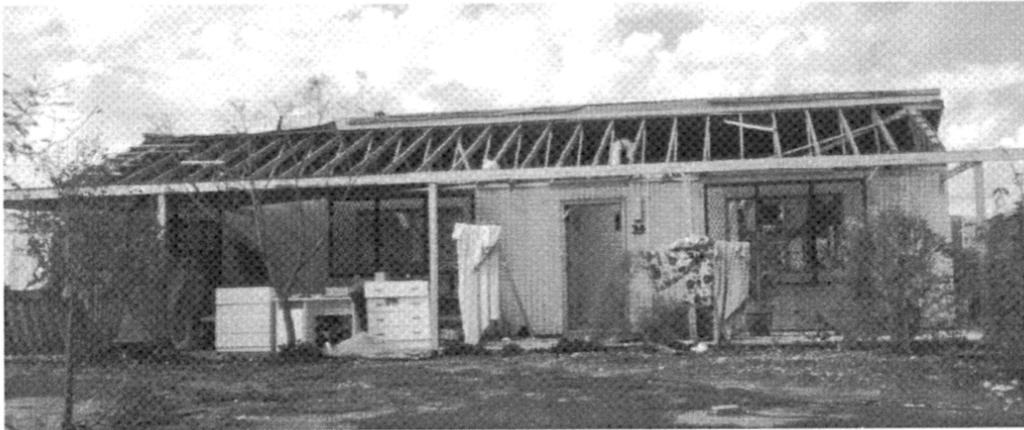
Figure 2.3 Loss of roof cladding and battens during cyclone Vance (Reardon et al. 1999)

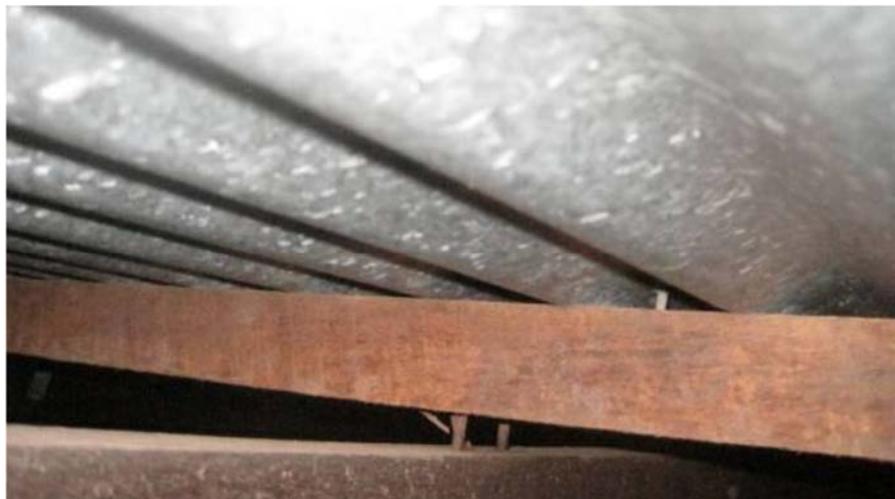
Figure 2.4 Hidden damage of batten to rafter connections caused by TC Yasi (Boughton et al. 2011)

This damage survey also noted several batten to rafter connections failures. Including a case of batten rafter failure on a roof repaired after a previous failure during Cyclone Larry. In this case, the nailed connections of a portion of the roof that had failed were replaced with framing anchors. However, the part that did not suffer damage during Larry was not upgraded and then failed during Yasi. This case highlights the requirements for thorough repair and renovation work following a severe wind event (Boughton et al. 2011). ‘Hidden damage’ may have played a role in this failure, Figure 2.4 shows an example of hidden damage in a roof during TC Yasi.

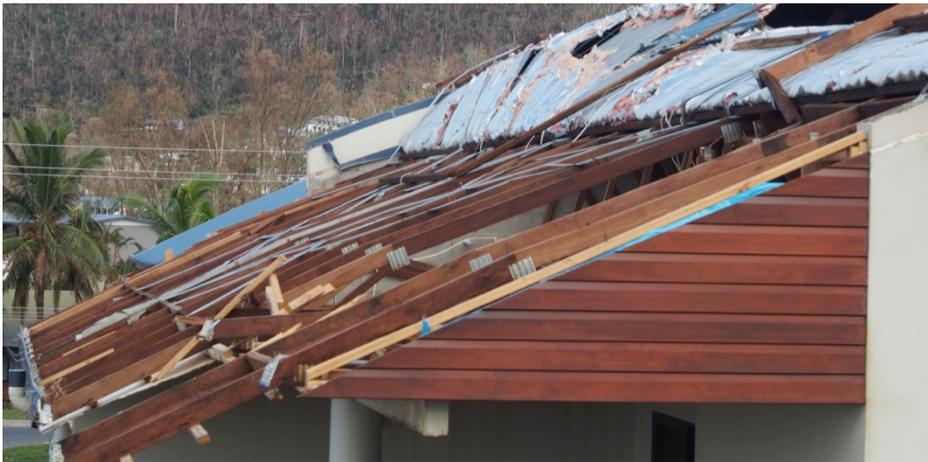
Figure 2.5 Batten to truss connection failure in a contemporary apartment building (Boughton et al. 2017)

In this most recent damage survey that the author was involved in, batten to rafter connections were again noted as the most common structural failure in older housing. However, batten to rafter connection failures were also observed in contemporary code compliant housing, as shown in Figure 2.5 (Boughton et al. 2017).

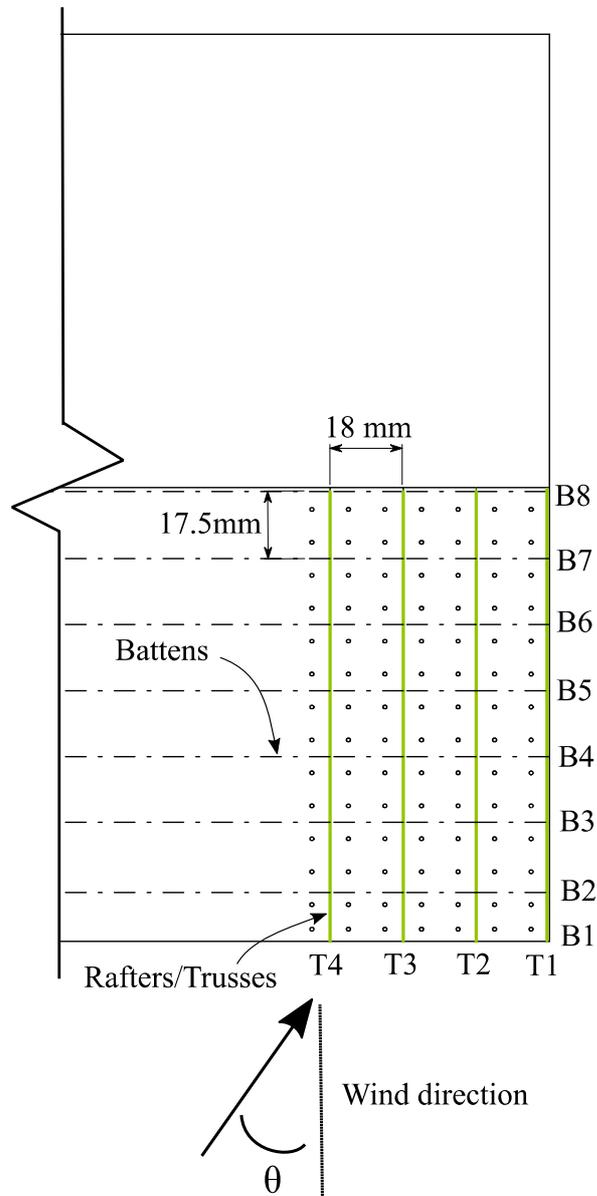
Figure 3.3 Tap layout and framing plan within the study area on the roof of the 1/50 scale wind tunnel model.

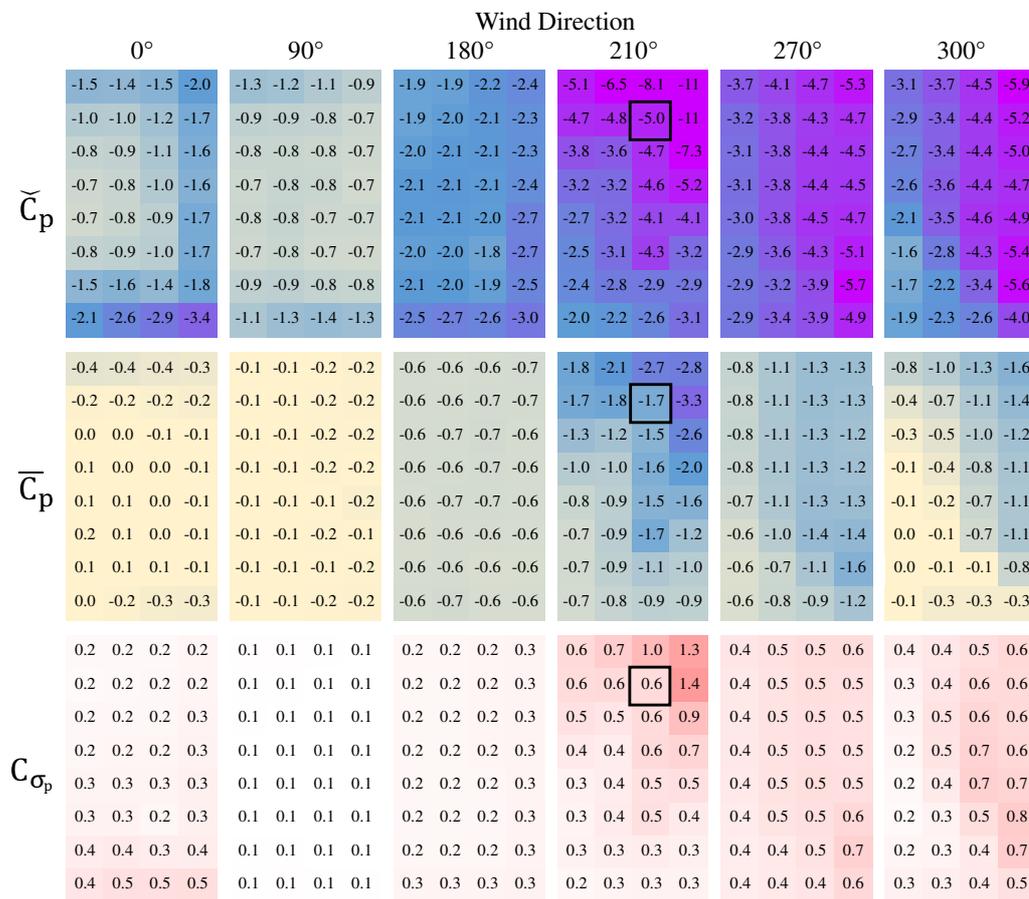
Figure 3.4 Minimum (top row) mean (middle) and standard deviation (bottom) pressure coefficients for the 32 connections in the study area for selected wind directions. The black square indicates the location of the critical connection for wind direction 210° .

The critical connection T2-B7 experiences large uplift forces for a range of wind directions and is subject to especially high loads for wind directions 210° to 240° , the critical sector. The highest uplift forces at the critical connection arise from wind direction 210° . Connections at roof corners and the apex of the gable end experience the highest peak loads for cornering winds. High uplift loads occur in ‘peak events’ of load more than 3.5 standard deviations from the mean lasting for about 0.5 to 2.0 s for a mean wind speed of 100 km/h at full scale.

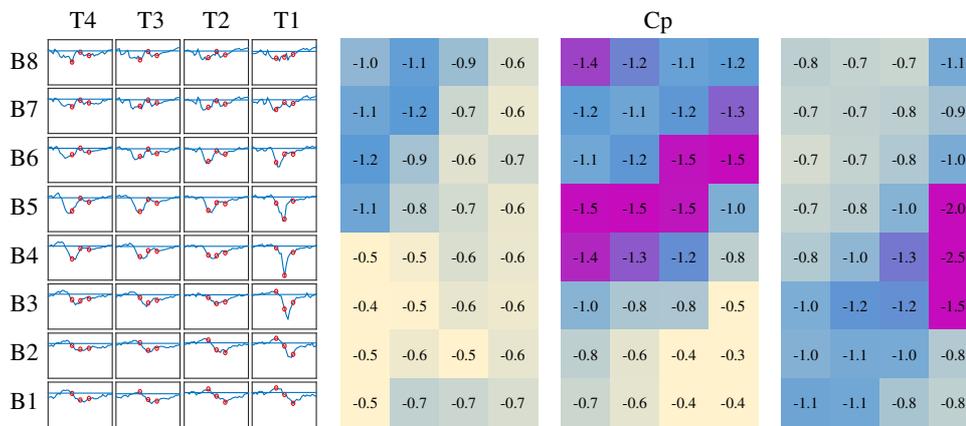
Figure 3.5 (Left): Two-second time histories of pressures at connections (arbitrary scale) for wind direction 180° . (Right): Selected time steps (encircled on left) are shown as colour scale diagrams on the right, showing the rolling peak event region on the leeward roof.

For the direction 180° , the study area lies on the leeward roof slope. Large negative pressures are experienced due to 2-dimensional flow separation as air moves over the discontinuity of the ridgeline. High negative pressures occur close to the ridgeline in the area of flow separation. However, the vortices and eddies generated periodically 'roll up' and are convected down the leeward roof slope, similar to that observed by Saathoff and Melbourne (1997). The movement of these eddies creates bands of high negative pressures that travel down the roof slope repeatedly as shown in Figure 3.5. Thus, 'peak events' at connections can occur over a large area of the leeward roof slope as shown in Figure 3.6.

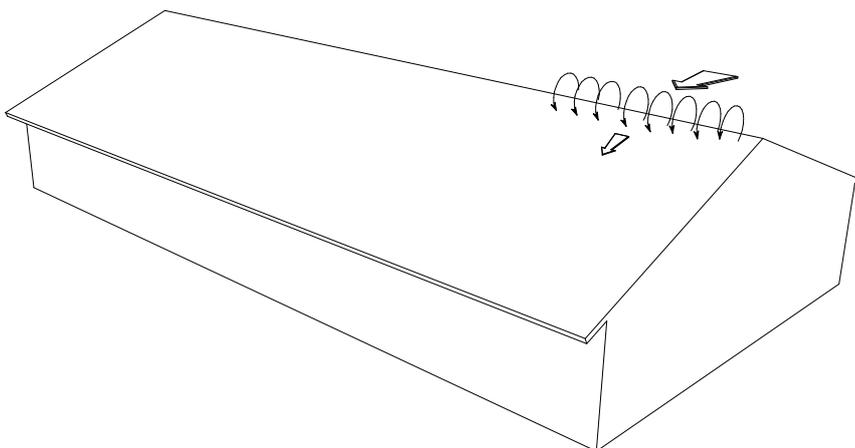
Figure 3.6 Schematic showing the moving vortex for wind direction 180°

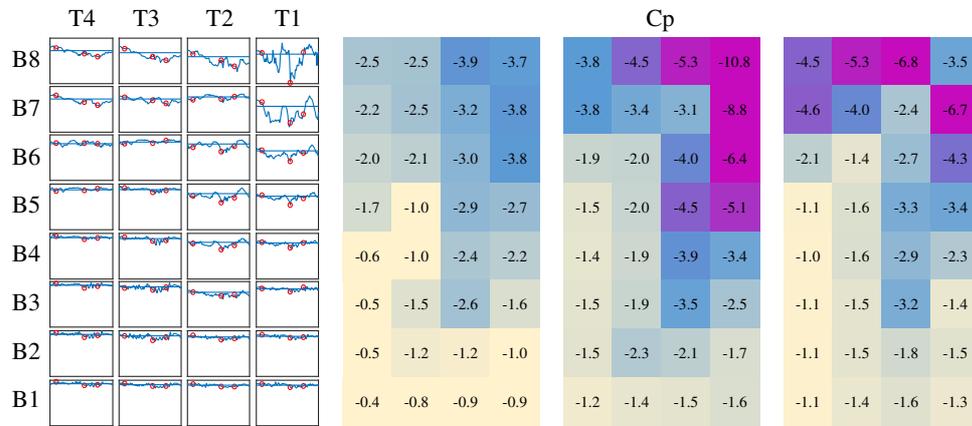
Figure 3.7 (Left): Five second time histories of pressures at connections (arbitrary scale) in the study area during a peak event for wind direction 210° . (Right): selected time steps (encircled on left) showing the evolution of a peak event on the roof surface.

For the critical wind direction 210° , high uplift loads are experienced at the ridgeline and near the gable end of the roof. High negative pressures are experienced here consistently throughout time. High standard deviations in the pressure signals at the apex of the roof indicate that additional building induced turbulence is being created in this area. Large suction pressures occur in a diagonal band extending from the apex of the roof diagonally down the roof slope at an angle of 10° to 30° measured from the gable end, shown in Figure 3.7. This diagonal high load area is caused by the formation of conical vortices, shown in Figure 3.8, as evidenced by its shape and angle on the roof surface. For connections in the diagonal band, high loads are experienced at similar times at connections along battens.

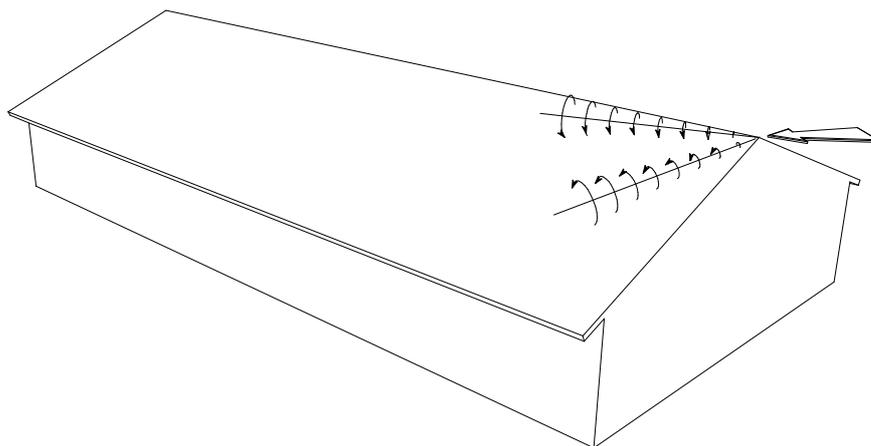
Figure 3.8 Schematic showing the conical vortices formed for wind direction 210°

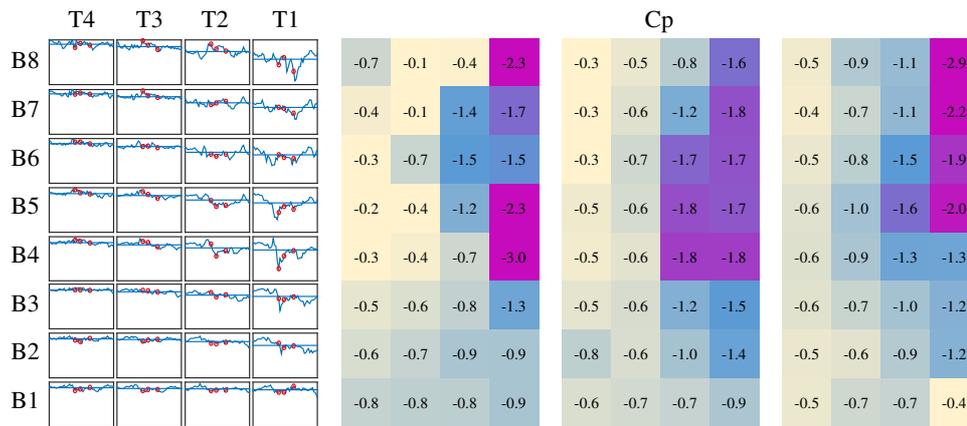
Figure 3.9 (Left): Two second time histories of pressures at connections (arbitrary scale) in the study area during a peak event for wind direction 270° . (Right): Successive time steps (encircled on left) showing movement of high load areas along the gable roof edge.

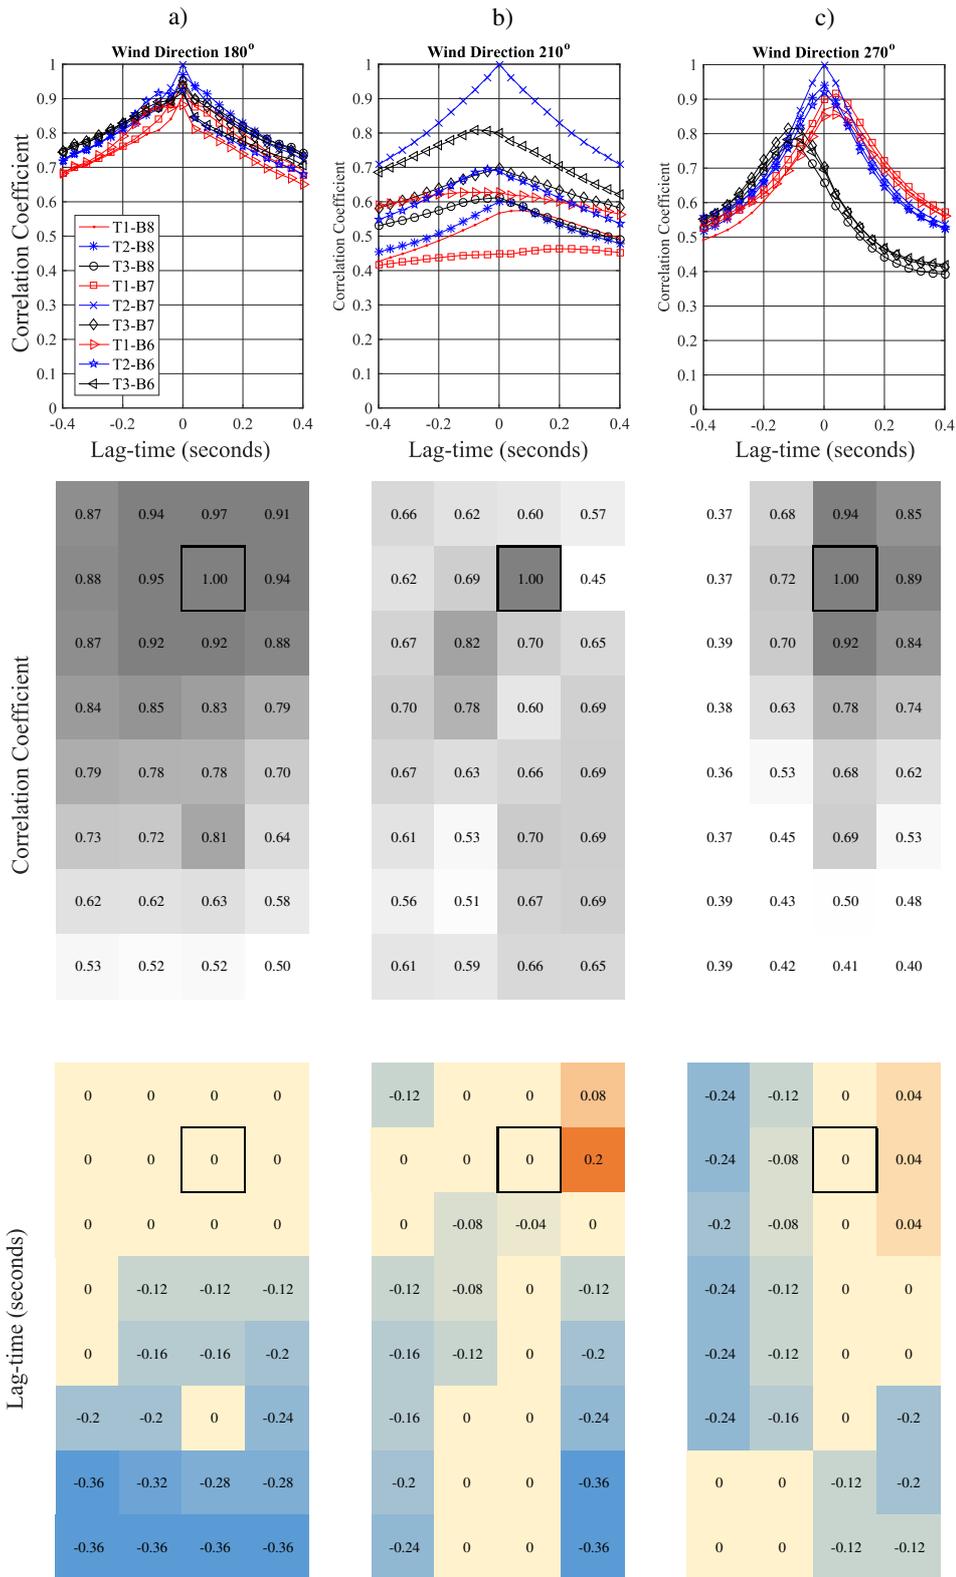
Figure 3.13: Top row: Correlation coefficient with respect to T2-B7 vs. lag time for a 3x3 grid of connections surrounding T2-B7. Middle row: Correlation coefficients with respect to T2-B7 at zero lag time for all connections in the study area. Bottom row: lag/lead time (s) that results in the maximum correlation at T2-B7.

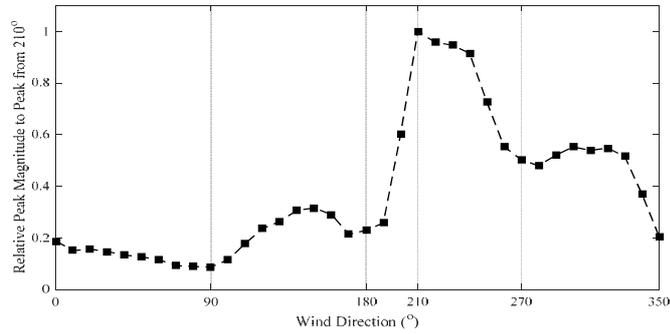
Figure 3.14 Magnitude of peaks relative to the peak caused by wind direction 210° for load at connection T1-B8, showing the critical sector 210° to 240°.

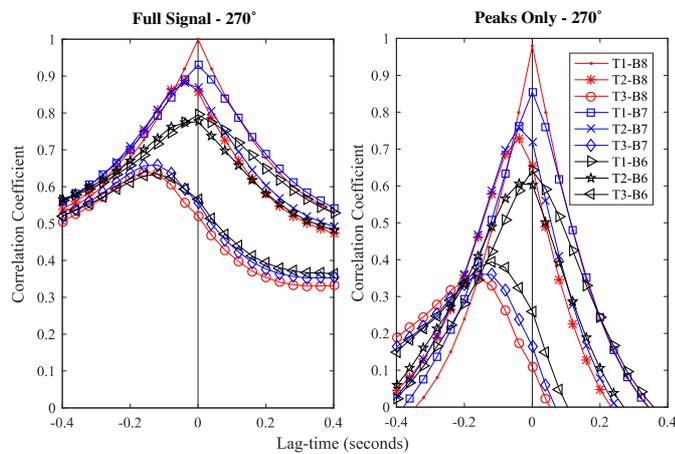
Figure 3.15 Correlation coefficient to connection T1-B8 vs. lag time for wind direction 270° for 10 minute runs (left) and during peak events only (right).

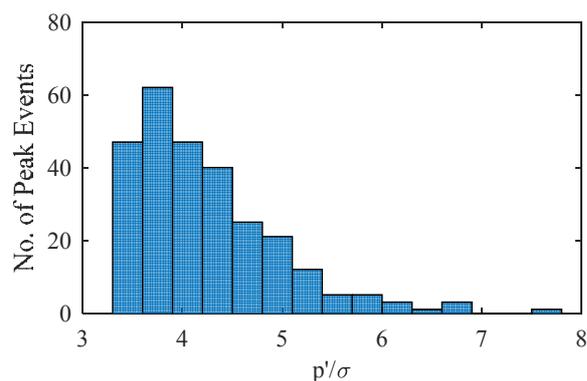
Figure 3.16 Histogram of peak event intensities at connection T2-B7 for wind direction 210°

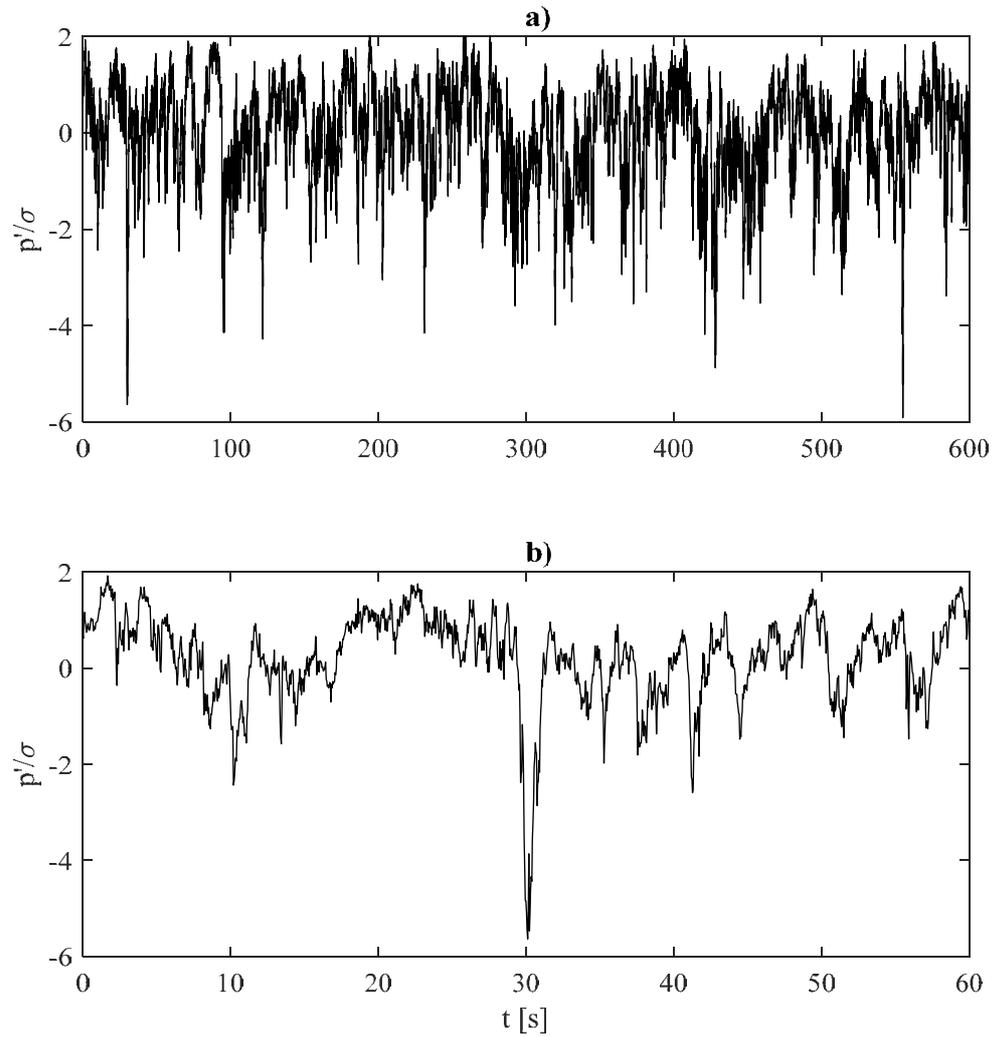
Figure 3.17 a) Ten minute time history of pressure fluctuations at connection T2-B7 for wind direction 210°. b) detail of the first 95th Percentile peak event in the same pressure signal as a).

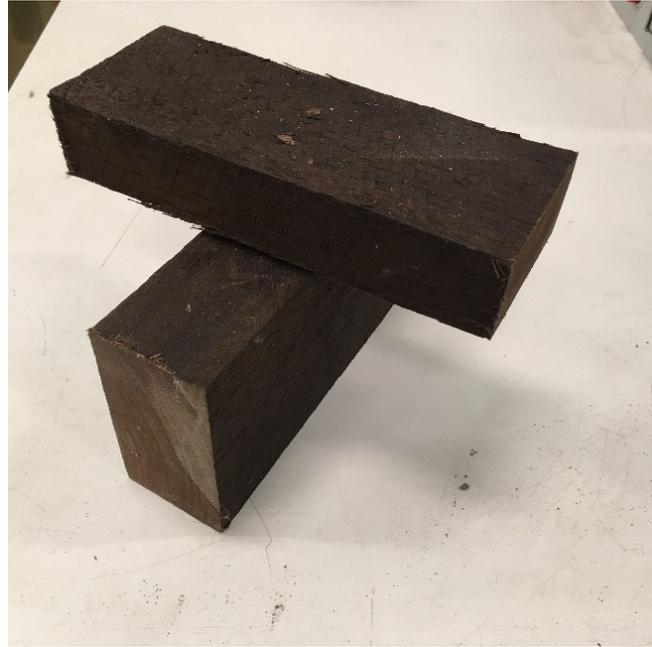
Figure 4.1 Batten to rafter connection Sample

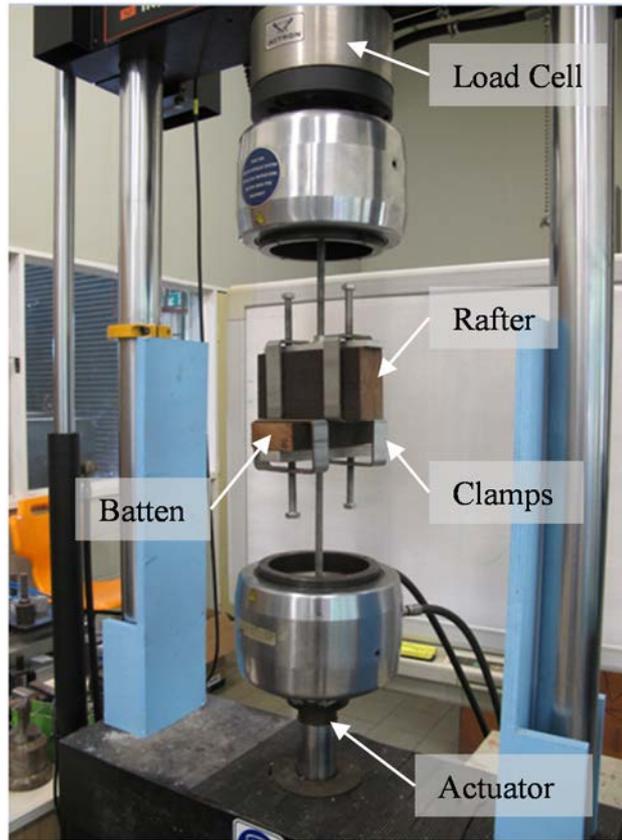
Static pull out testing was conducted using a 100kN Instron Model 1342 servo hydraulic universal testing machine with an 8800 series controller, shown in Figure 4.2. Test specimens were subject to a displacement controlled pull out at a rate of 2.5mm/min as specified in the Australian Standard AS1649 (2001). Connections were held in place with a customised aluminium clamping system that allows the sample to be secured for loading in tension or compression. The reason for using aluminium construction was to minimise any inertia effects during dynamic loading.

Figure 4.2 Apparatus for static and dynamic connection testing

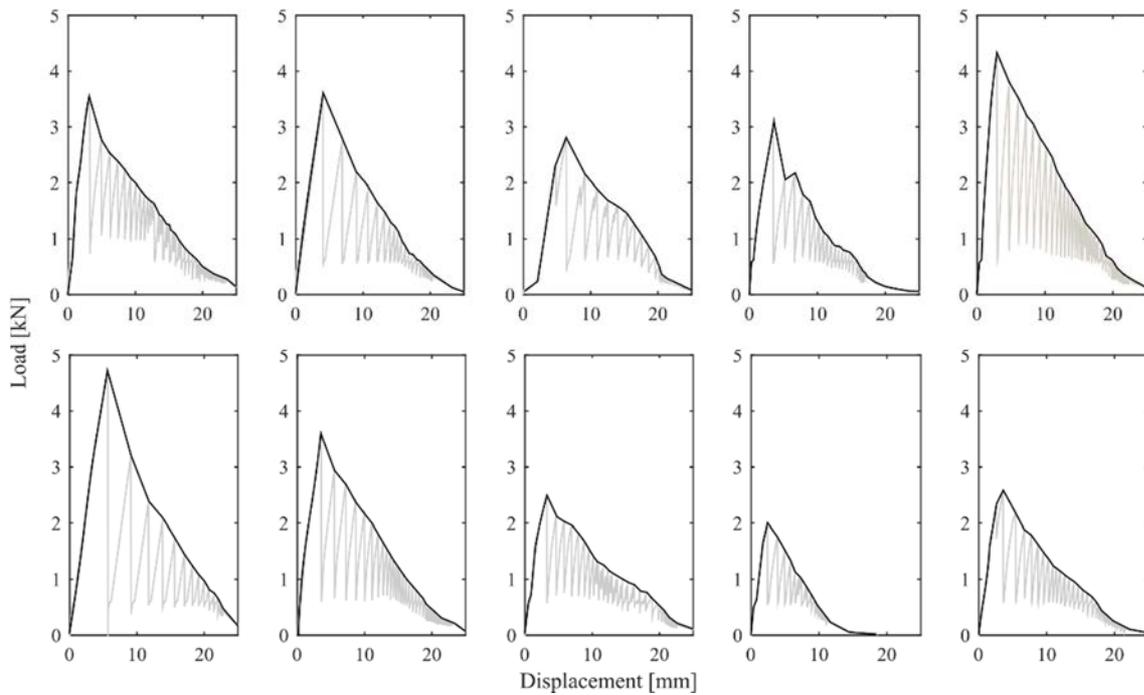
Figure 4.3 Load-displacement curves of the 'green' specimens

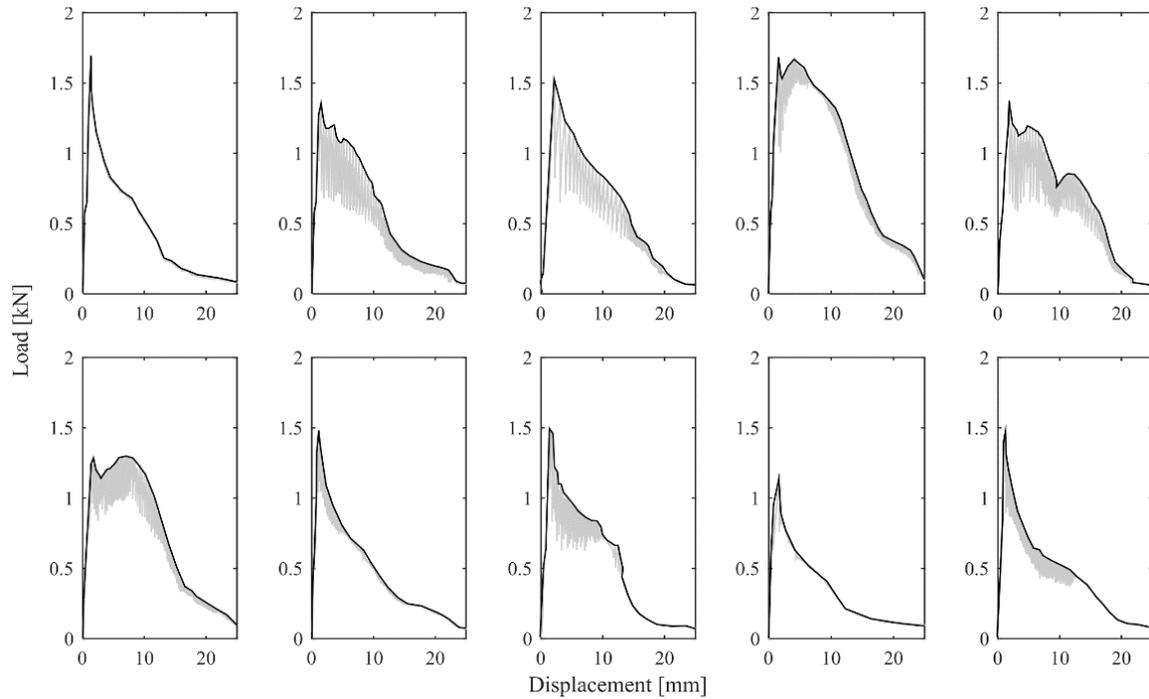
Figure 4.4 Load-displacement curves of the oven dried test specimens

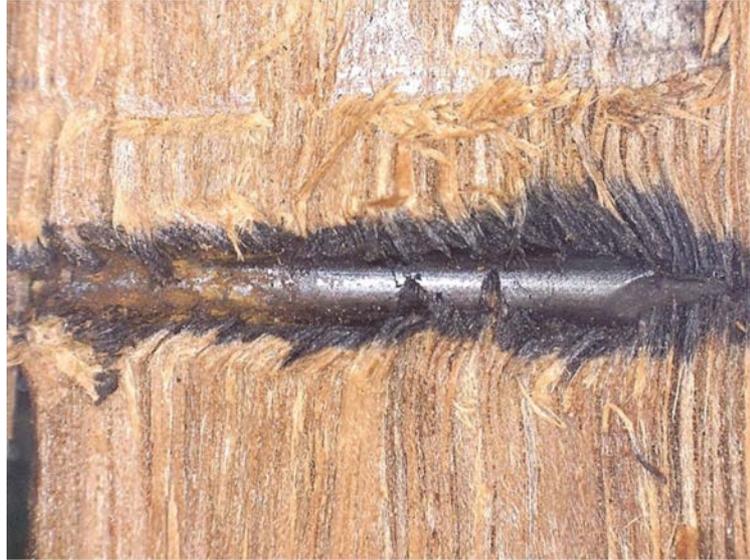
Figure 4.5 Cross section through oven dried test specimen showing deformation of fibres due to nail penetration and dark coloured corrosion bi-product.

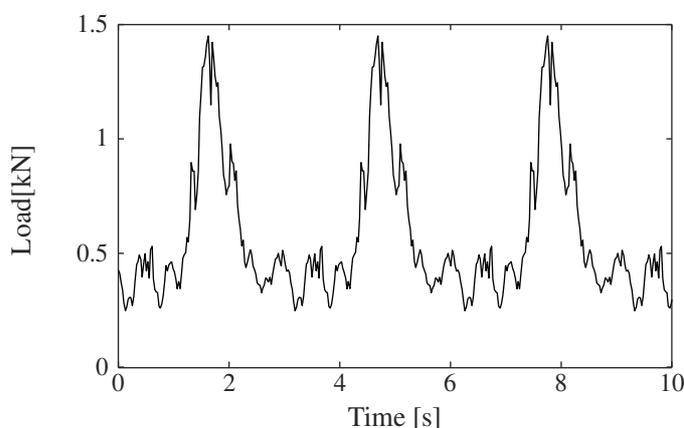
Figure 4.6 Three repeated peak events at a load of 1.45kN, i.e. the mean connection strength of the static tests.

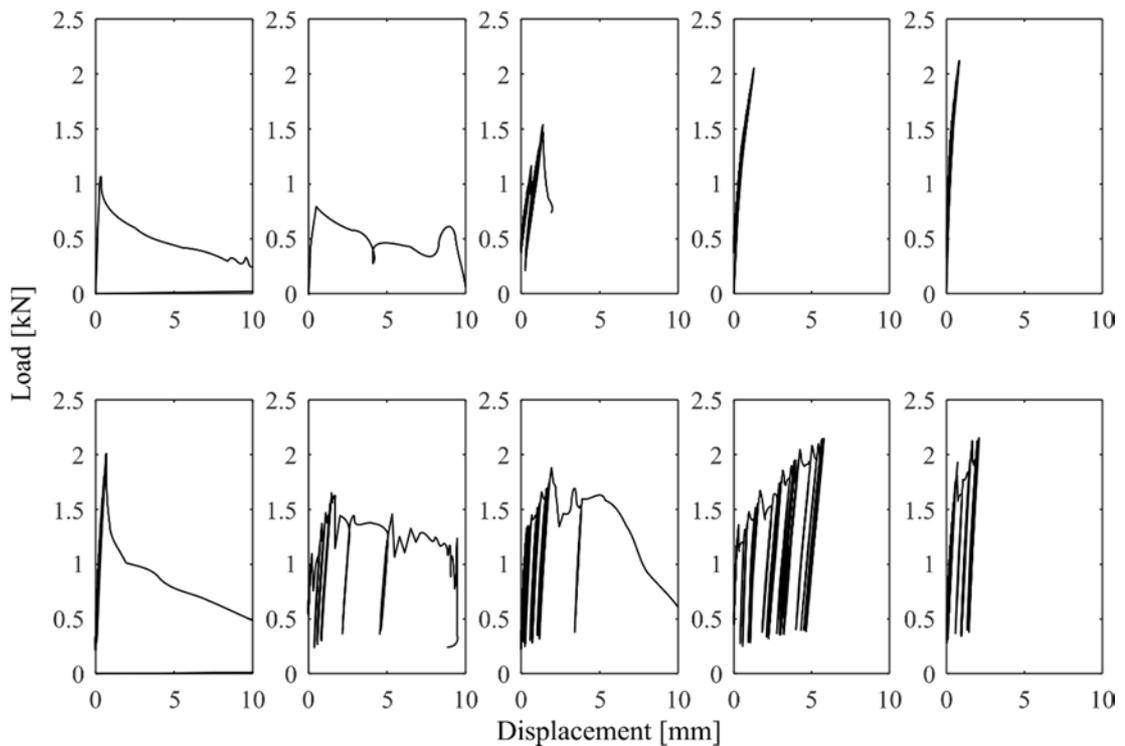
Figure 4.7 Connection response (load vs. displacement) under repeated dynamic peak events

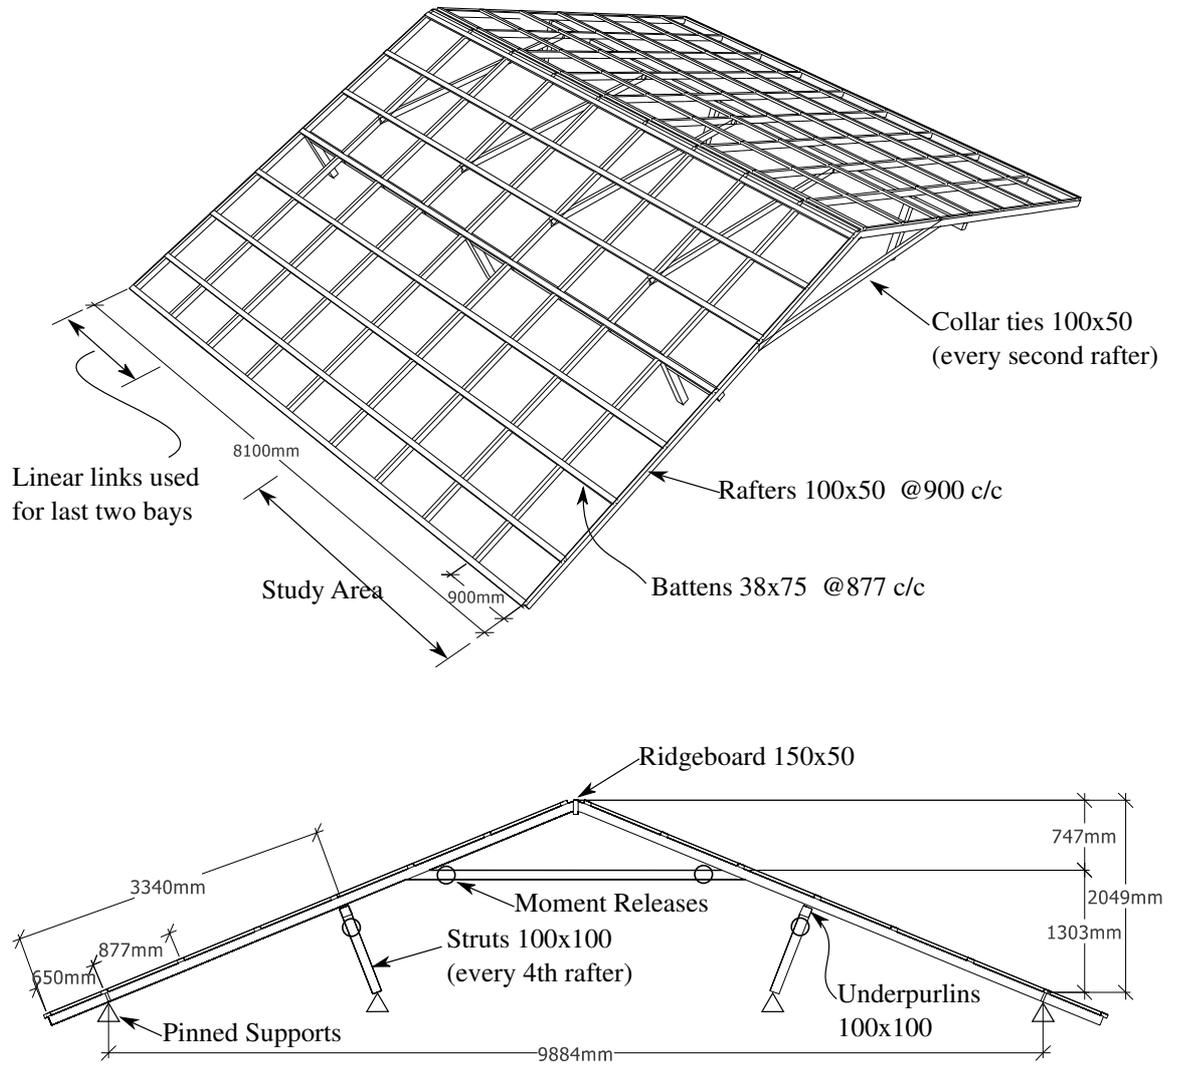
Figure 5.1 Schematic of the nonlinear structural analysis model.

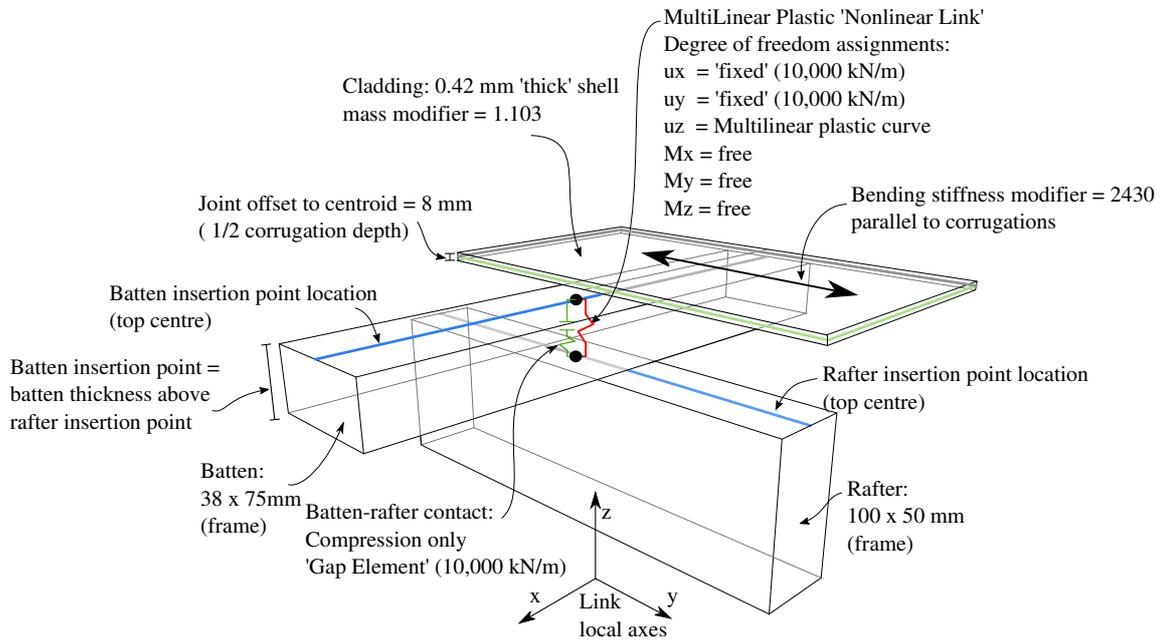
Figure 5.2 Geometry of modelled batten to rafter intersections and offsets used to account for partial composite action

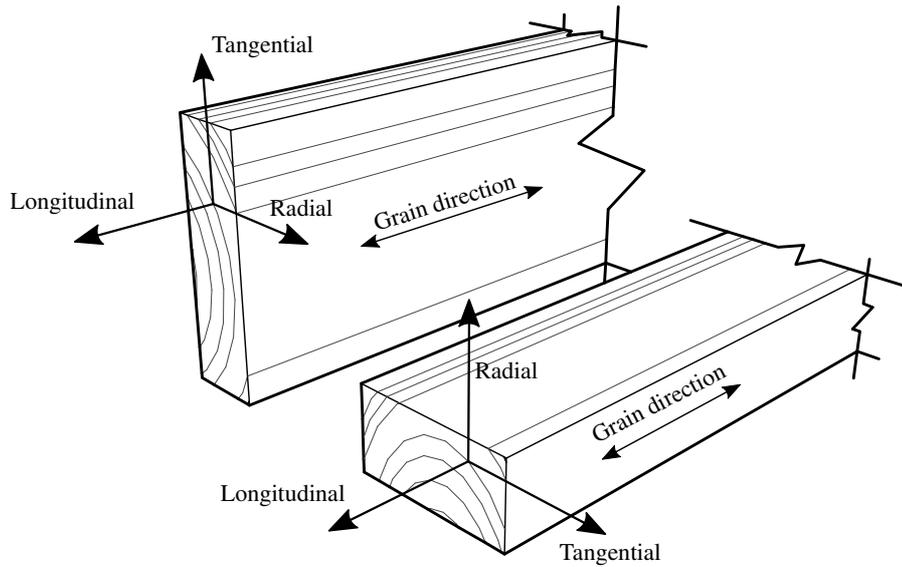
Figure 5.3 Approximate longitudinal, radial and tangential grain directions used to define material properties in the analysis model.

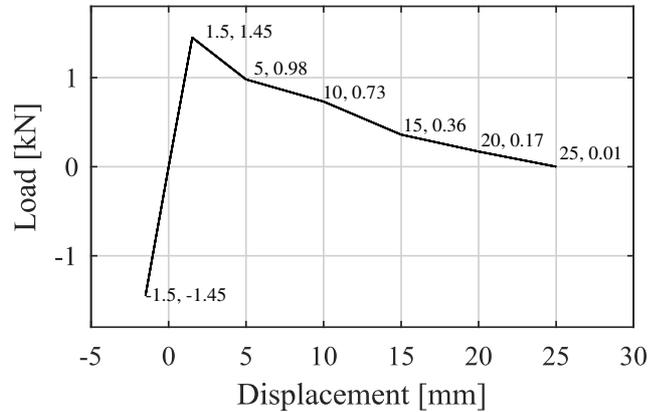
Figure 5.4 Idealised force-displacement curve of a nailed connection

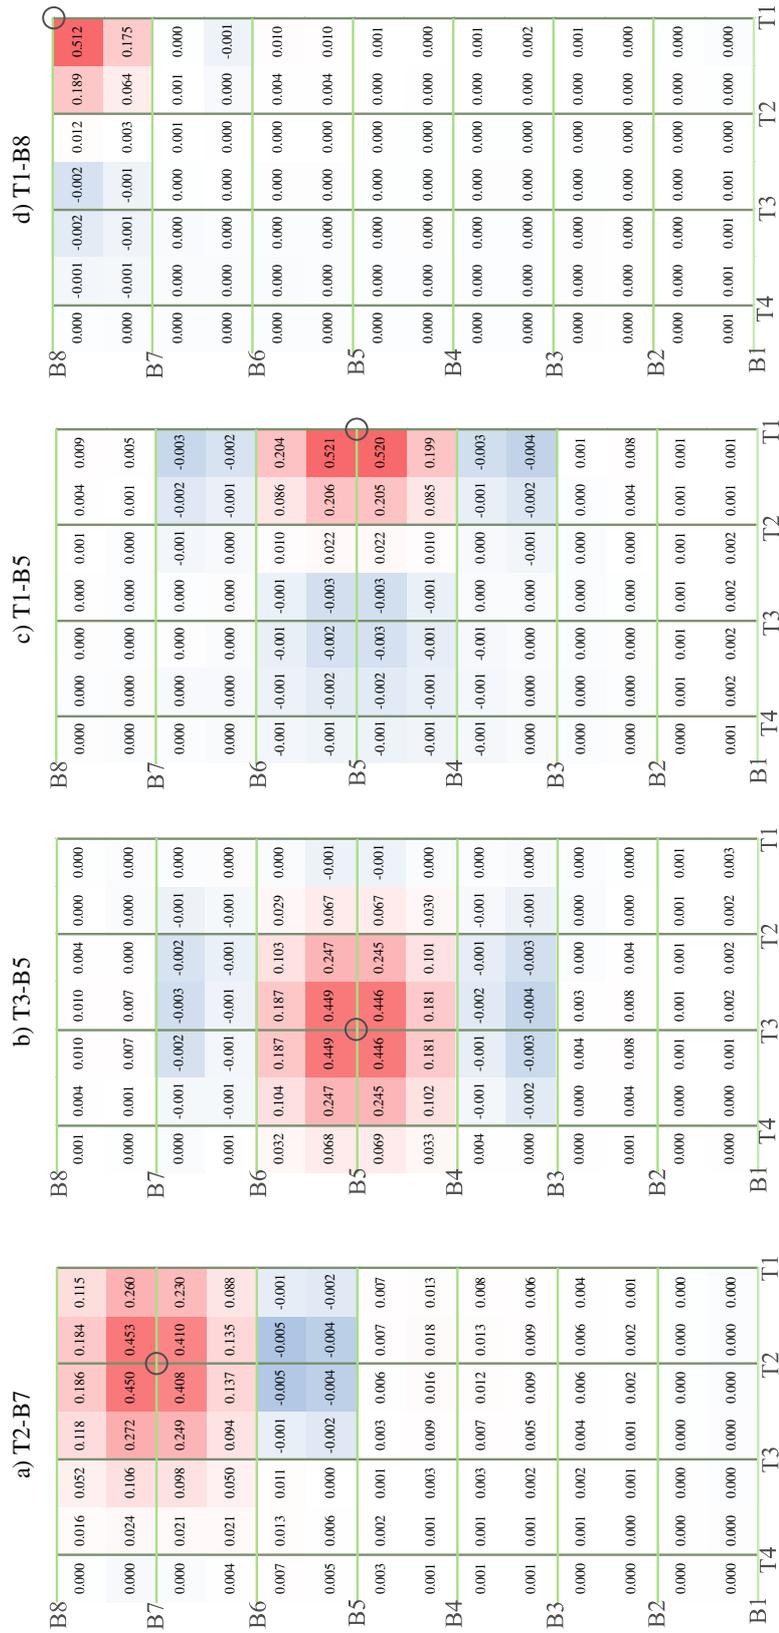
Figure 6.1 Influence coefficients for reaction forces at selected batten to rafter connections: a) T2-B7, b) T3-B5, c) T1-B5, d) T1-B8.

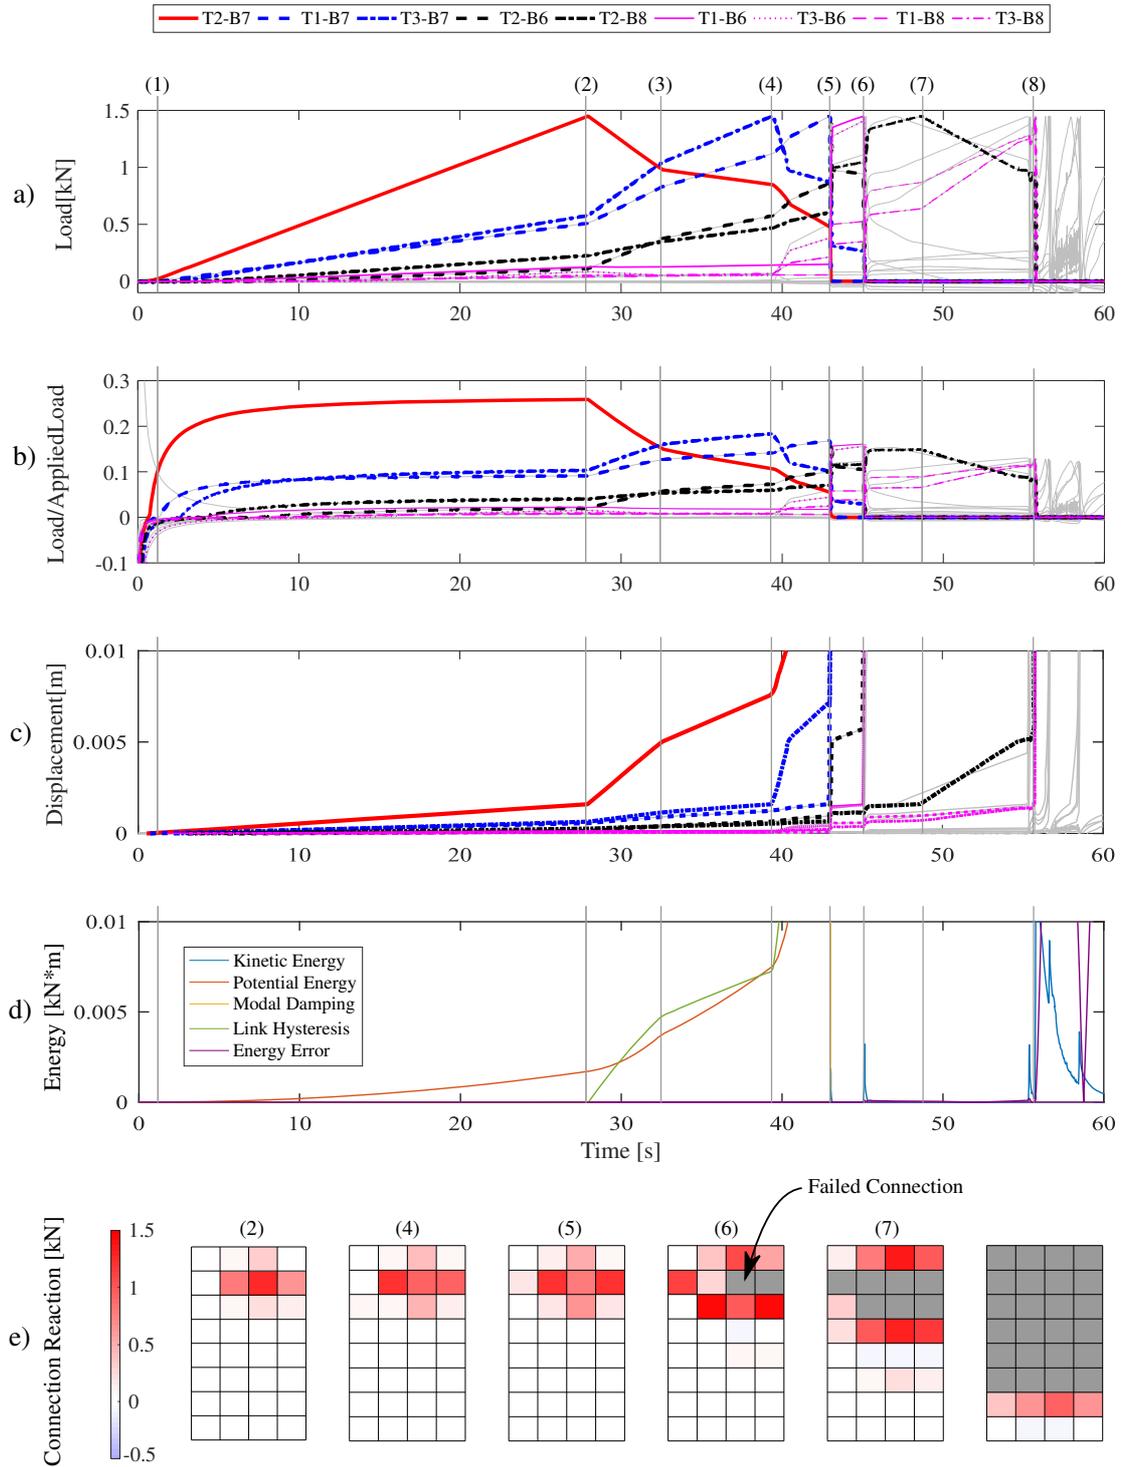
Figure 6.2 Connection response through time: a) reaction forces, b) proportions of applied load, c) connection displacement, d) energy balance, e) connection reactions showing the spread of damage
