The Structural Response and Progressive Failure of Batten to Rafter Connections
under Wind Loads

DOCTORAL THESIS

Doctor of Philosophy

(Structural Engineering)

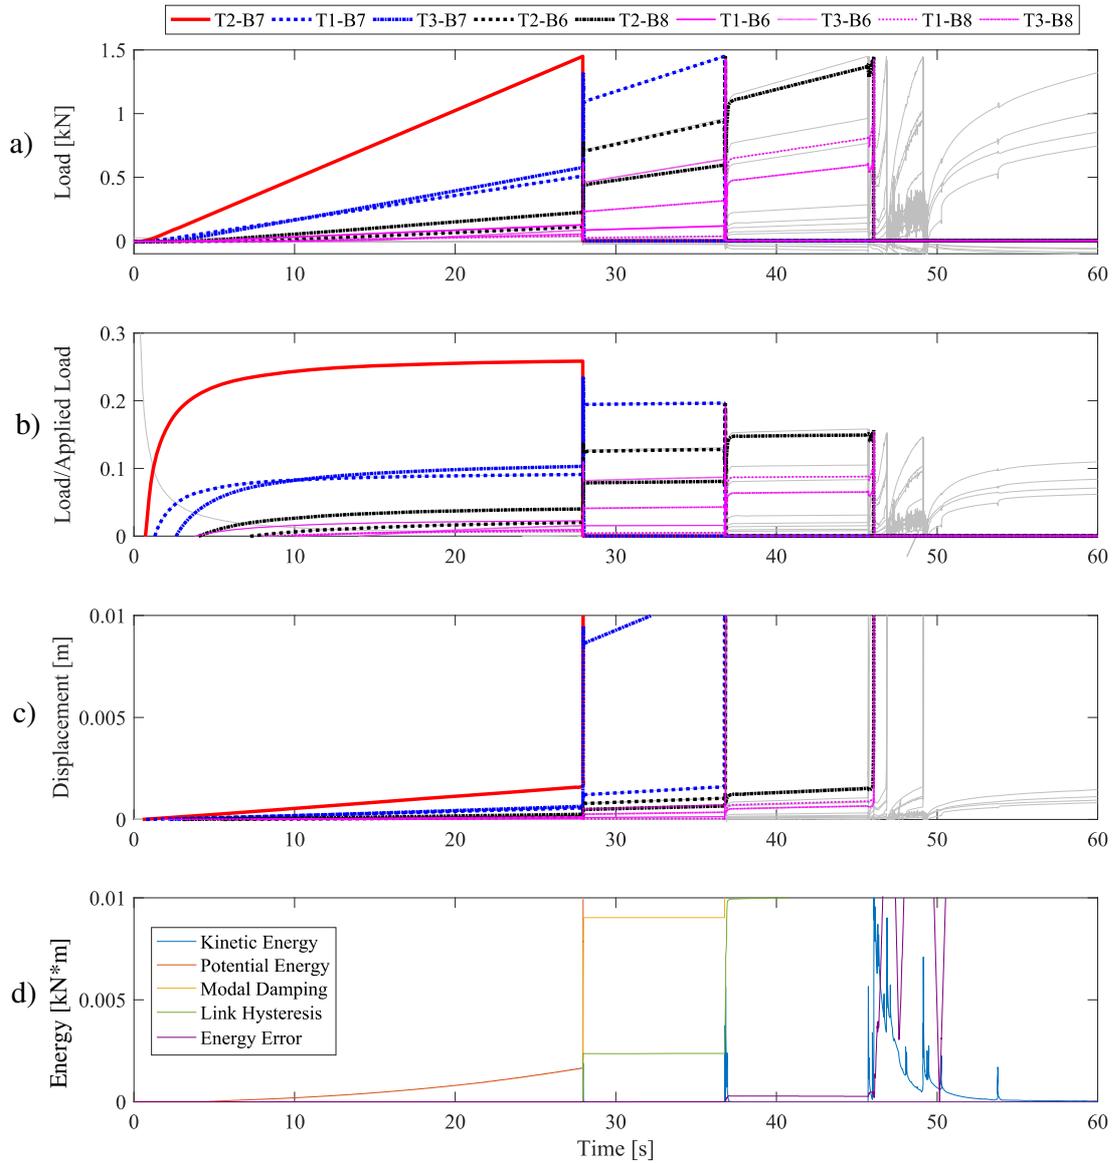
Figure 6.3 Connection response through time for brittle connections: a) reaction forces, b) proportion of applied load, c) connection displacement, d) energy balance.

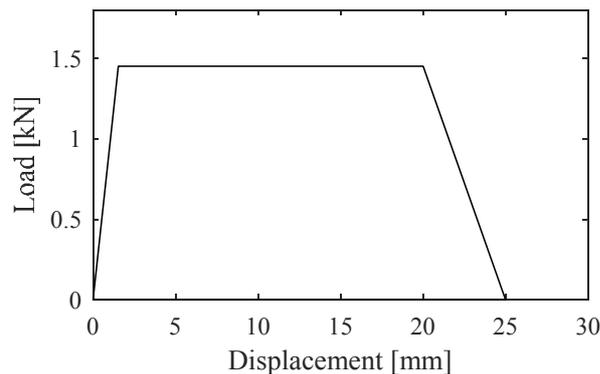
Figure 6.4 Force-displacement relation assigned to ductile connections

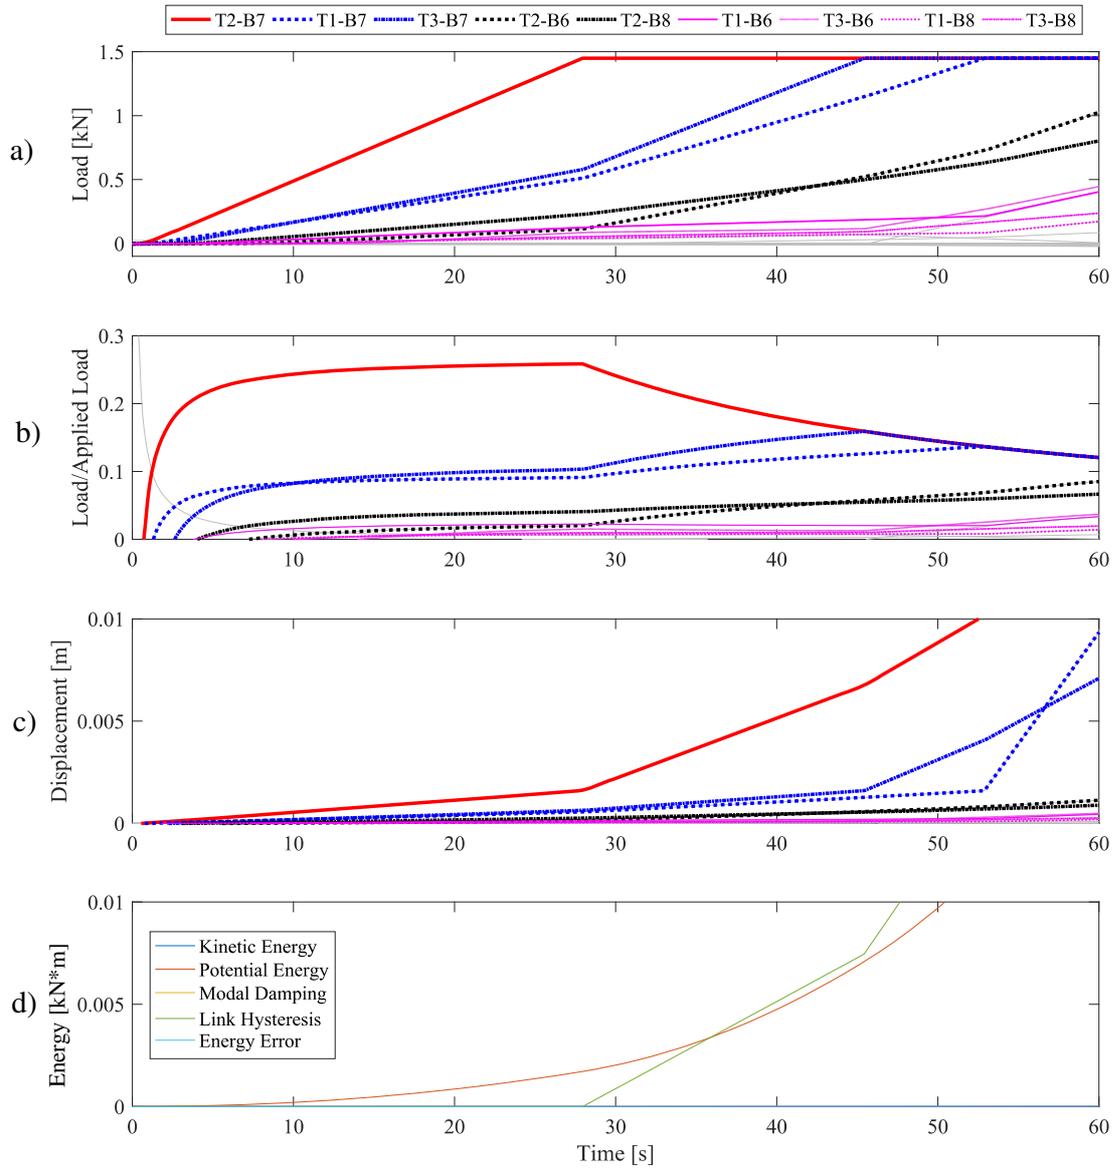
Figure 6.5 Connection response through time for ductile connections: a) reaction forces, b) % of applied load, c) connection displacement, d) energy balance.

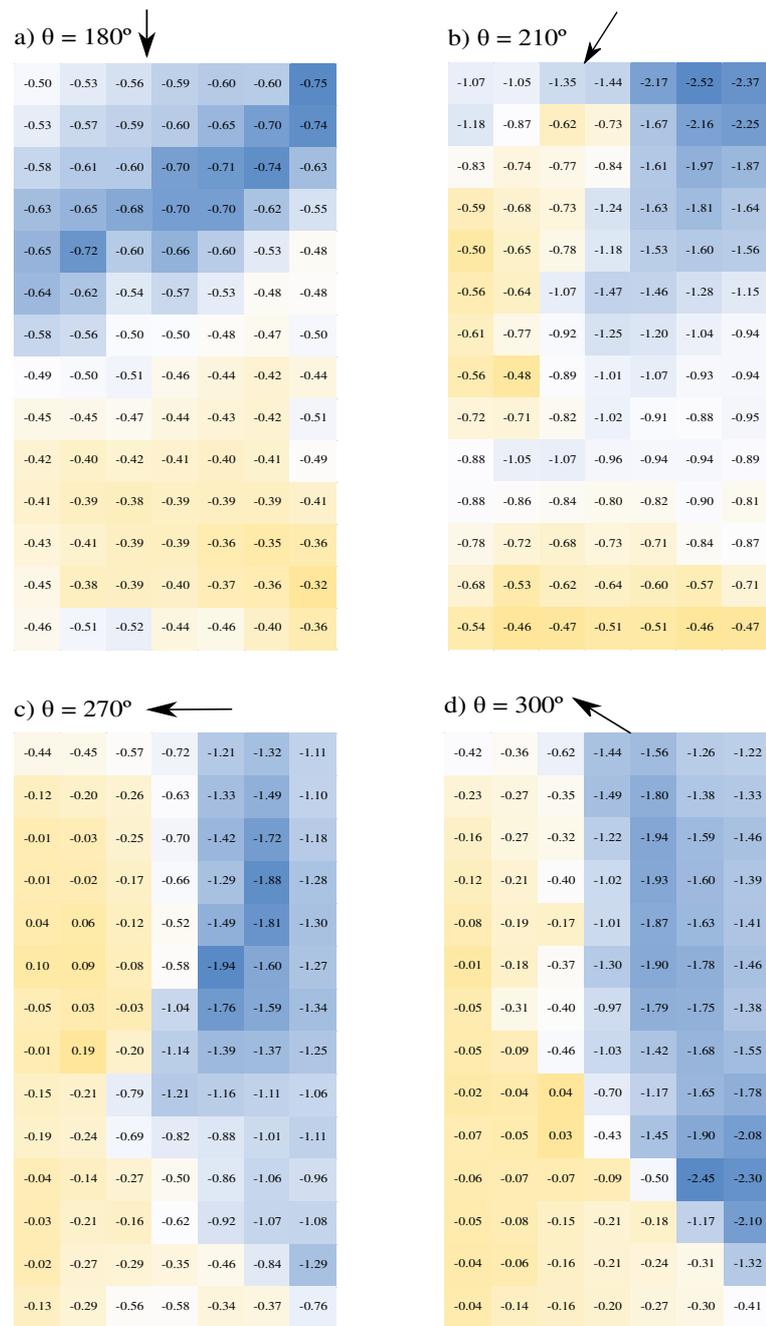
Figure 6.6 Pressure distributions (C_p) that occur during 'peak events' for selected wind directions

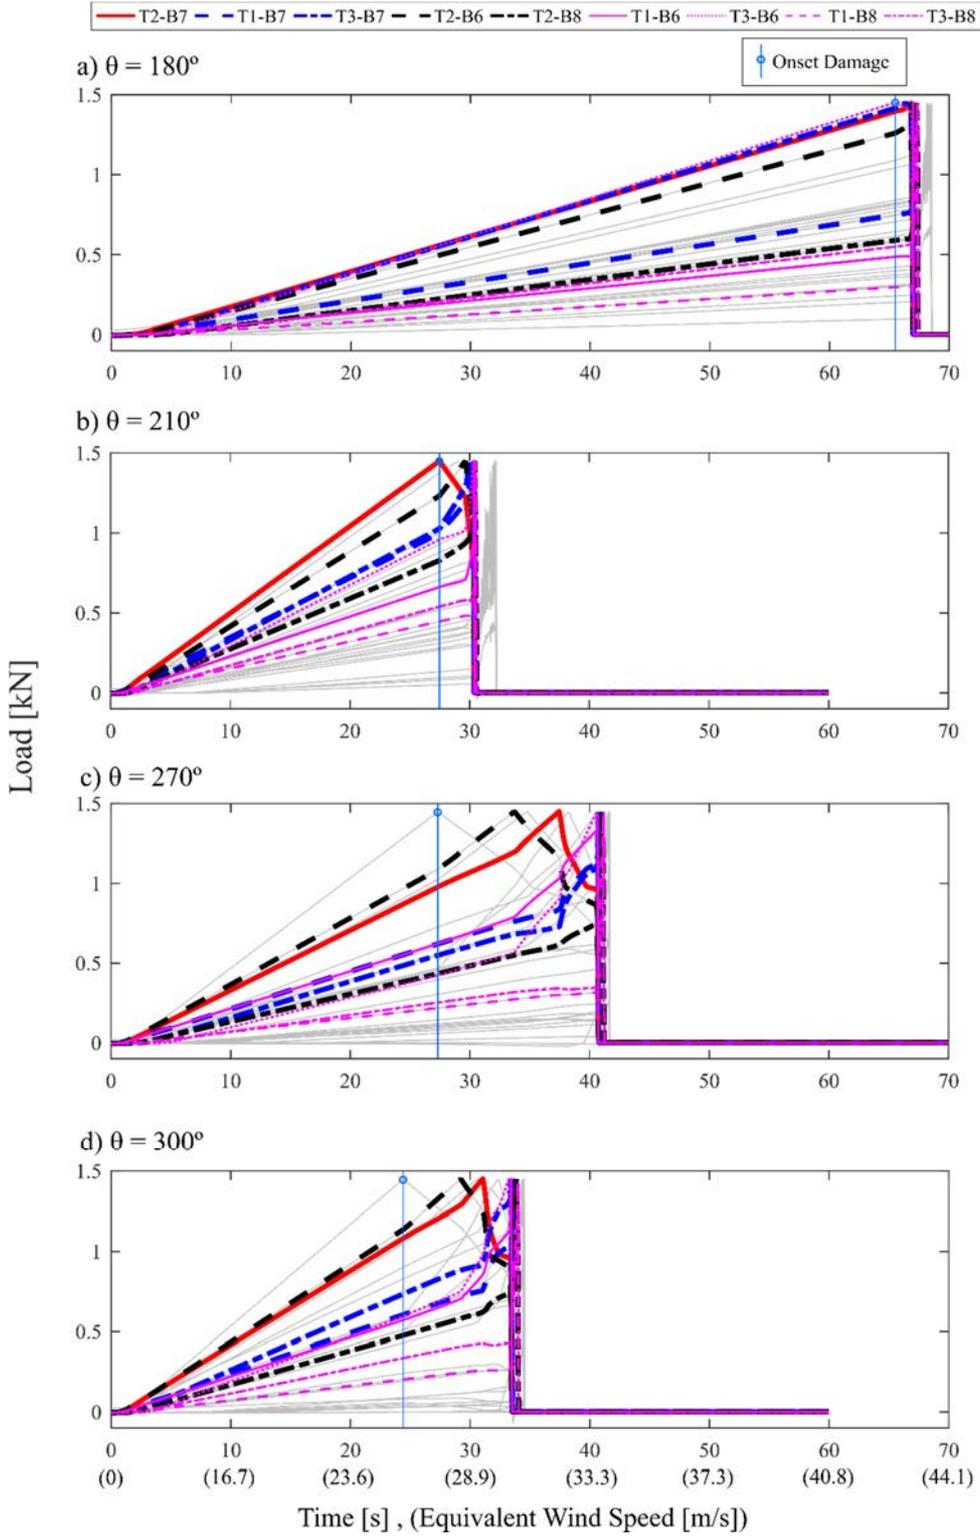
Figure 6.7 Reaction forces at connections through time during the pull up analysis for selected wind directions.

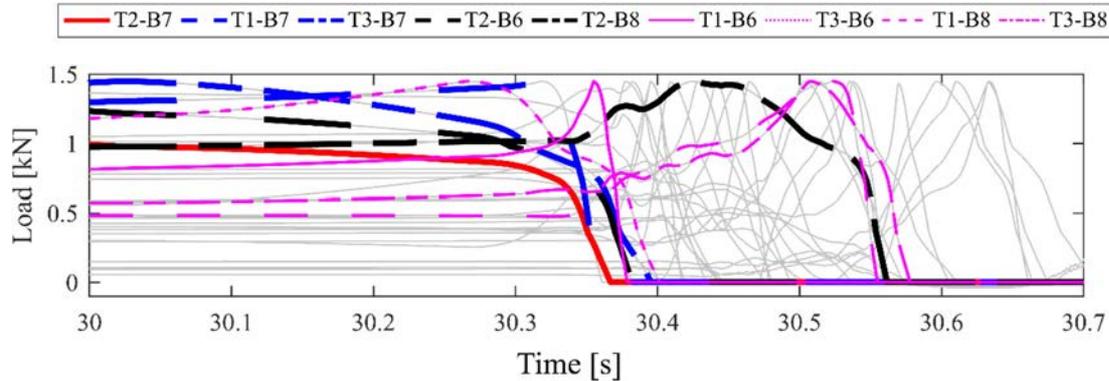
Figure 6.8 Connection reaction forces during the failure cascade for wind direction 210°

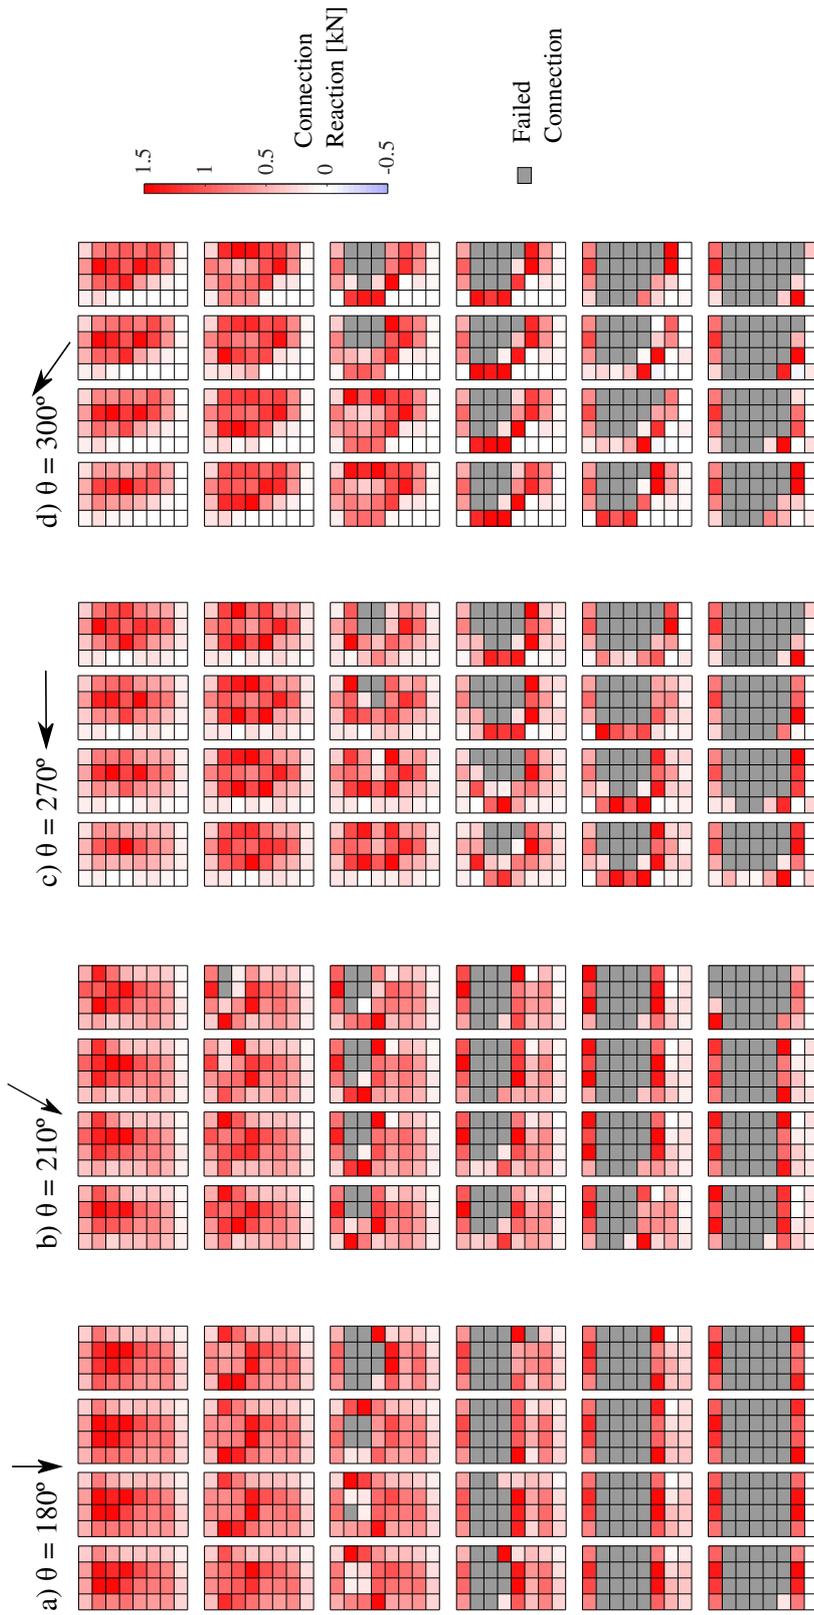
Figure 6.9 Connection reaction forces and spread of failure for selected wind directions

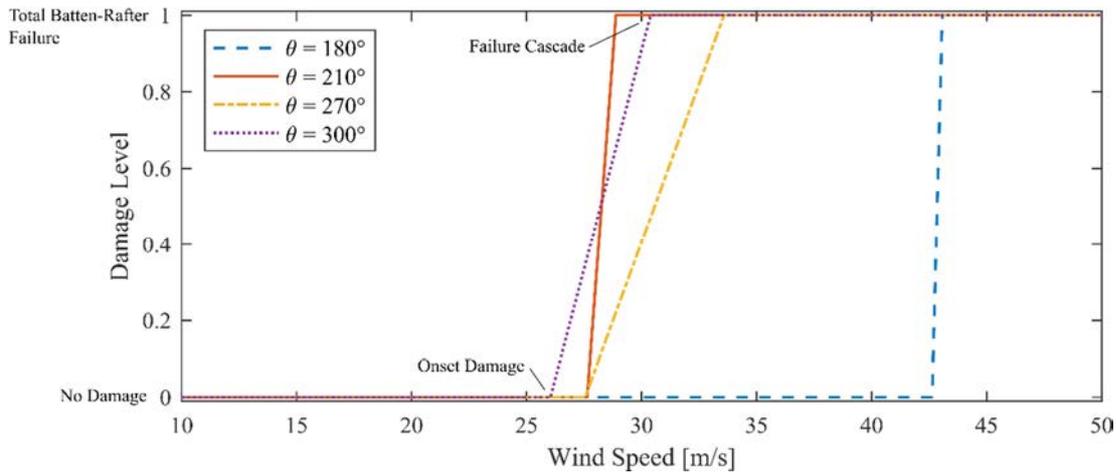
Figure 6.10 Basic fragility curves for batten-rafter failures for different wind directions

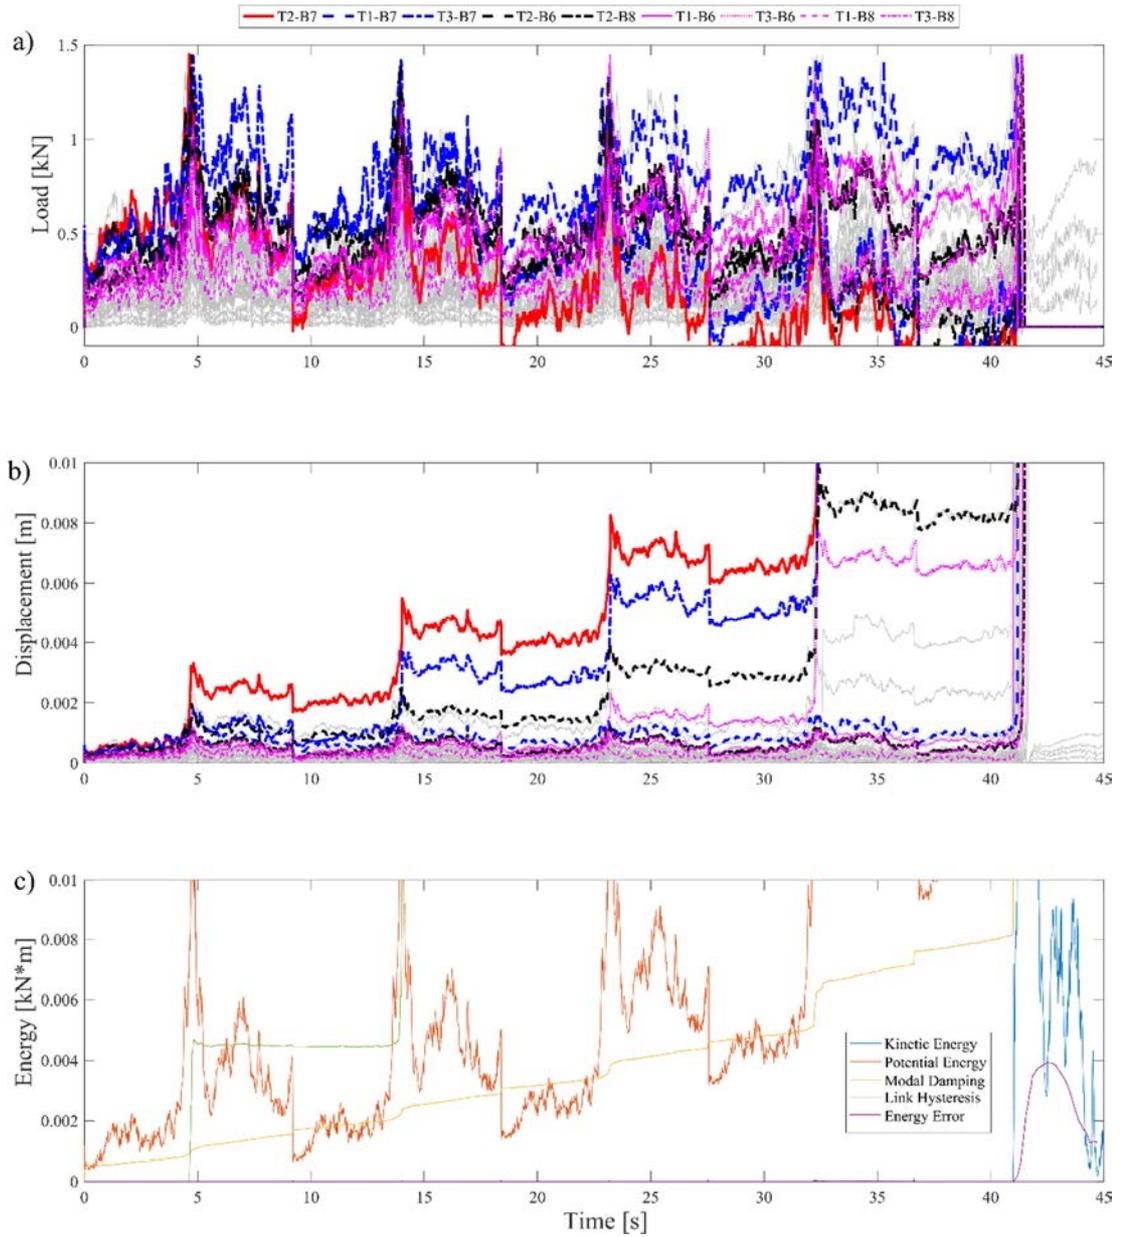
Figure 6.11 Repeated Peak Events at 28.4m/s for wind direction 210° showing incremental damage until a failure cascade at the 5th peak event.

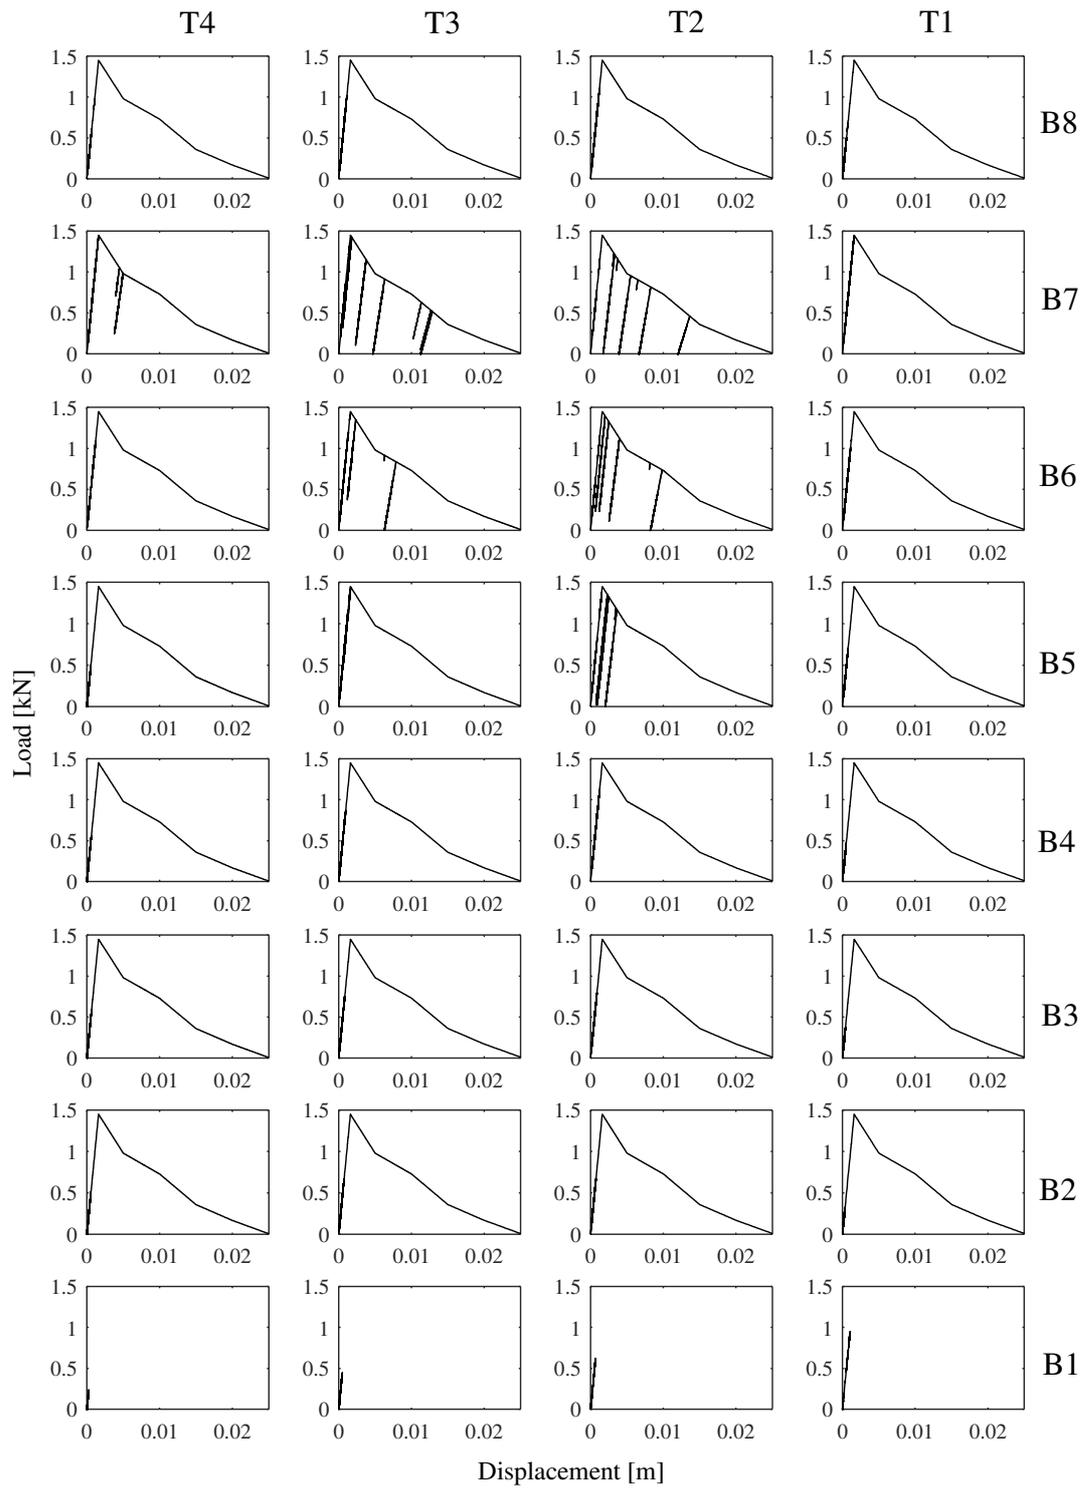
Figure 6.12 Force-displacement plots of the 32 connections in the study area showing diagonal bands from the incremental nail slips (28.4m/s at wind direction 210°).

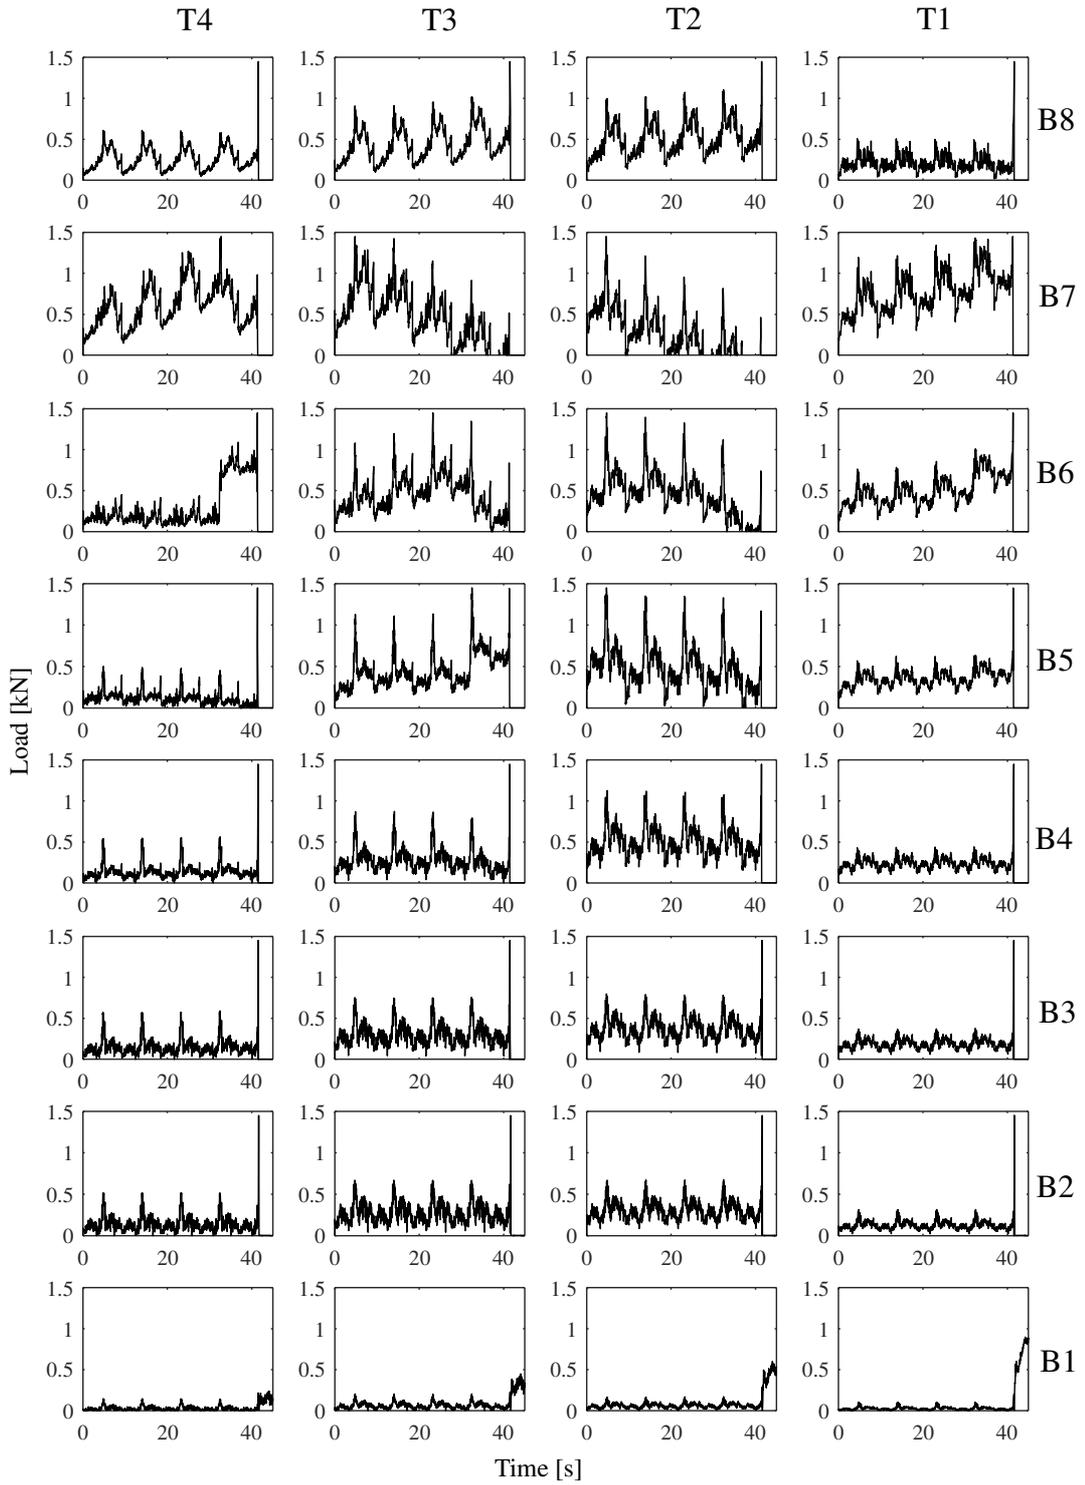
Figure 6.13 Reaction forces at connection over time showing load redistribution as loads increase and decrease at various connections as damage spreads from the critical connection (28.4m/s at wind direction 210°).

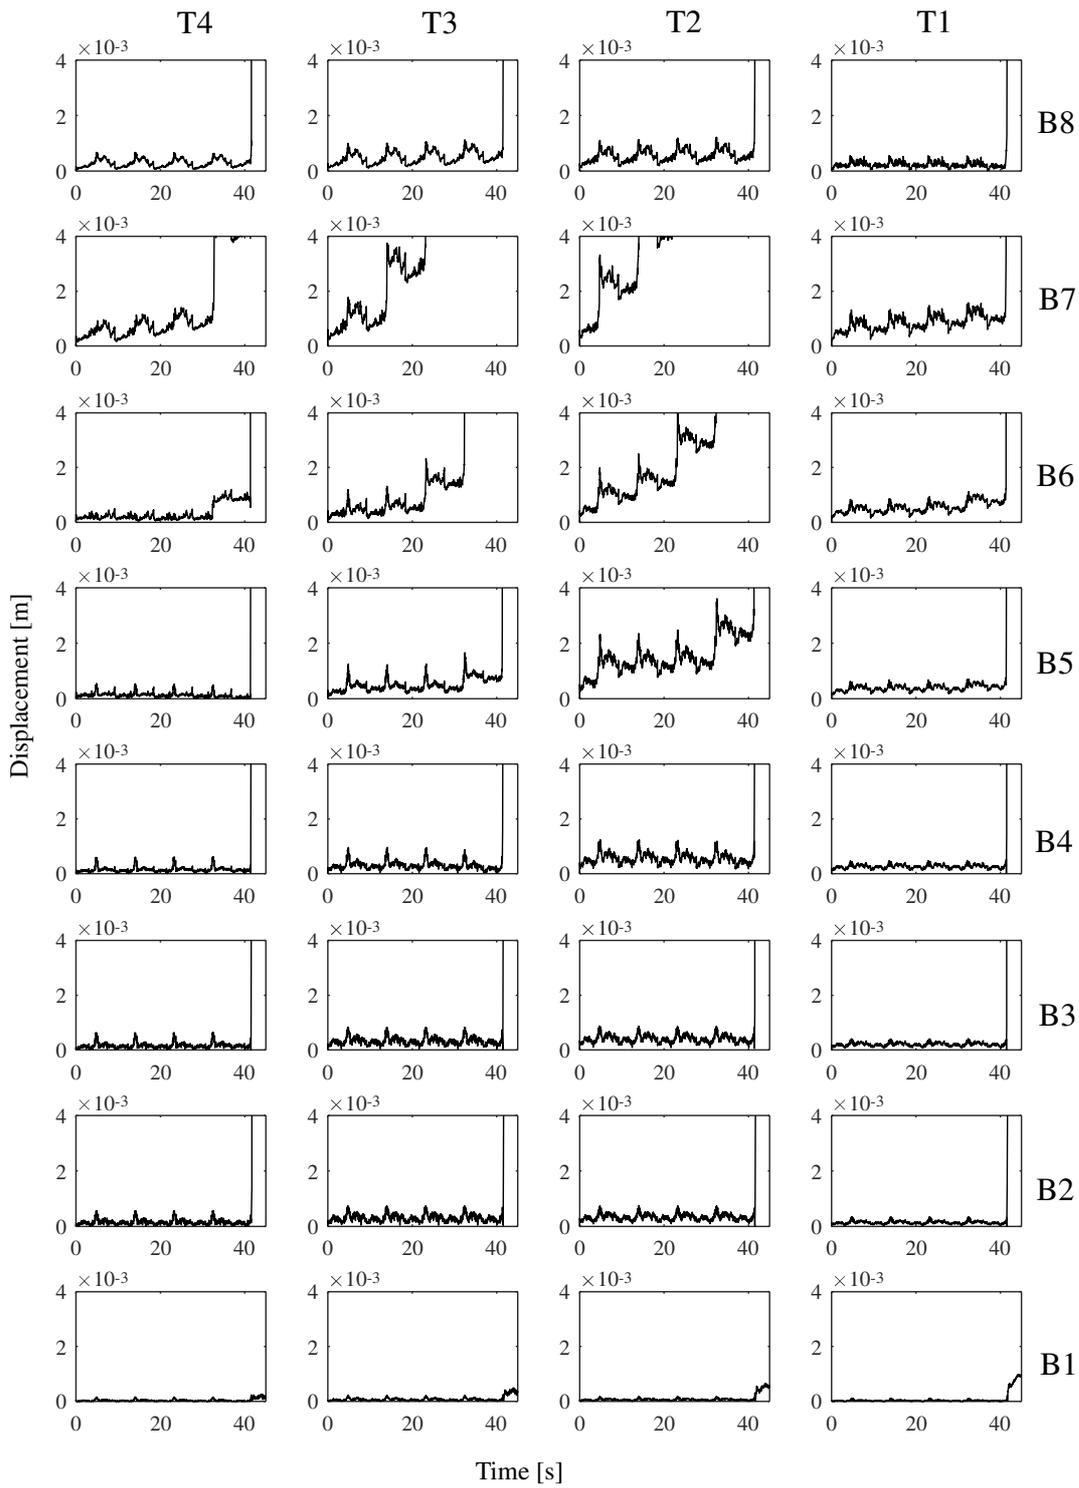
Figure 6.14 Displacement of connections over time showing jumps in displacement when nails slip (28.4m/s at wind direction 210°).

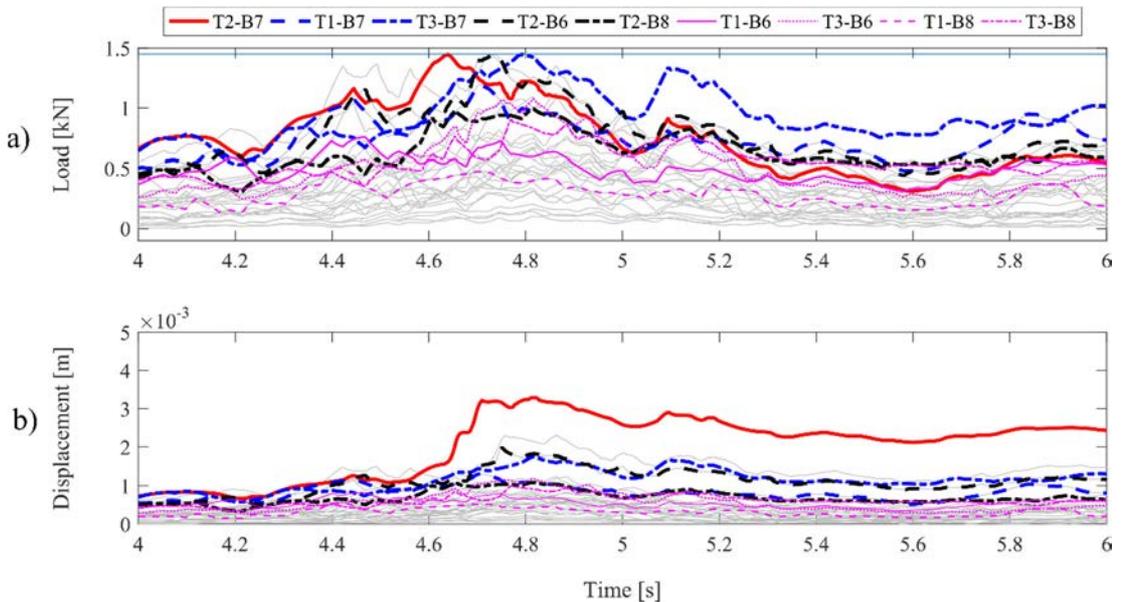
Figure 6.15 Detail of Load redistribution during a 'peak-event' for wind direction 210° at 28.4m/s

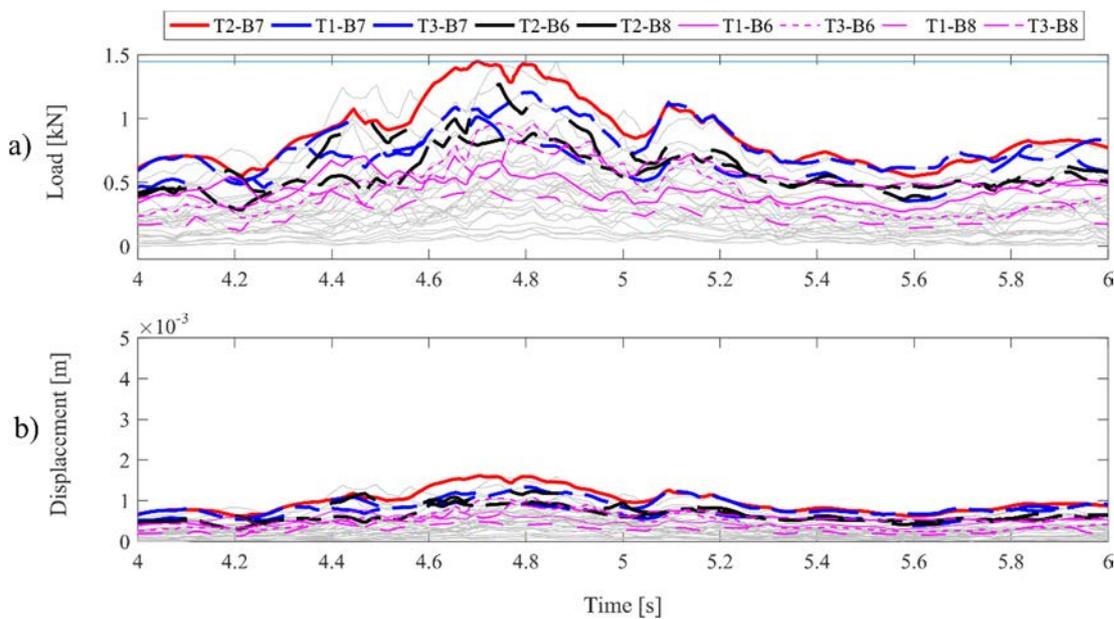
Figure 6.16 Detail of 'peak-event' for wind direction 210° at 27.6m/s, showing no damage.

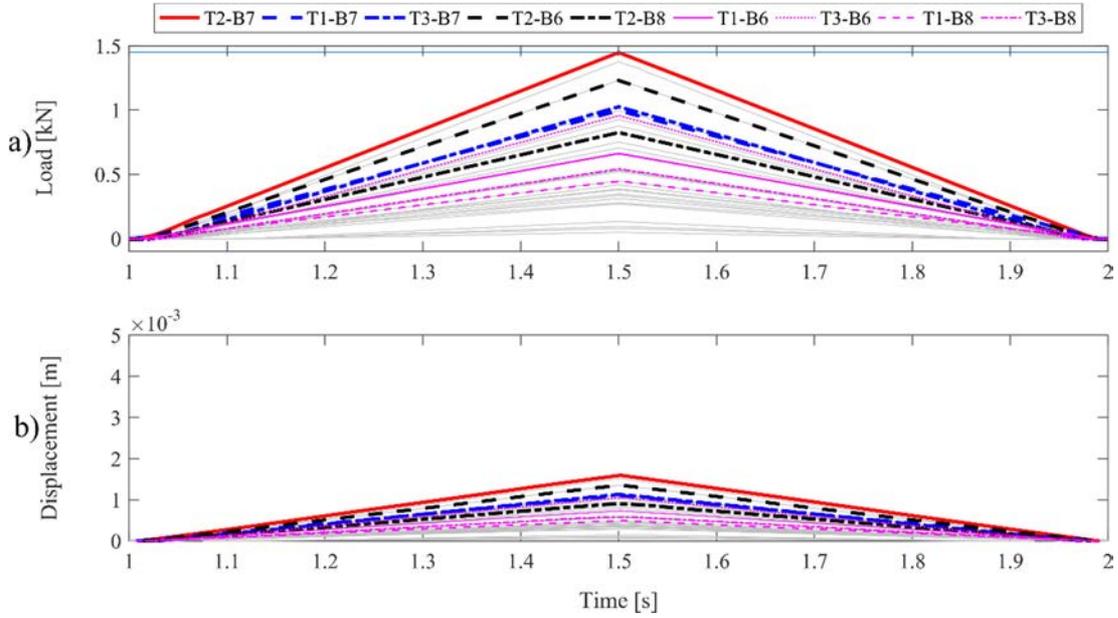
Figure 6.17 Perfectly correlated triangular peak event, representing a wind speed of 27.6m/s at 210° causing no damage to the structure.

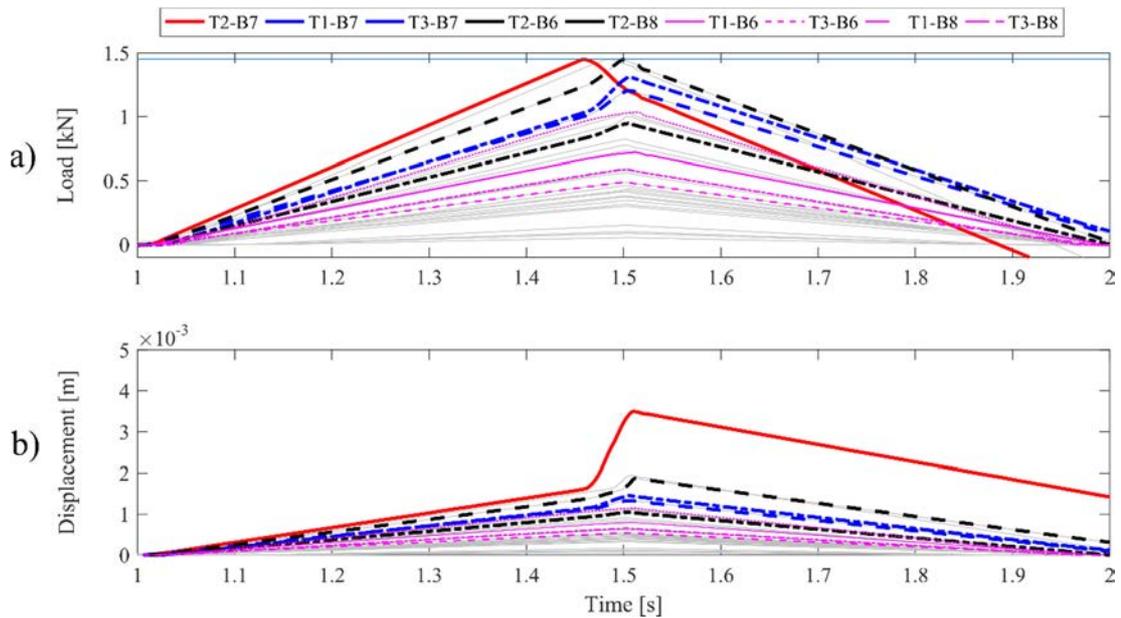
Figure 6.18 Triangular 'peak-event' representing a wind speed of 28.8m/s at 210° Showing load redistribution during a perfectly correlated peak event.

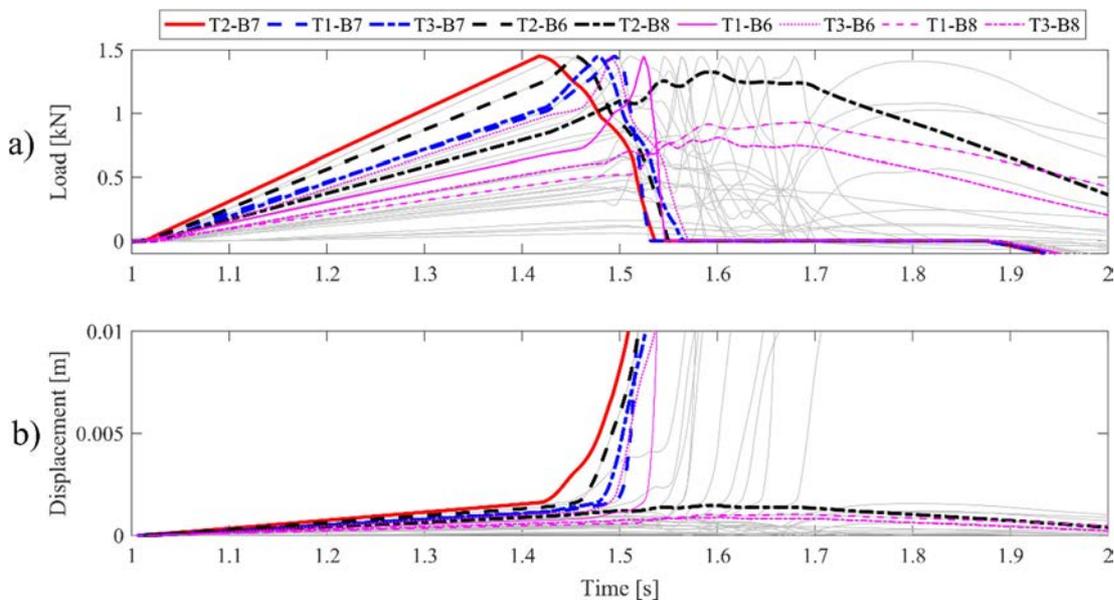
Figure 6.19 Triangular 'peak-event' representing a wind speed of 30.3m/s at 210° showing a partial failure cascade during a perfectly correlated peak event.

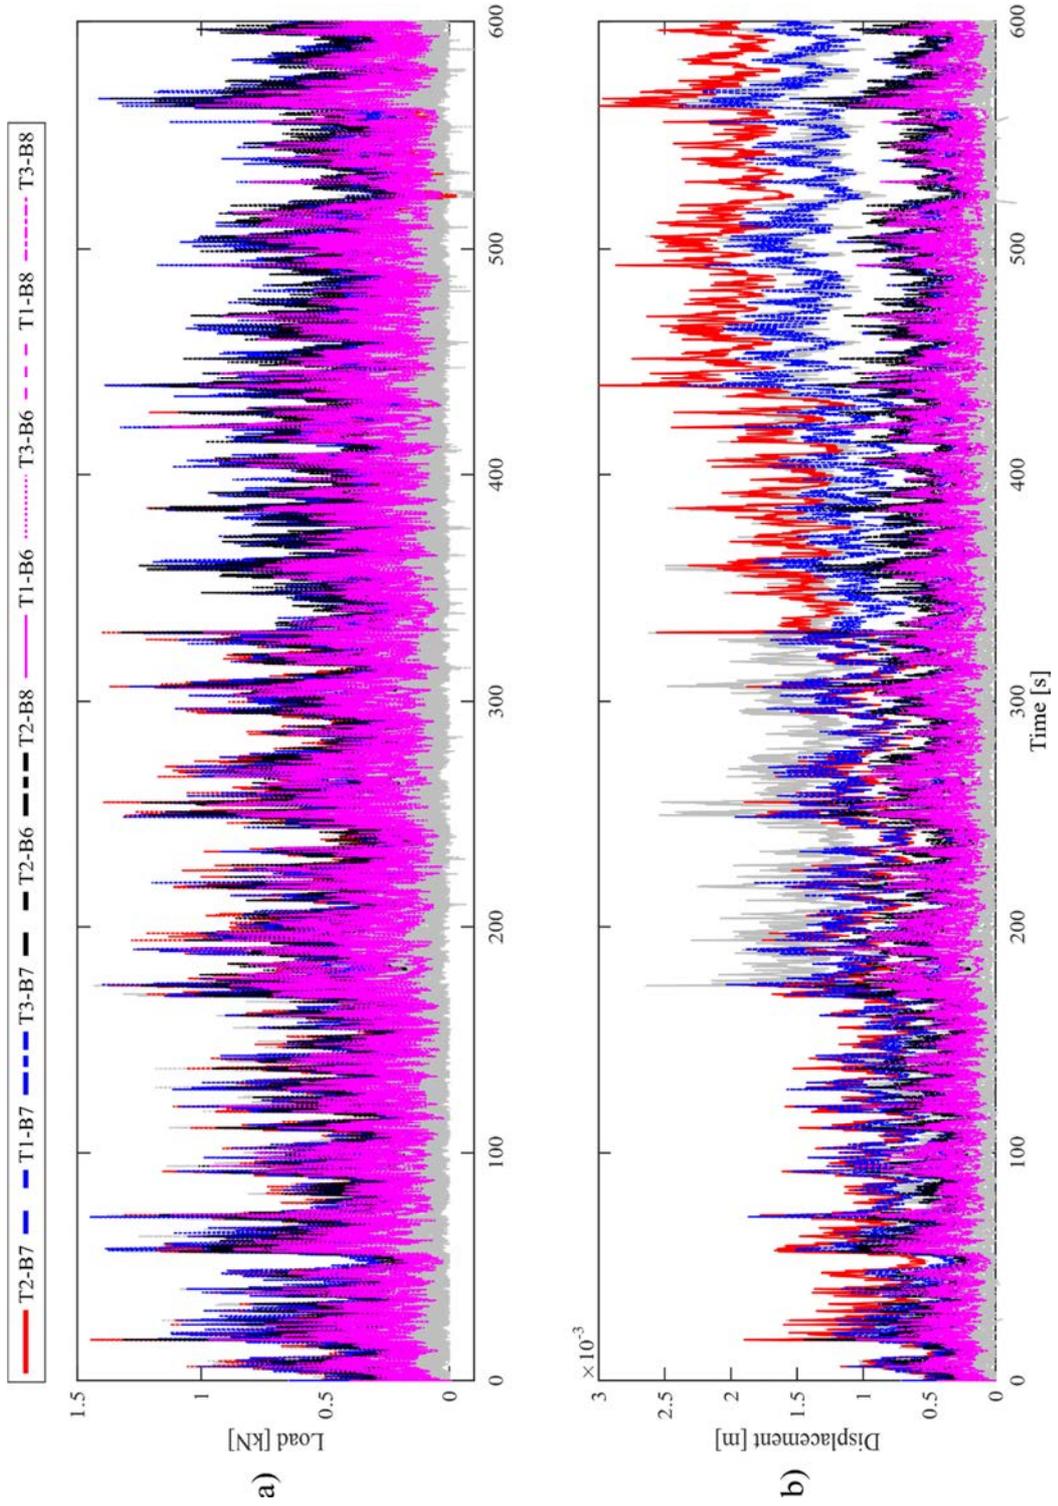
Figure 6.20 Structural response over 600s at 27.6m/s from wind direction 210° - a) reaction forces at connections, b) connection displacements

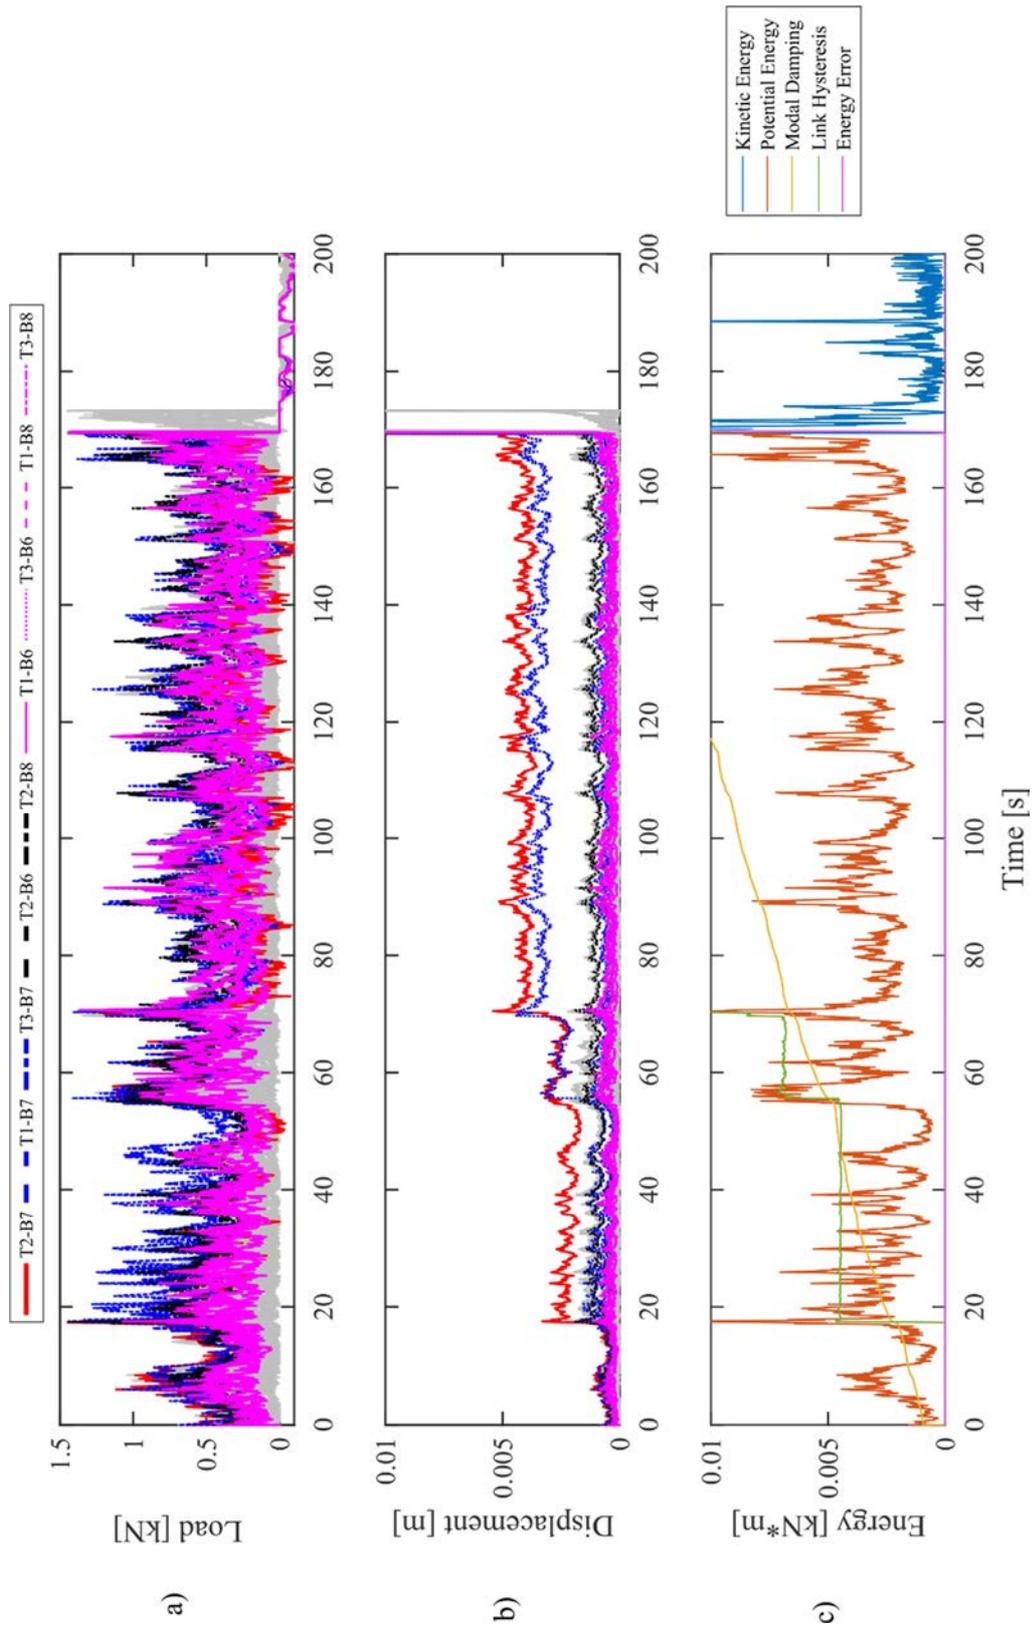
Figure 6.21 Structural response over 200s at 28.4m/s from wind direction 210° - a) reaction forces at connections, b) connection displacements, c) energy plots

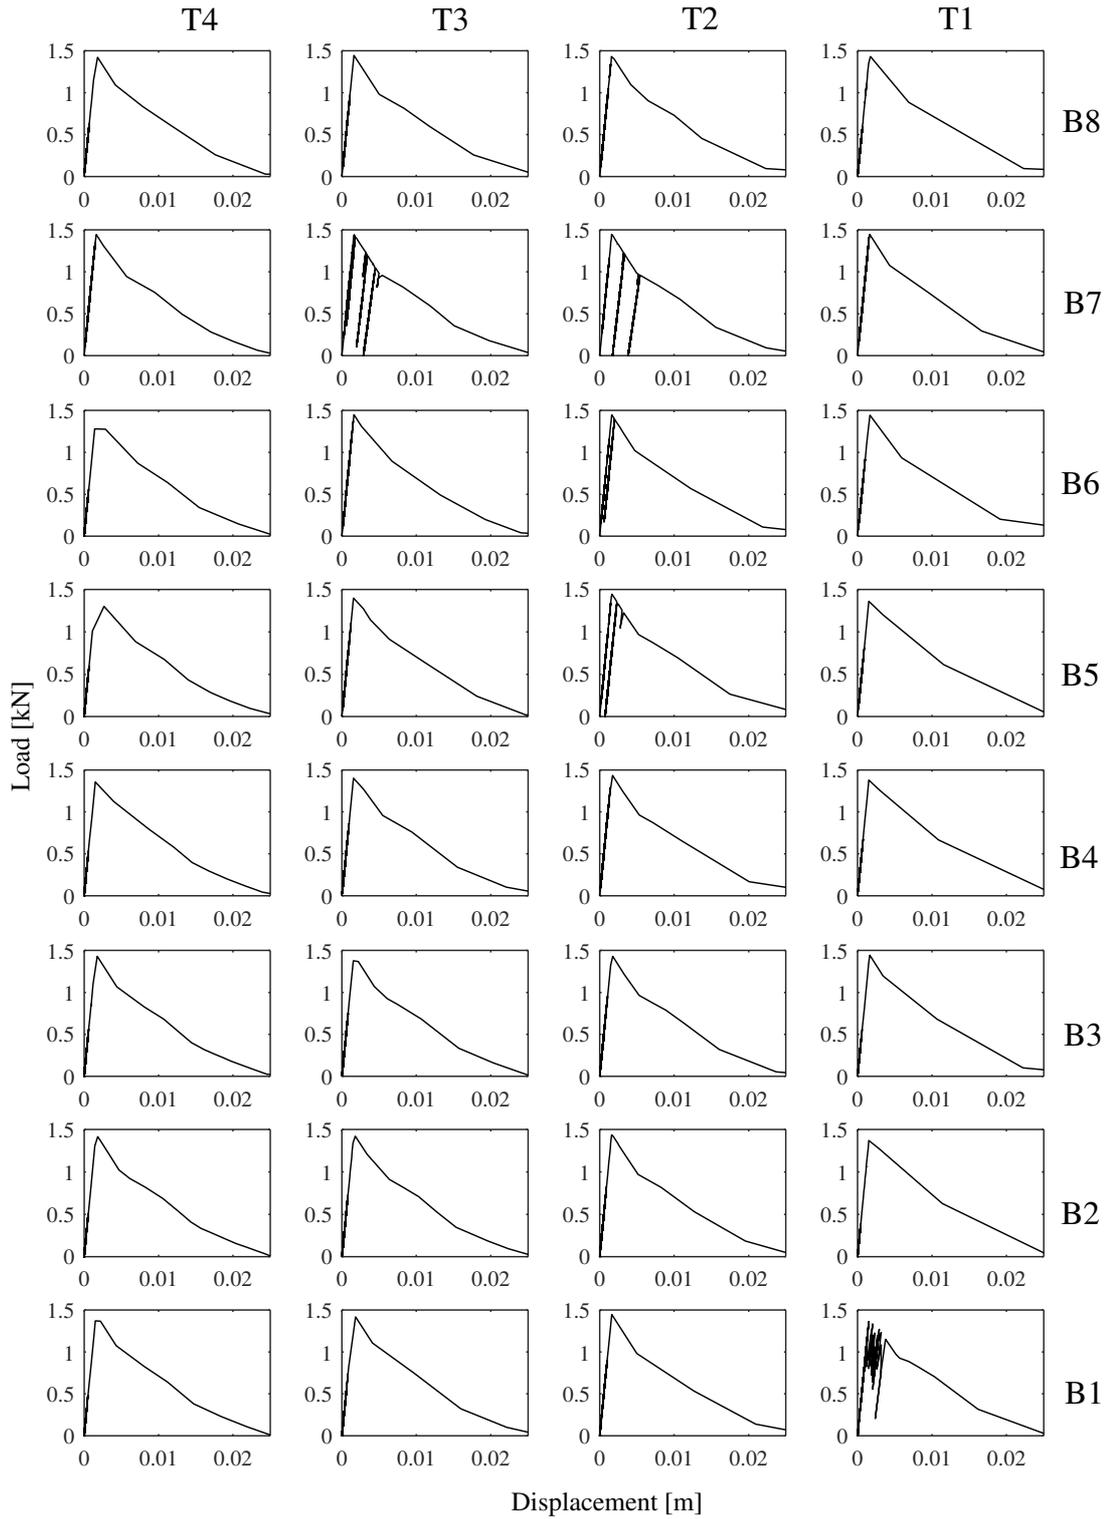
Figure 6.22 Force-displacement plots of the 32 connections in the study area showing diagonal bands from the incremental nail slips (wind speed 28.4m/s, wind direction 210°)
