The Structural Response and Progressive Failure of Batten to Rafter Connections
under Wind Loads

DOCTORAL THESIS

Doctor of Philosophy

(Structural Engineering)

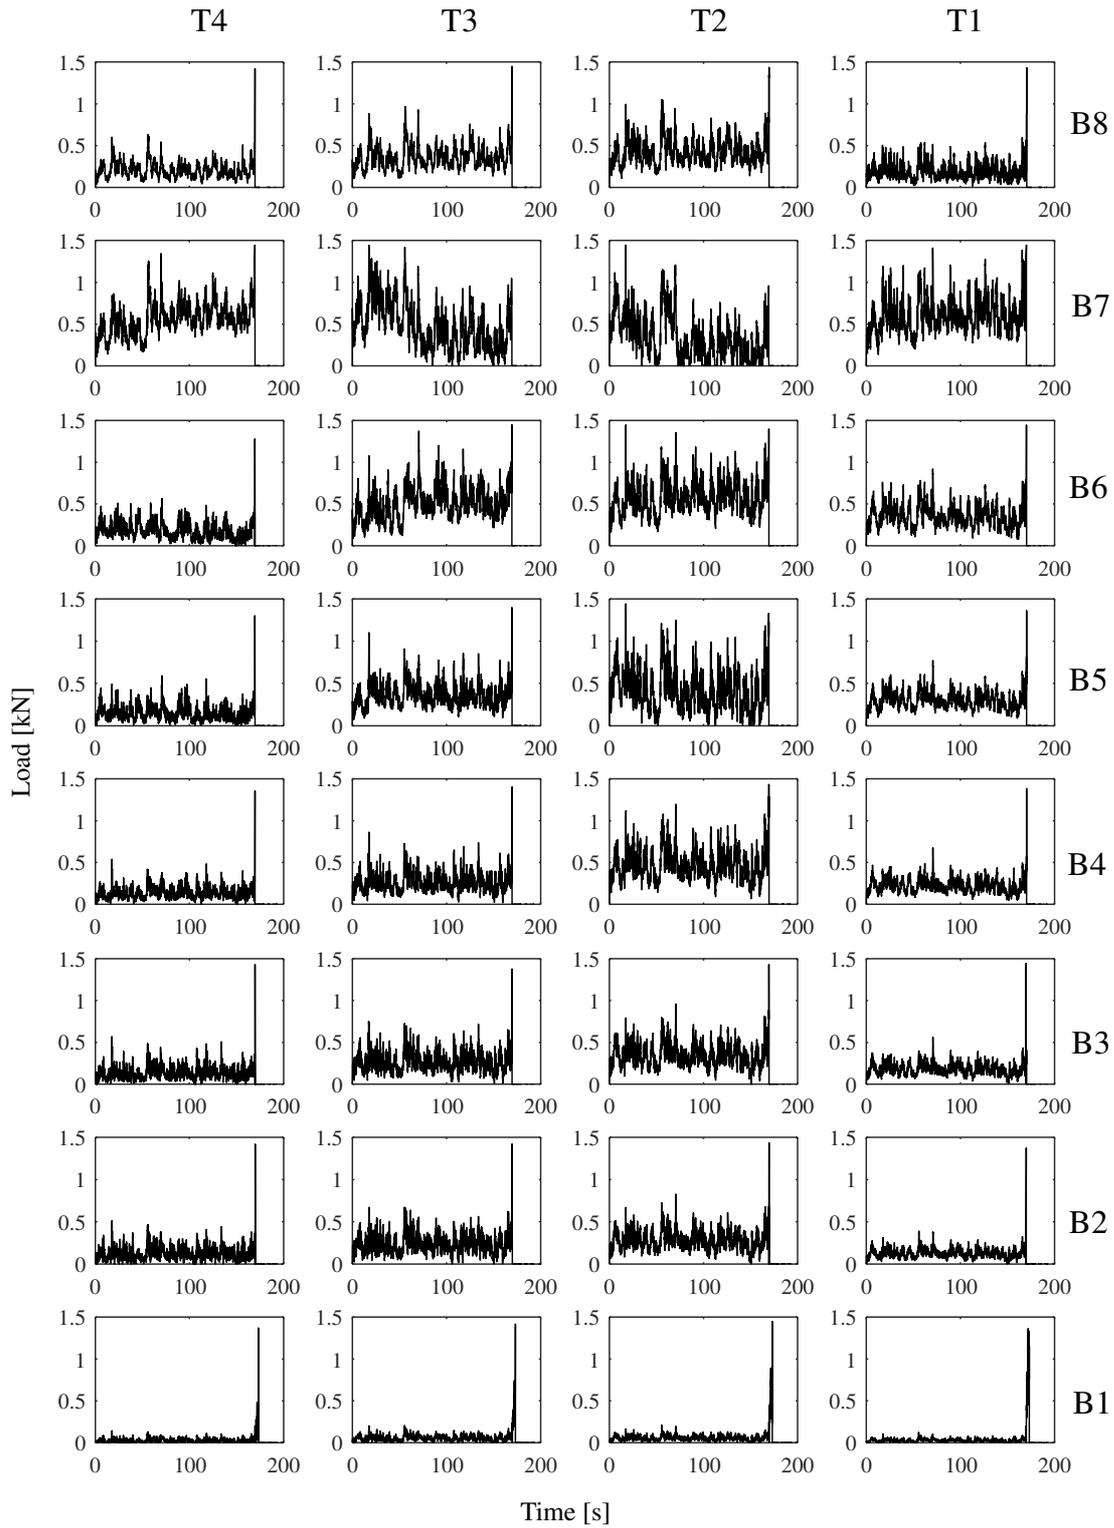
Figure 6.23 Reaction forces at connection over time showing load redistribution (wind speed 28.4m/s, wind direction 210°)

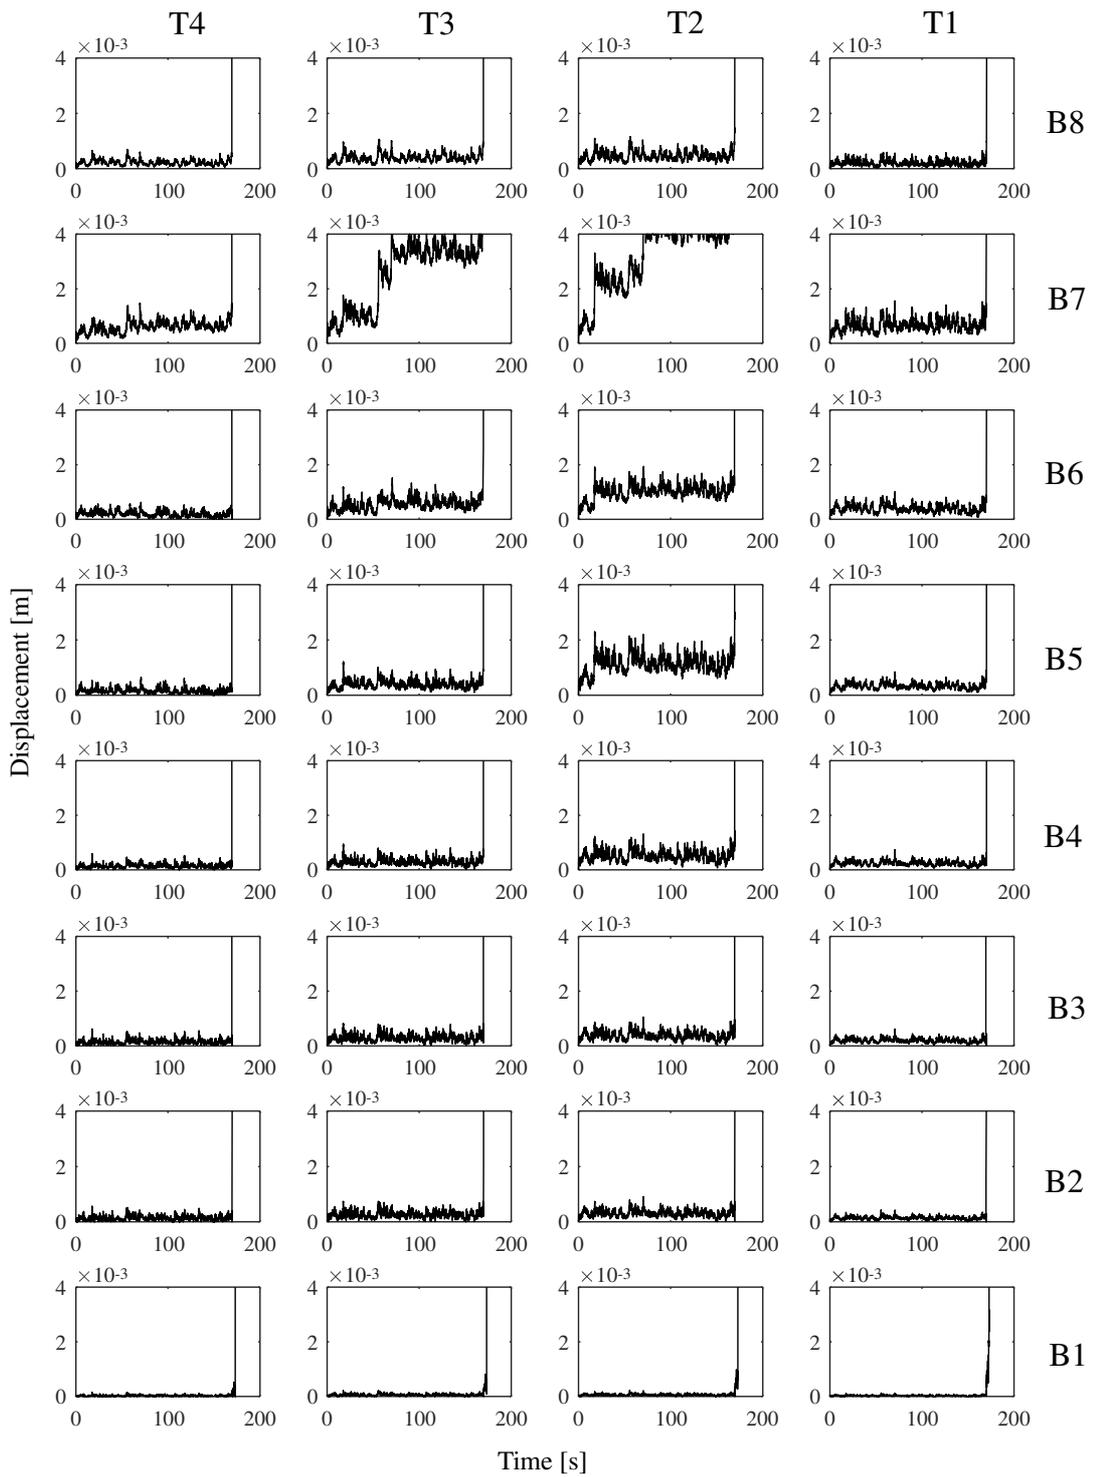
Figure 6.24 Displacement of connections over time showing jumps in displacement when nails slip (wind speed 28.4m/s, wind direction 210°)

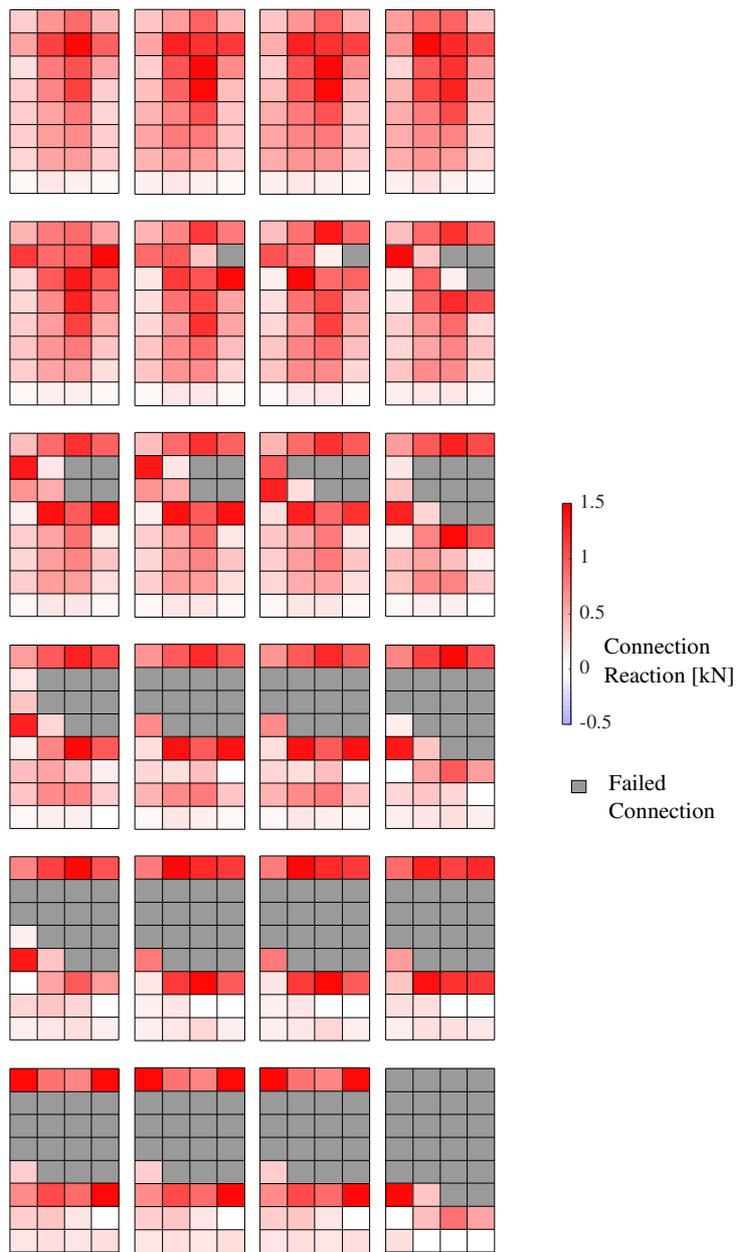
Figure 6.25 Colour-scale diagram showing sequence of connection failures during the time-history analysis (wind speed 28.4m/s, wind direction 210°), bearing a close resemblance to the results from the pull-up analyses.

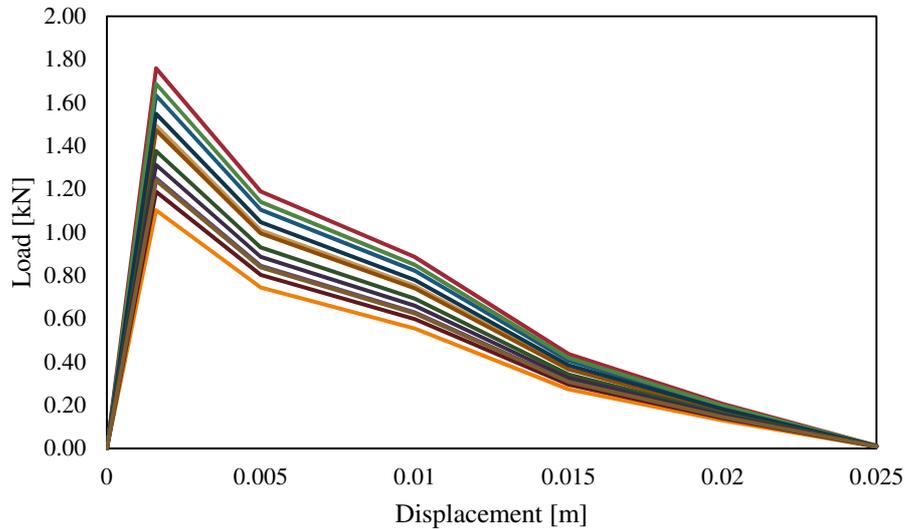
Figure 7.1 Force-displacement relationships of a set of 10 randomised connection properties

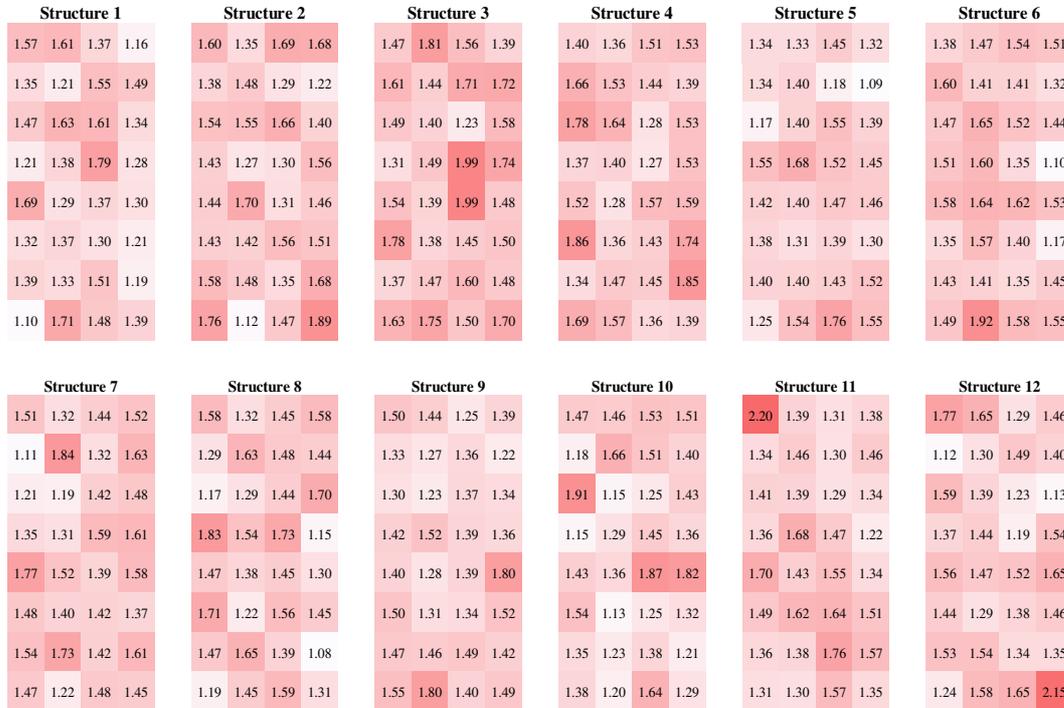
Figure 7.2 Strengths of twelve randomised connection sets [kN], based on a probability distribution determined from connection testing.

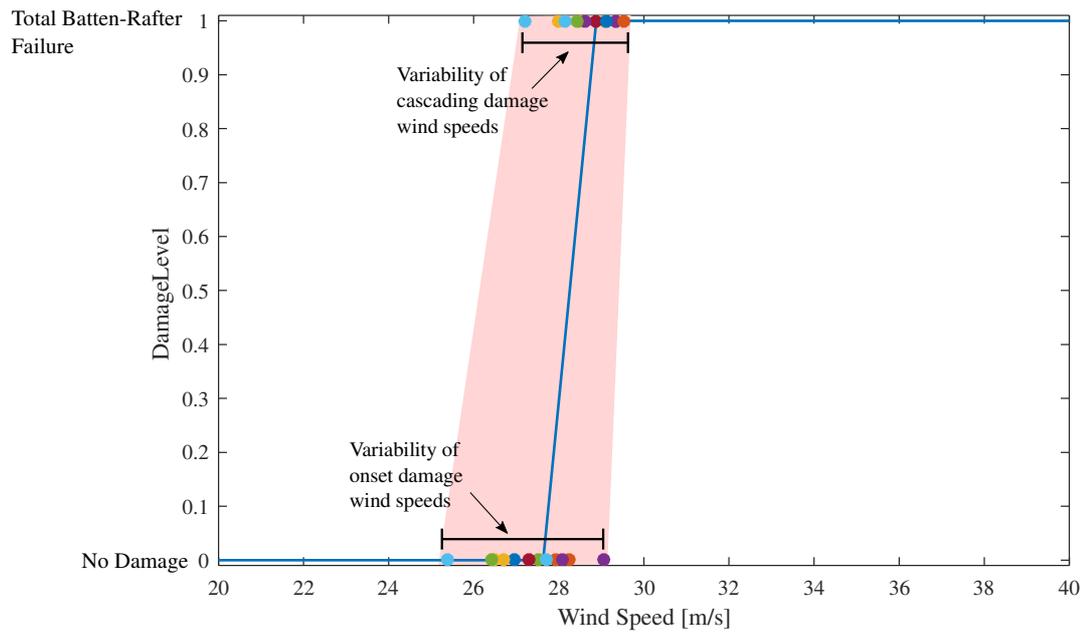
Figure 7.3 Batten-rafter fragility for wind direction 210° showing the expected range of onset and cascading damage wind speed accounting for variability of connections.

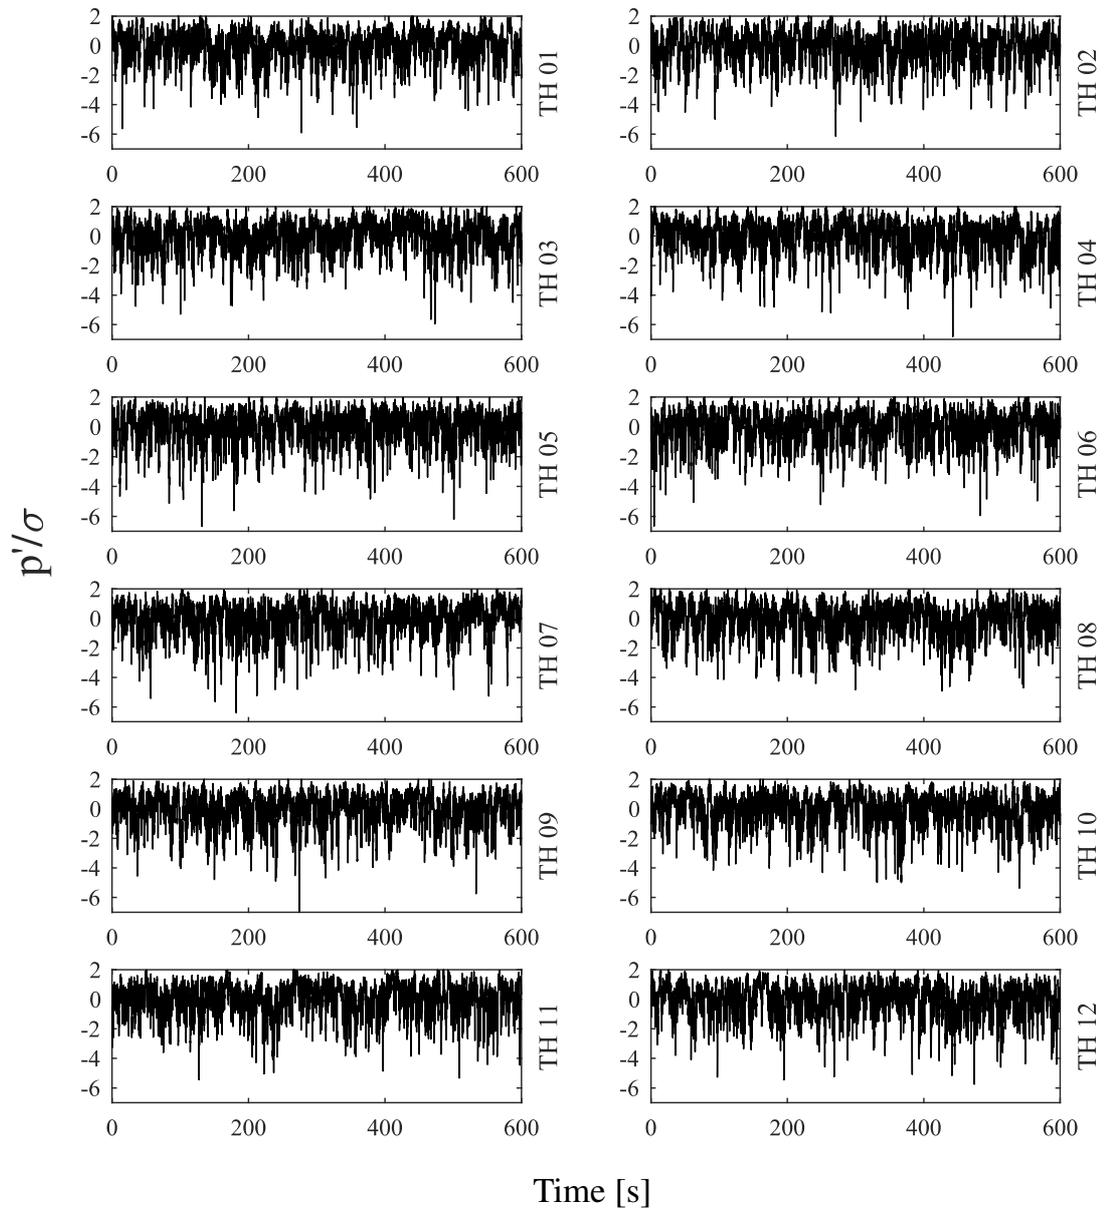
Figure 7.4 The twelve different wind time histories used for the analysis. Pressures only above connection T2-B7 are shown.

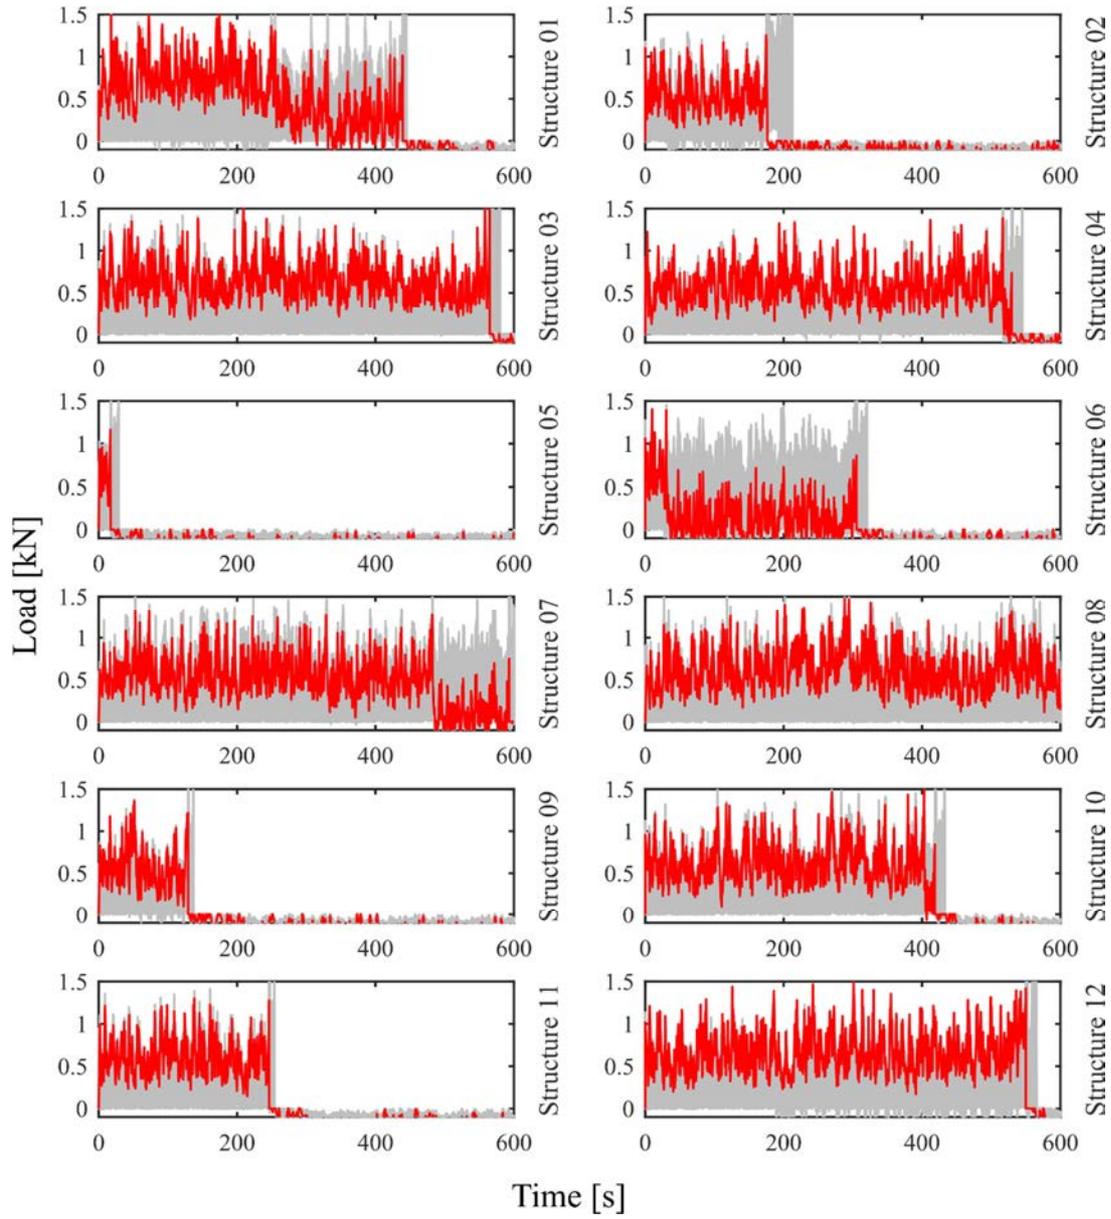
Figure 7.5 Ten-minute time histories of connection reactions at the onset damage wind speed (27.6m/s). Connection T2-B7 shown in red and all other connections shown in grey.

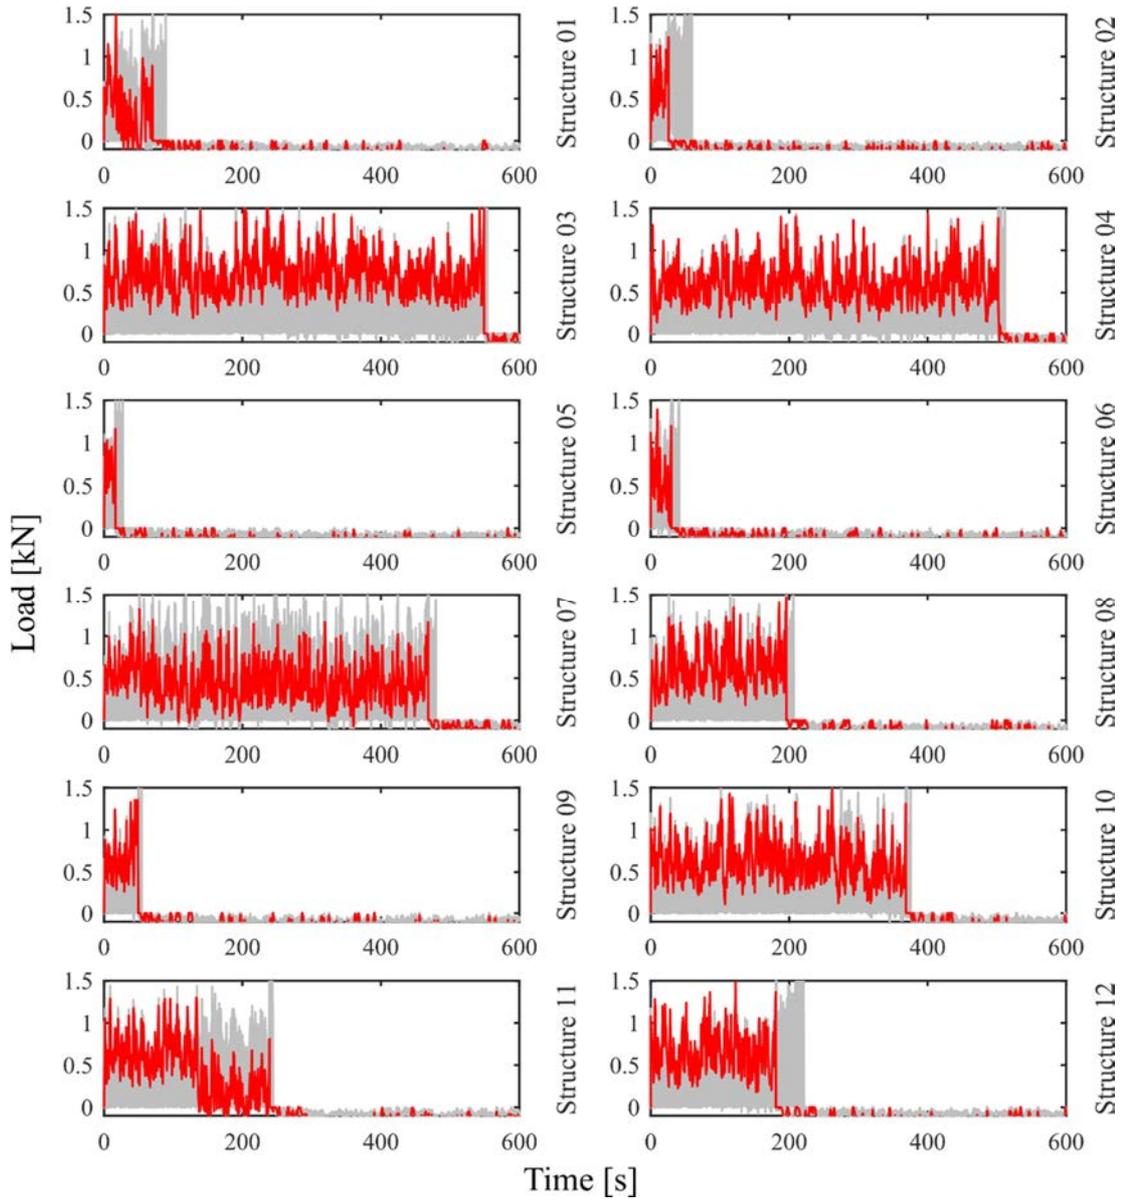
Figure 7.6 Ten-minute time histories of connection reactions at an intermediate damage wind speed (28.4m/s). Connection T2-B7 shown in red and all other connections shown in grey.

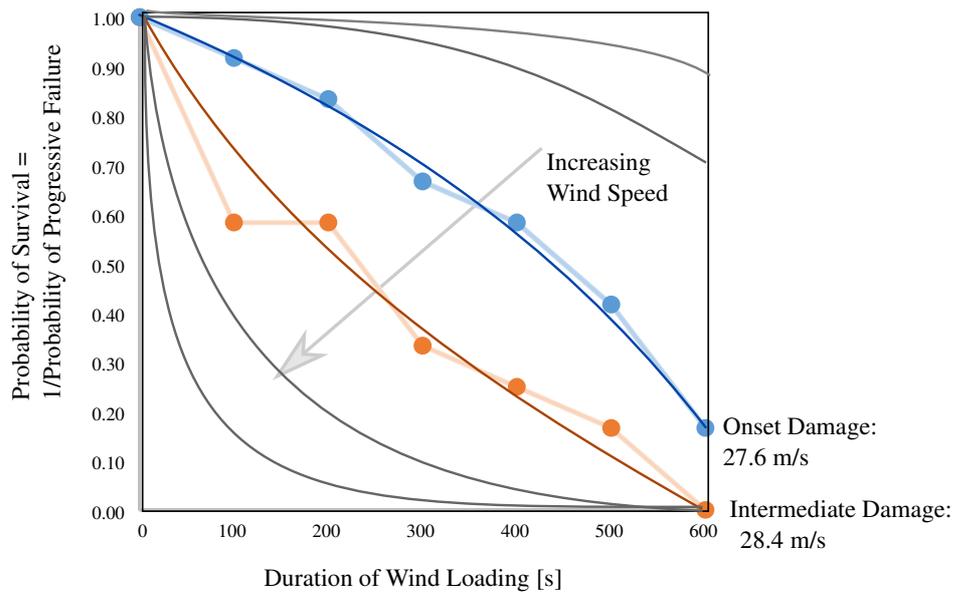
Figure 7.7 Survival functions for a range of wind speeds at wind direction 210°

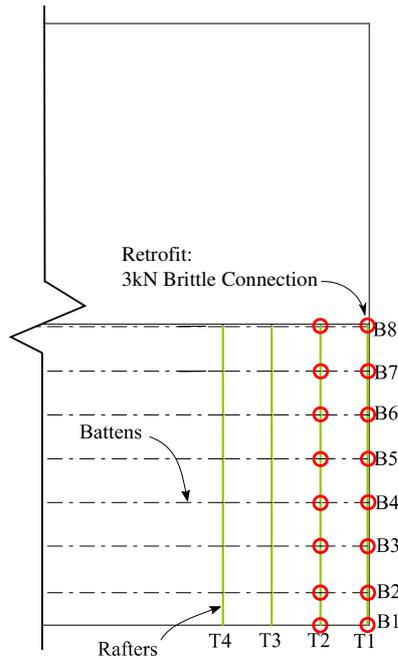
Figure 7.8 Locations of retrofitted connections

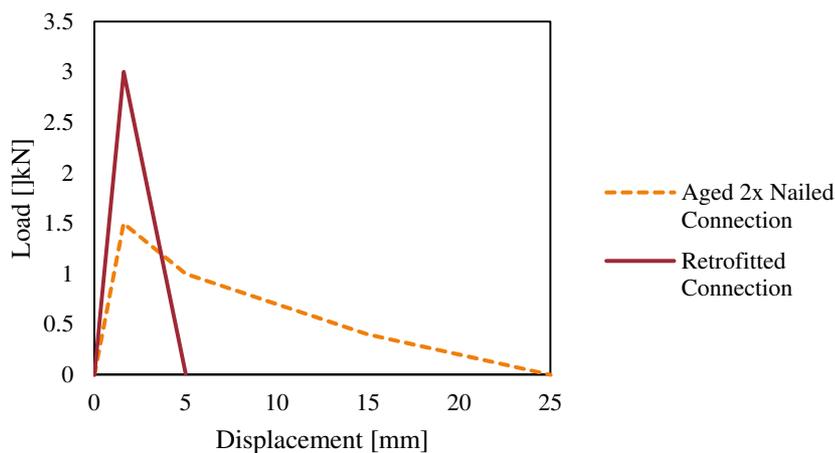
Figure 7.9 Connection properties of existing aged connections and retrofitted connections

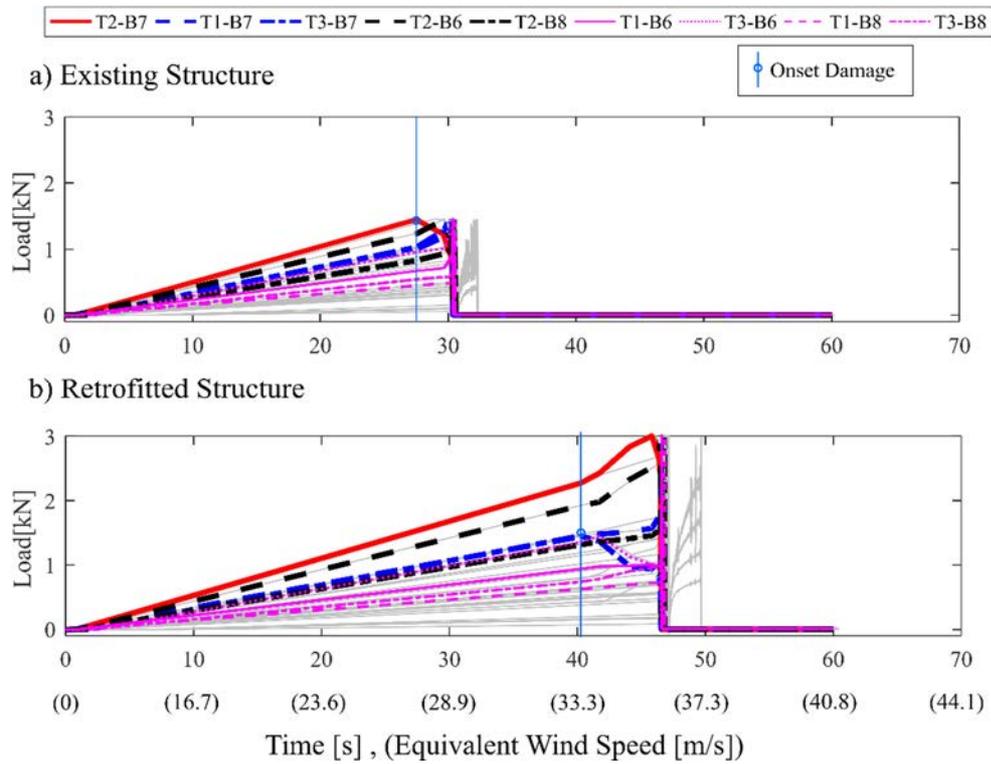
Figure 7.10 Reaction forces during the pull up analysis of connections during pull up analysis for a) the existing structure and b) the retrofitted structure

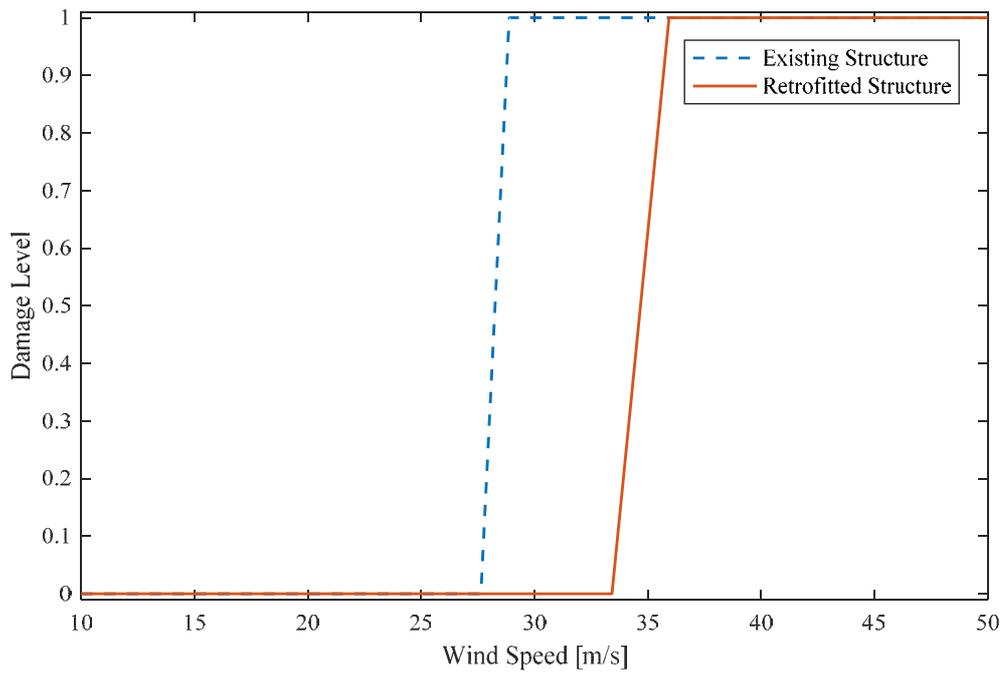
Figure 7.11 Fragility relationships for the existing and retrofitted structure showing increase in wind speeds required for the onset of damage and cascading damage for the retrofitted structure

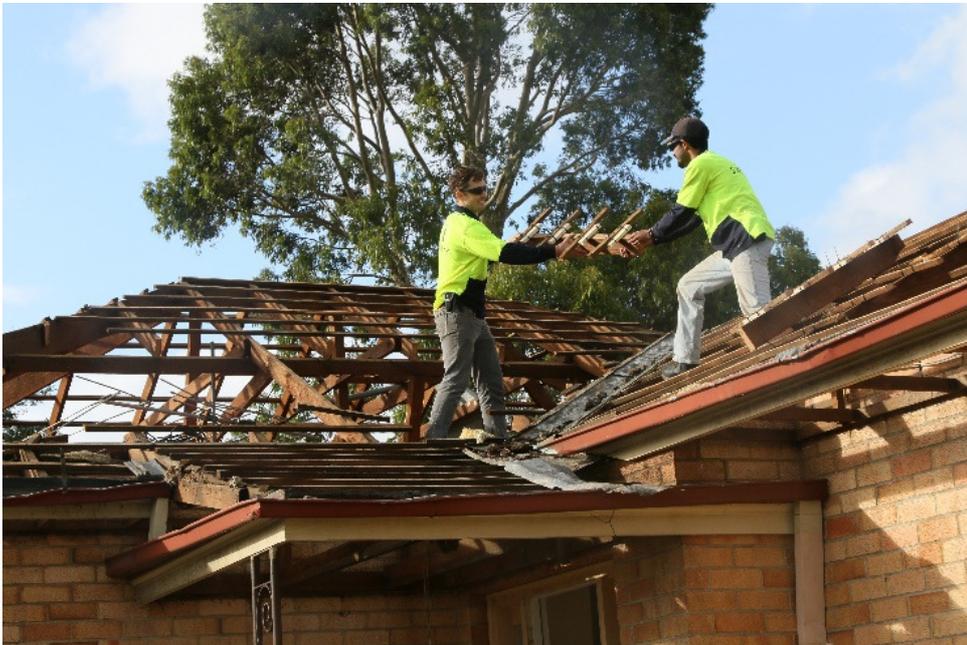
Figure A.1 Extraction of as built batten to rafter connections

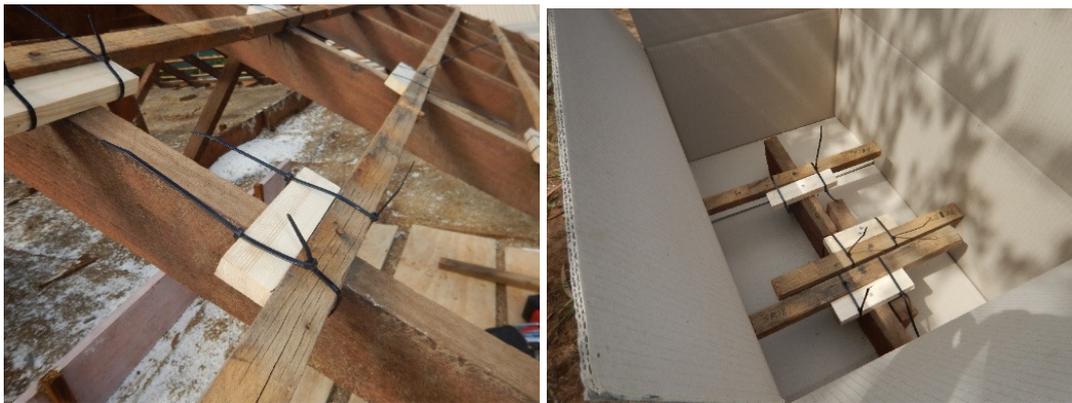
Figure A.2 Connections being prepared for extraction (left) and being packed for transit (right).

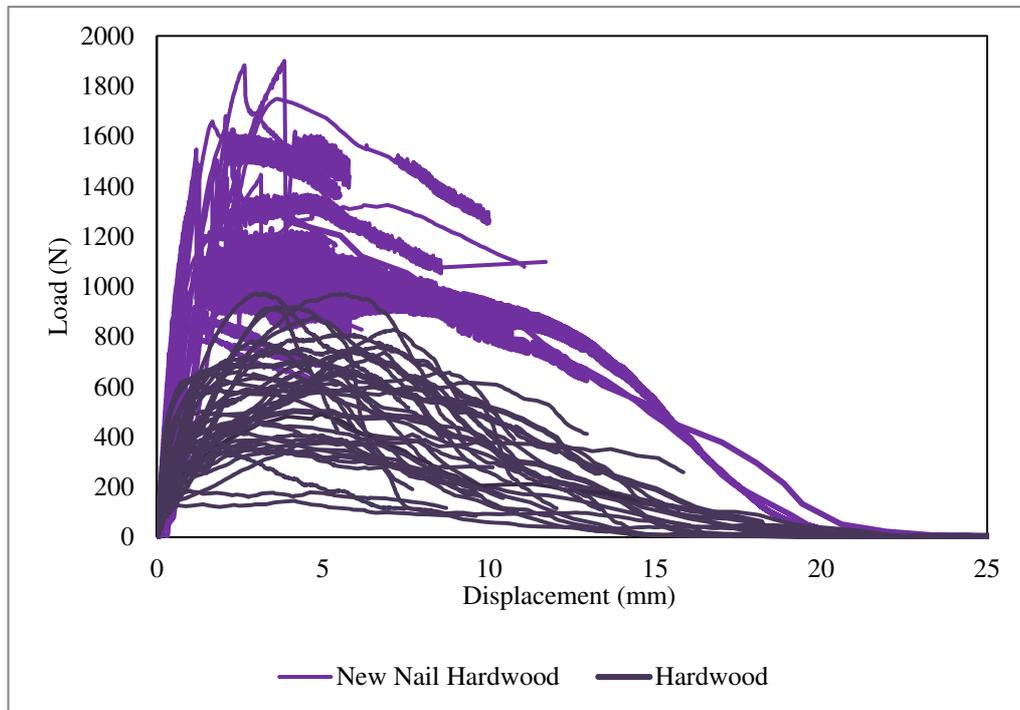
Figure A.4 Force-displacement behaviour of static pullout tests.

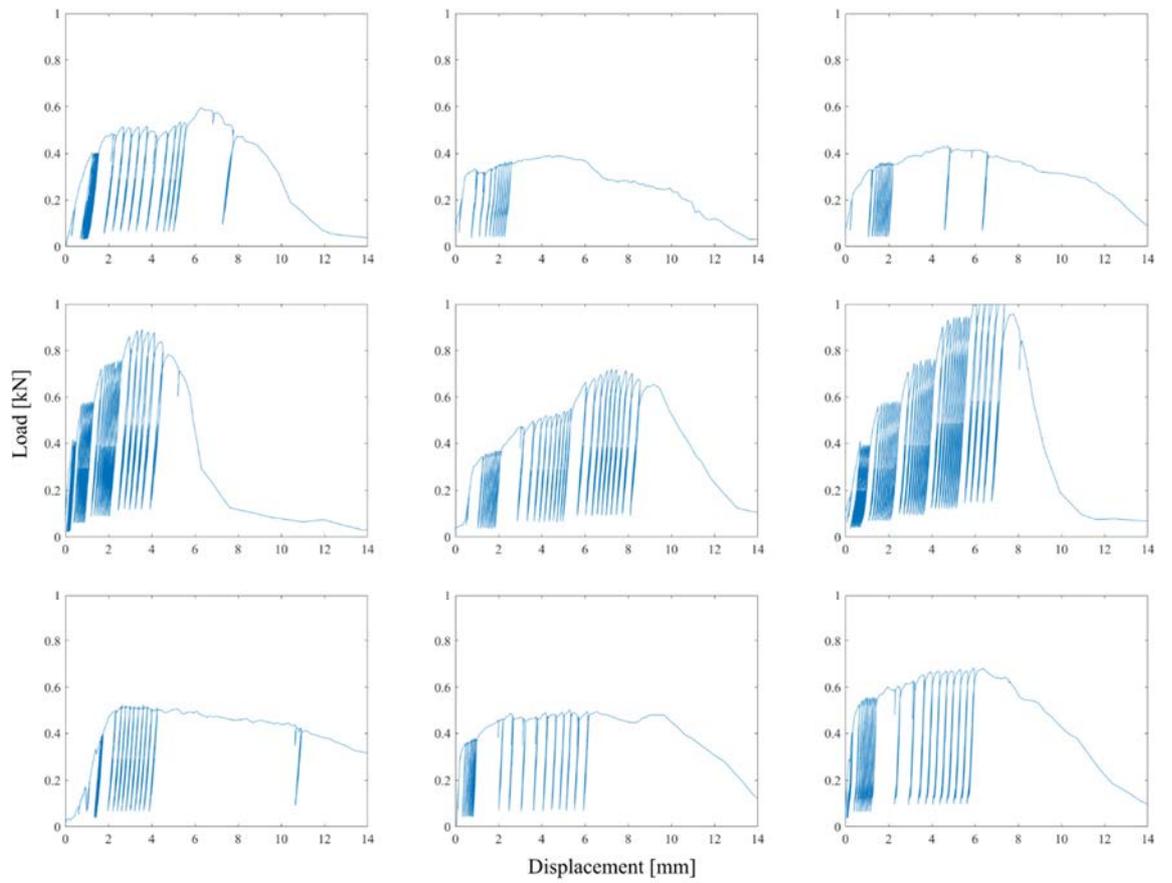
Figure A.5 Force - displacement behaviour under stepped peak events showing the eventual failure of connections at different magnitudes of loading.

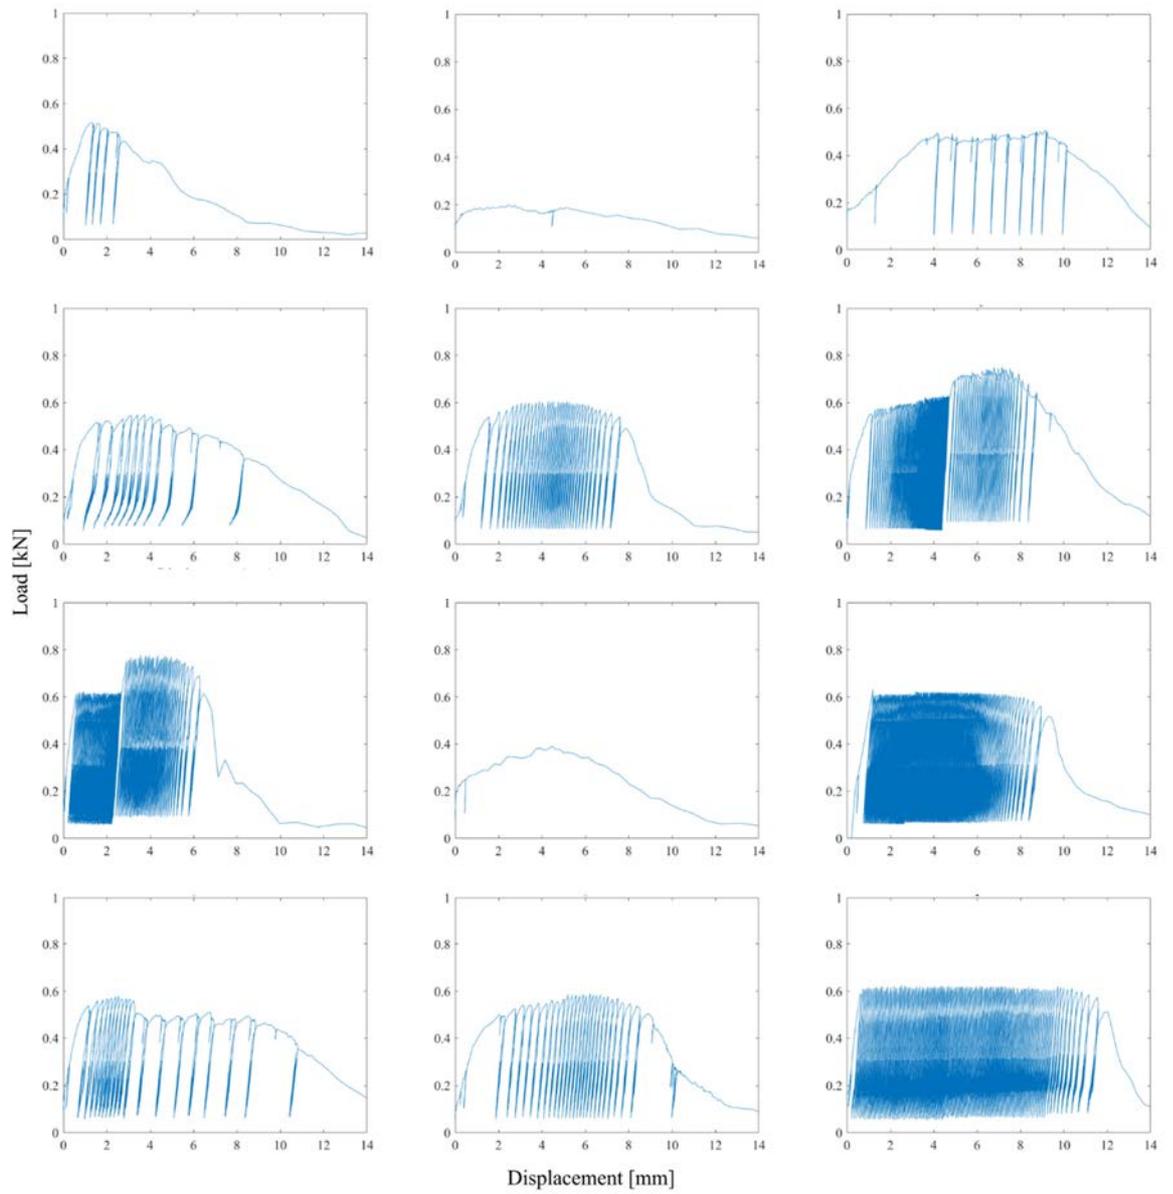
Figure A.6 Force vs. displacement behaviour of a hardwood batten to rafter connection under repeated peak events

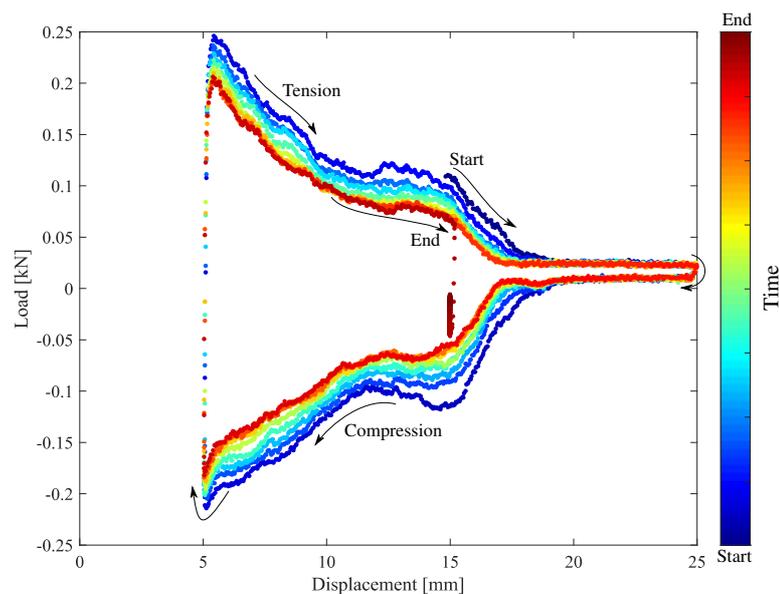
Figure B.1 Connection response under reverse cycle loading
