IMPROVING THE RESILIENCE OF EXISTING HOUSING TO SEVERE WIND EVENTS

MANY OF US LIVE IN HOMES WITH VULNERABILITIES THAT CONTRIBUTE TO COMMUNITY WIND RISK. THIS PROJECT AIMS TO INVESTIGATE WINDSTORM RISK MITIGATION BY: (A) DEVELOPING VULNERABILITY MODELS FOR STRUCTURAL STRENGTH OF HOUSING FROM FIELD AND LABORATORY OBSERVATIONS, AND (B) EVALUATING POTENTIAL UPGRADING AND RETROFITTING SOLUTIONS FOR RESIDENTIAL STRUCTURES.

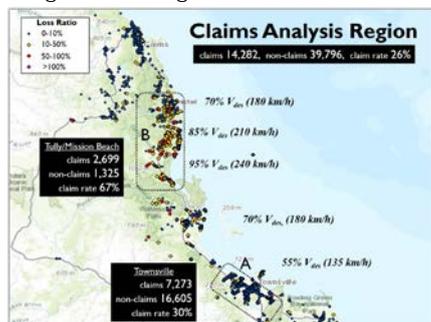
North Queensland coastal region impacted by Cyclone Yasi (2011) with distribution of claims subdivided by four loss ratio bins (claim value/insured value) and wind field estimation: http://www.suncorpgroup.com.au/sites/default/files/pdf/news/Suncorp_Report_PhaseII_Final_21_07_2015.pdf

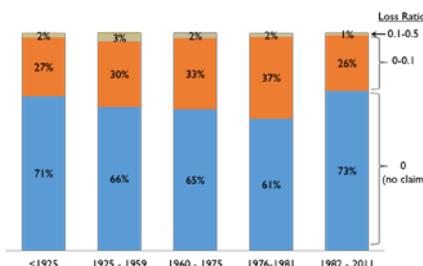
Claims loss ratio proportions for five building age groups to the total number of claims filed in relation to Cyclone Yasi for the Townsville region.
