IMPROVING THE RESILIENCE OF EXISTING HOUSING TO SEVERE WIND EVENTS

Proceedings of the Research Forum at the Bushfire and Natural
Hazards CRC & AFAC conference
Wellington, 2 September 2014

D.J. Henderson^{1,2} and J.D. Ginger^{1,2}

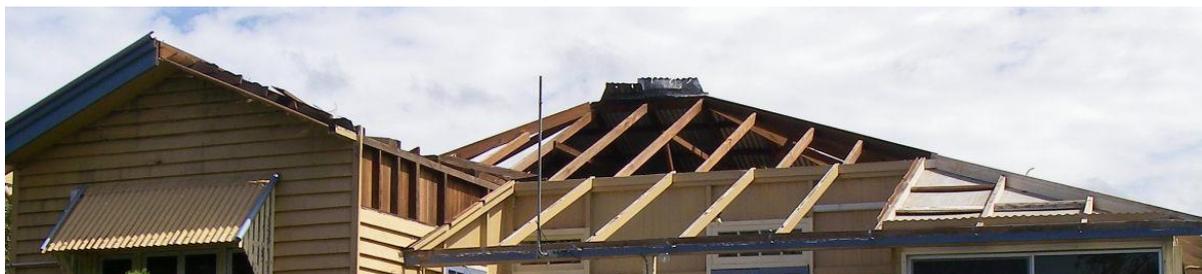
Figure 1. Removal of roof cladding and battens from wind ward face

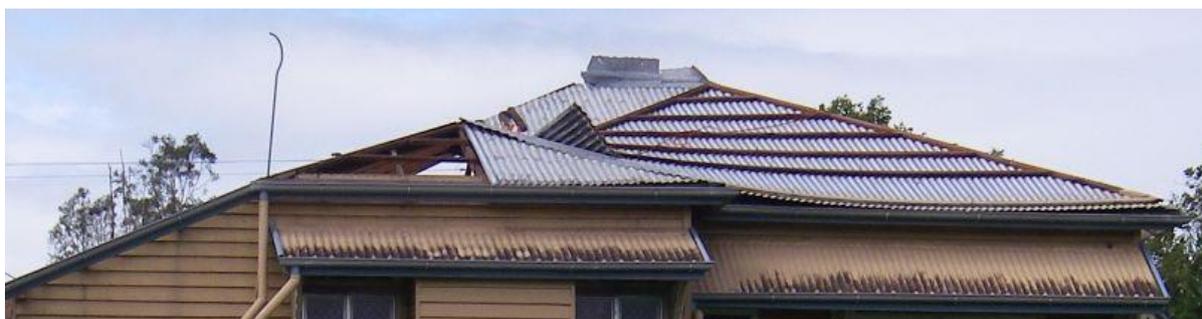
Figure 2. Part of the roof cladding with battens still attached flipped on to the leeward side

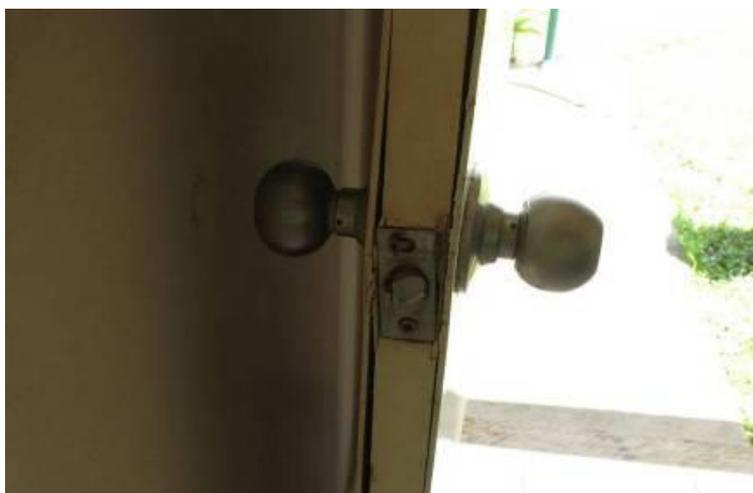
Figure 4. Standard lock and damaged door after being blown inwards during Cyclone Yasi

Figure 3 gives a representation of the pressures acting on a house. The high suction pressures at the leading edge of the roof can be seen. If there is a breach in the building envelope on this windward face, such as from broken window or failed door (Figure 4), the interior of the house is suddenly pressurised. These internal loads act in concert with the external pressures greatly increasing the load on the house cladding elements and structure. Depending on the geometry of the building, the increase in internal pressure caused by this opening can double the load on the structure, thereby increasing the risk of failure especially if the building has not been designed for a dominant opening.

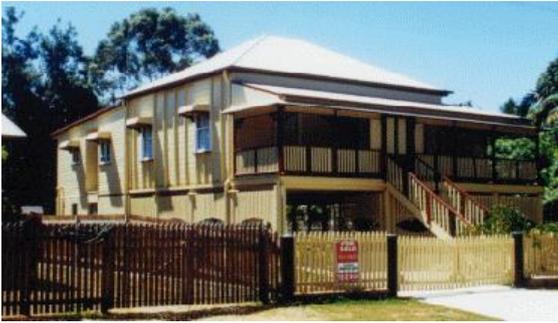
Table 1. Generalised examples of housing constructions types (King et al, 2013)

Built During	Example of geometry and features	Generalised features
< 1920s

Houses are complex structures and do not lend themselves to simple design and analysis due to various load paths from multiple elements and connections with many building elements providing load sharing and in some cases redundancy. Different types of house construction will have varying degrees of resilience to wind loads. From a review of building regulations, interviews, house inspections and load testing, the CTS classified the housing stock in the North Queensland region into six basic types (Henderson and Harper, 2003). These types are shown in Table 1.

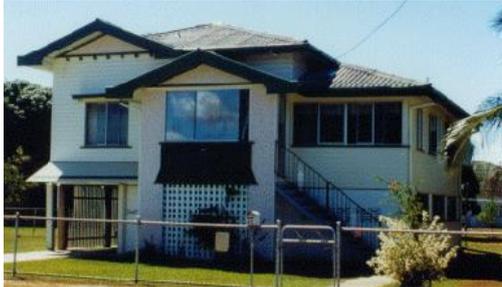
<p>Hip roof, reduced rafter spans, central core, exposed studs, on stumps (low and high)</p>
1920 – 1950s

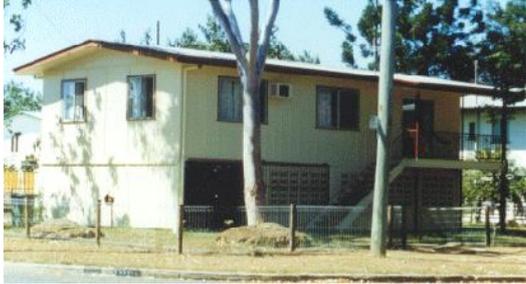
<p>Hip and gable, VJ lining, reduced rafter spans, on stumps (low and high)</p>
1960s – 1970s

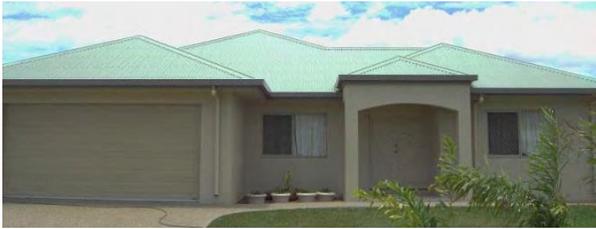
<p>Gable low pitch, vermin proof flooring (studs not mortice and tennon into bearers), panel cladding, on stumps</p>
> early 1980s

<p>Reinforced masonry block, hip and gable, large truss spans, medium roof pitch, slab on ground</p>
